UNIVERSITY OF NAIROBI

**EVALUATION OF EFFECTIVENESS OF NON DESTRUCTIVE TESTING
TECHNIQUES FOR INSPECTION OF CRITICAL AIRCRAFT COMPONENTS:
A CASE OF THE KENYAN AVIATION INDUSTRY**

A thesis submitted to the Graduate School in partial fulfillment of the requirements for the award
of Master of Science degree in Nuclear Science of the University of Nairobi

January 2020

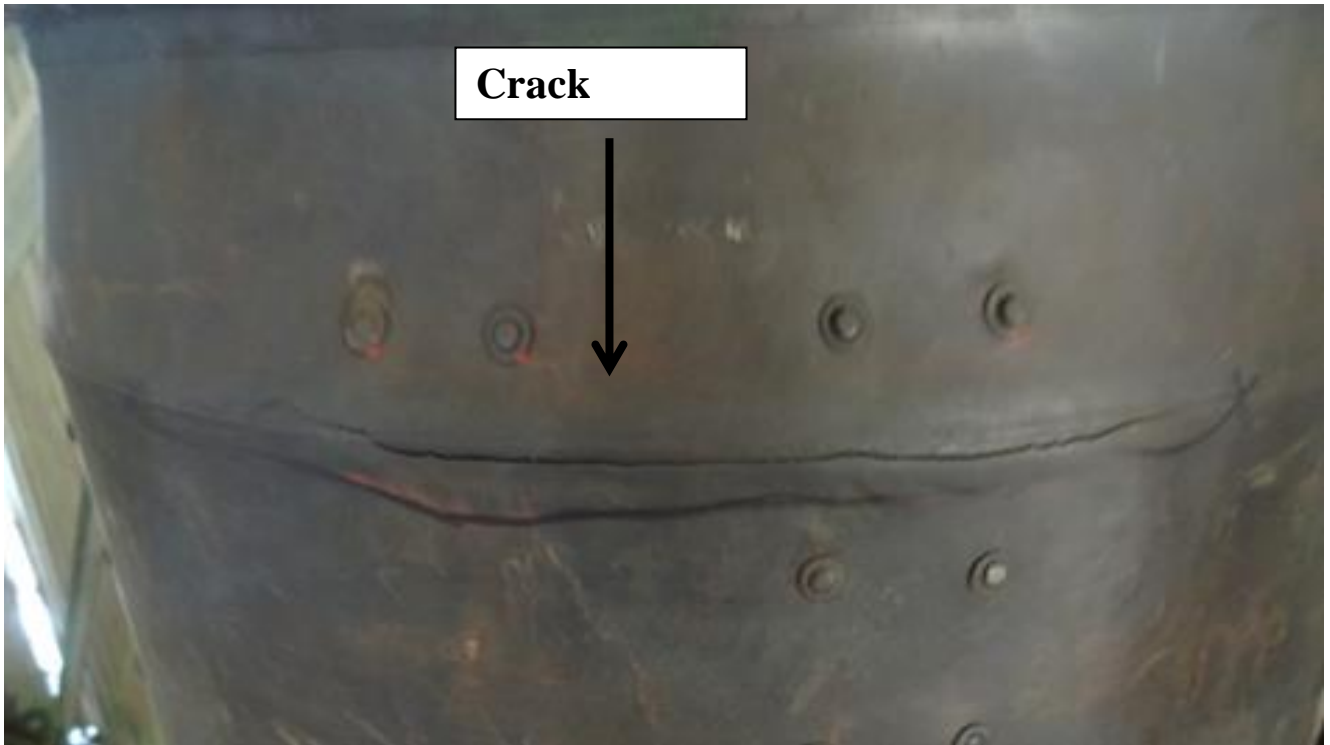
Figure 4.5: Boroscopic Image of Longitudinal Crack defect in the Engine Exhaust Section.

Figures 4.5 and 4.6 show typical cracks which were characterized as either longitudinal or transverse cracks in the Engine Exhaust using Visual Inspection (Borosopic). Other methods used for cracks detection include; UT and MPI.

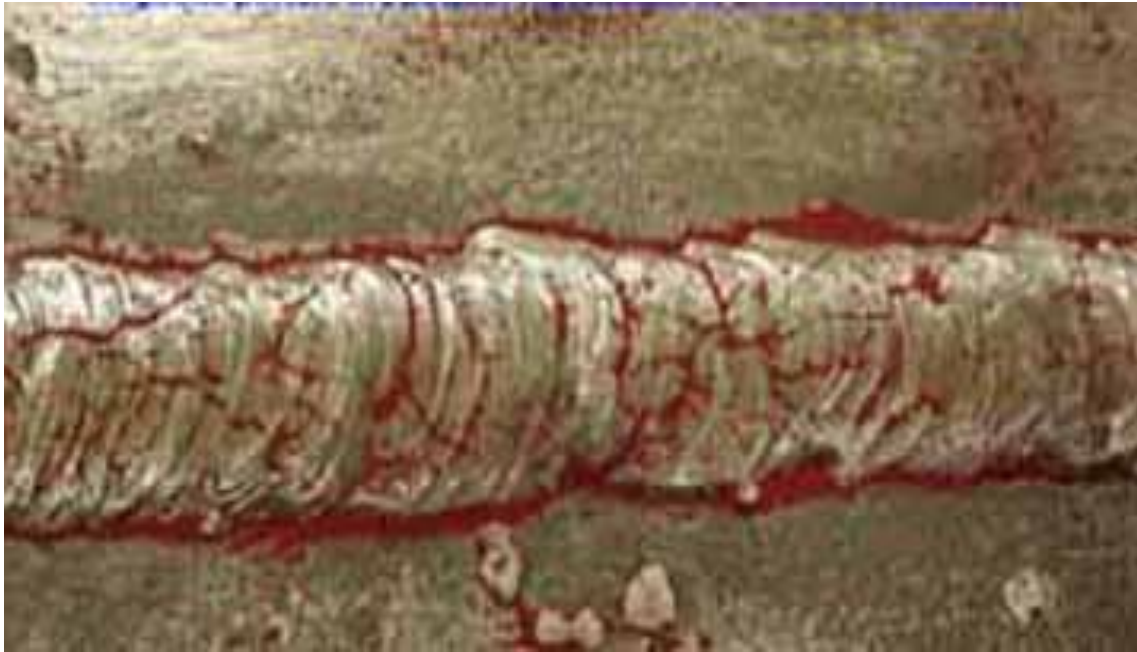
Figure 4.7: Corrosion defect in the aircraft Engine Compressor Section

Figures 4.7 and 4.8 show typical corrosion defects in the aircraft engine component, as observed by visual inspection. In general, an aircraft component experiences corrosion depending on its service conditions, operation and maintenance. Corrosion is the degradation of metals through interaction with the environment and was caused by the moisture from humid environment.

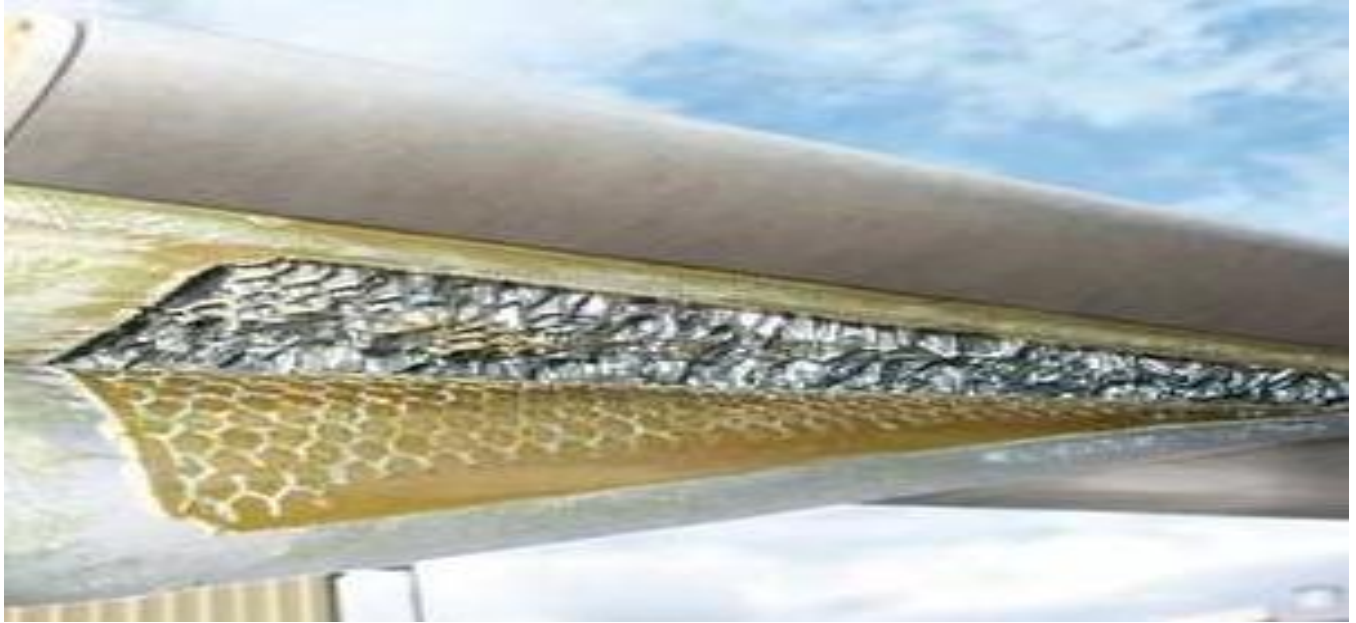
Figure 4.9: Delamination defect in the other aircraft Engine parts

Figure 4.9 shows a typical delamination defect in engine cowling of the aircraft that were detected by visual inspection method.

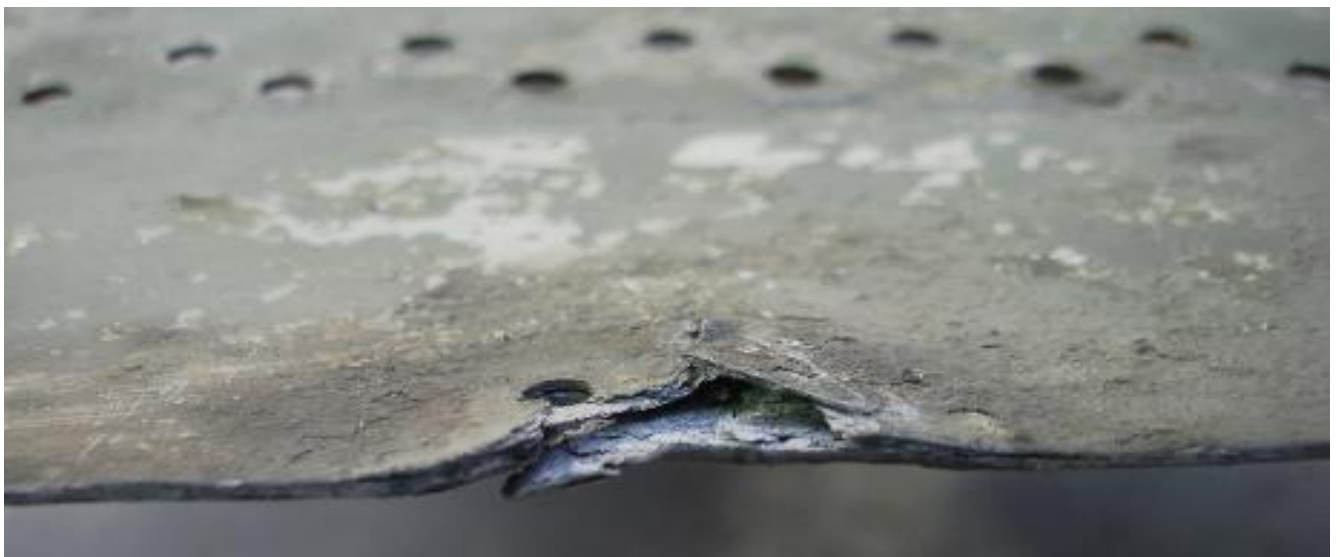
Figure 4.10: A disbond defect in the other Engine Sections.

Figure 4.10 shows a typical disbond defect in the engine assembly of the aircraft in the combustion chamber and other engine sections, disbond defects were detected by visual inspection method.

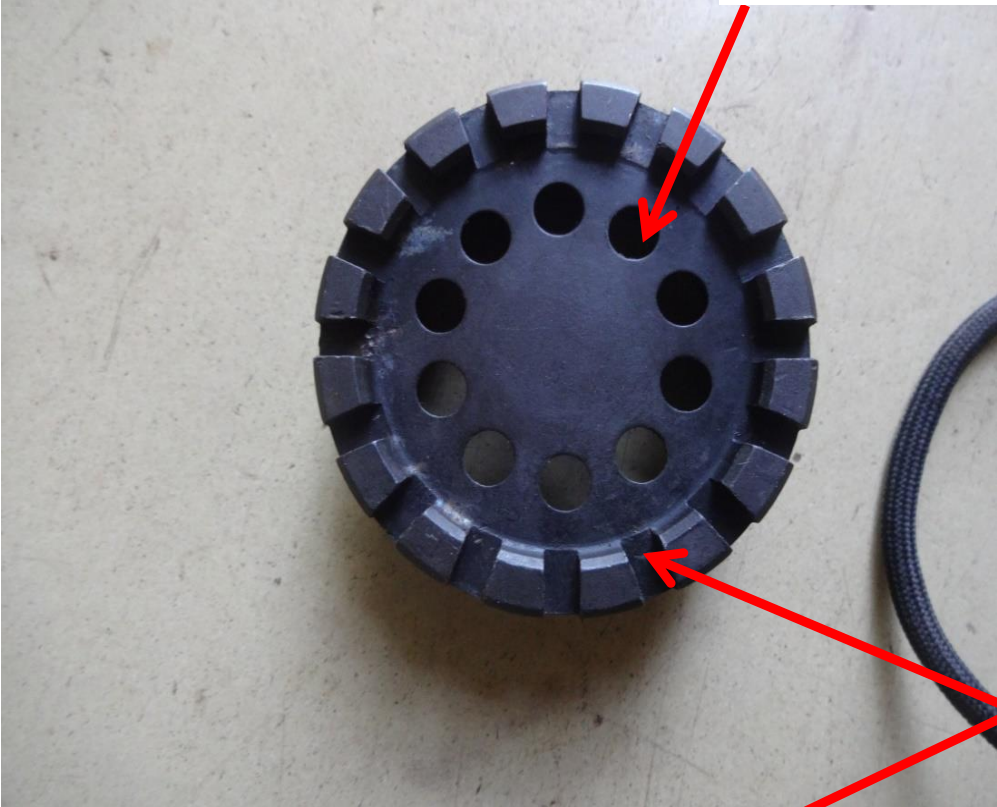
LOCK NUT SLOTS

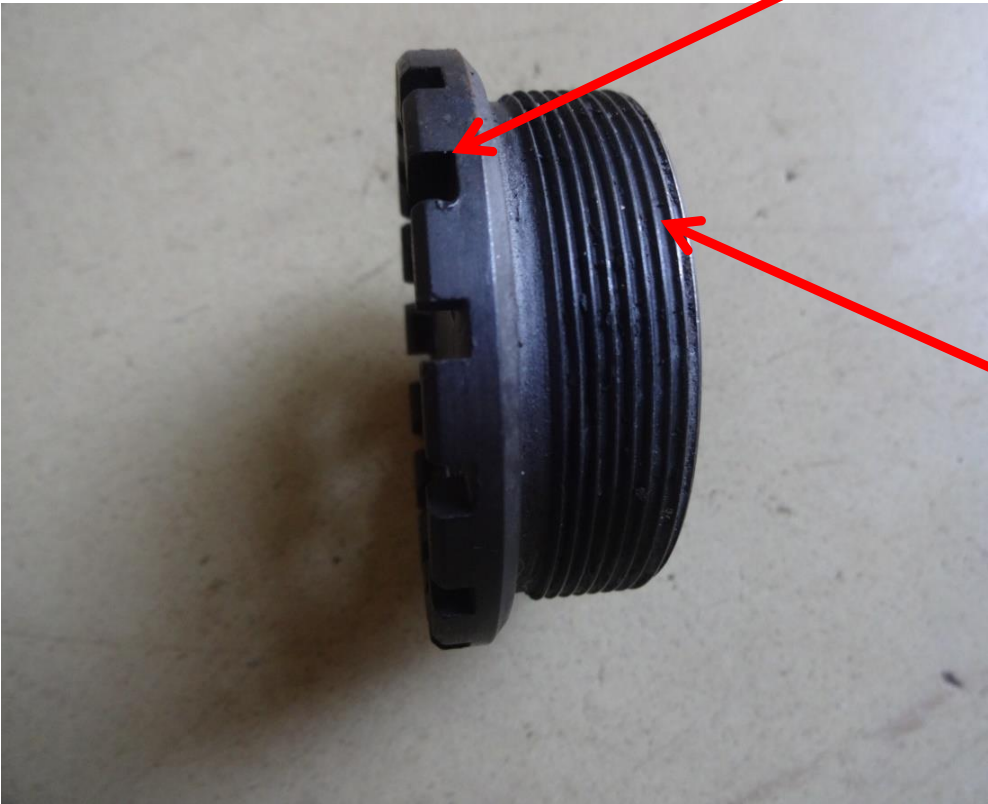
ALONG THE THREADS

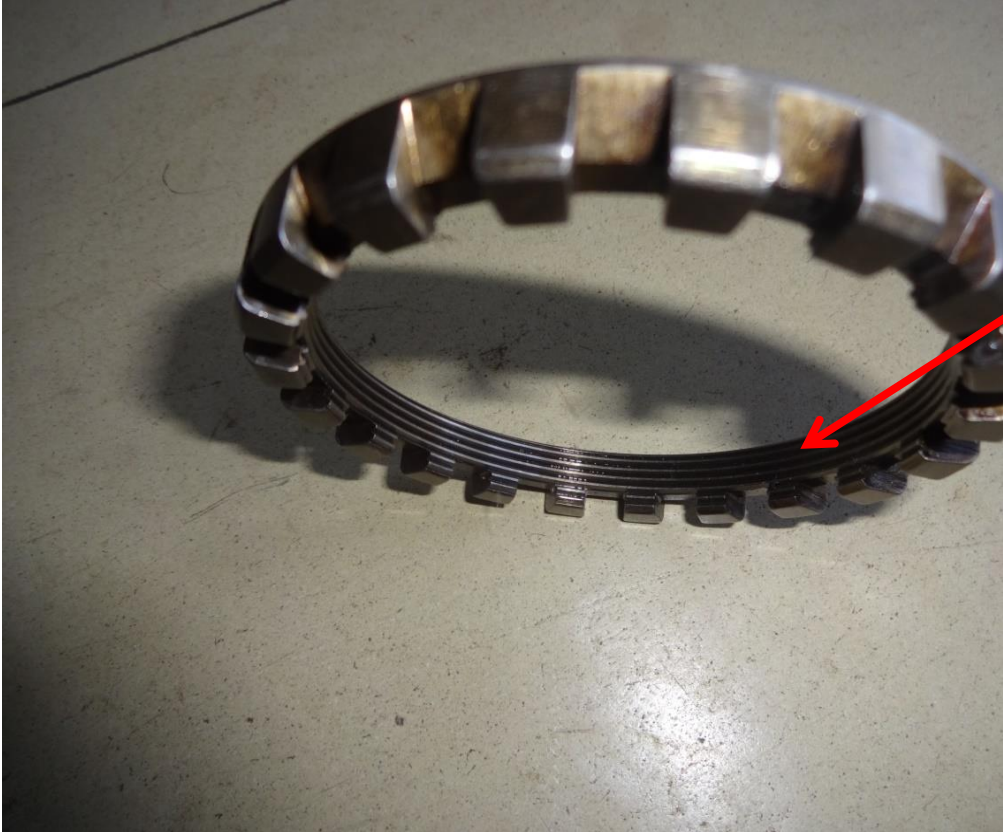
Appendix 22: Photos of Defects on The Bearing Locknut (Along the nut threads)

**ALONG THE NUT
THREADS**

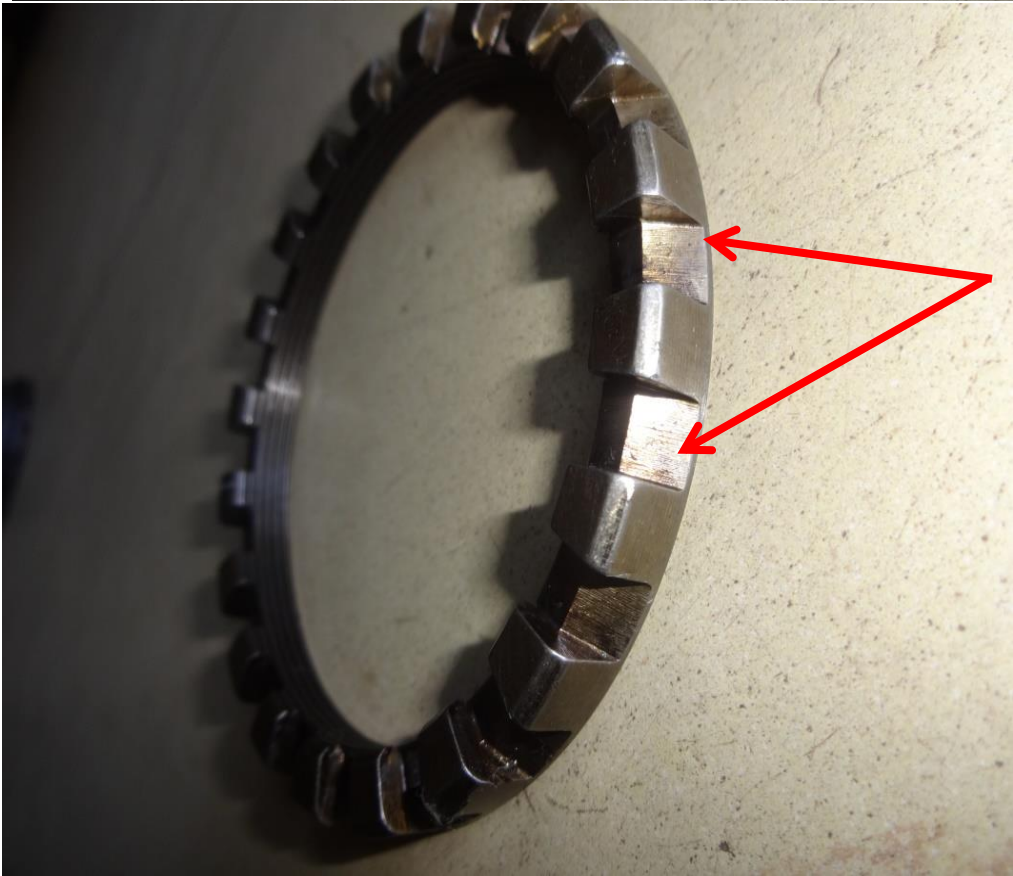
**POINTS FOR
CRACKS**

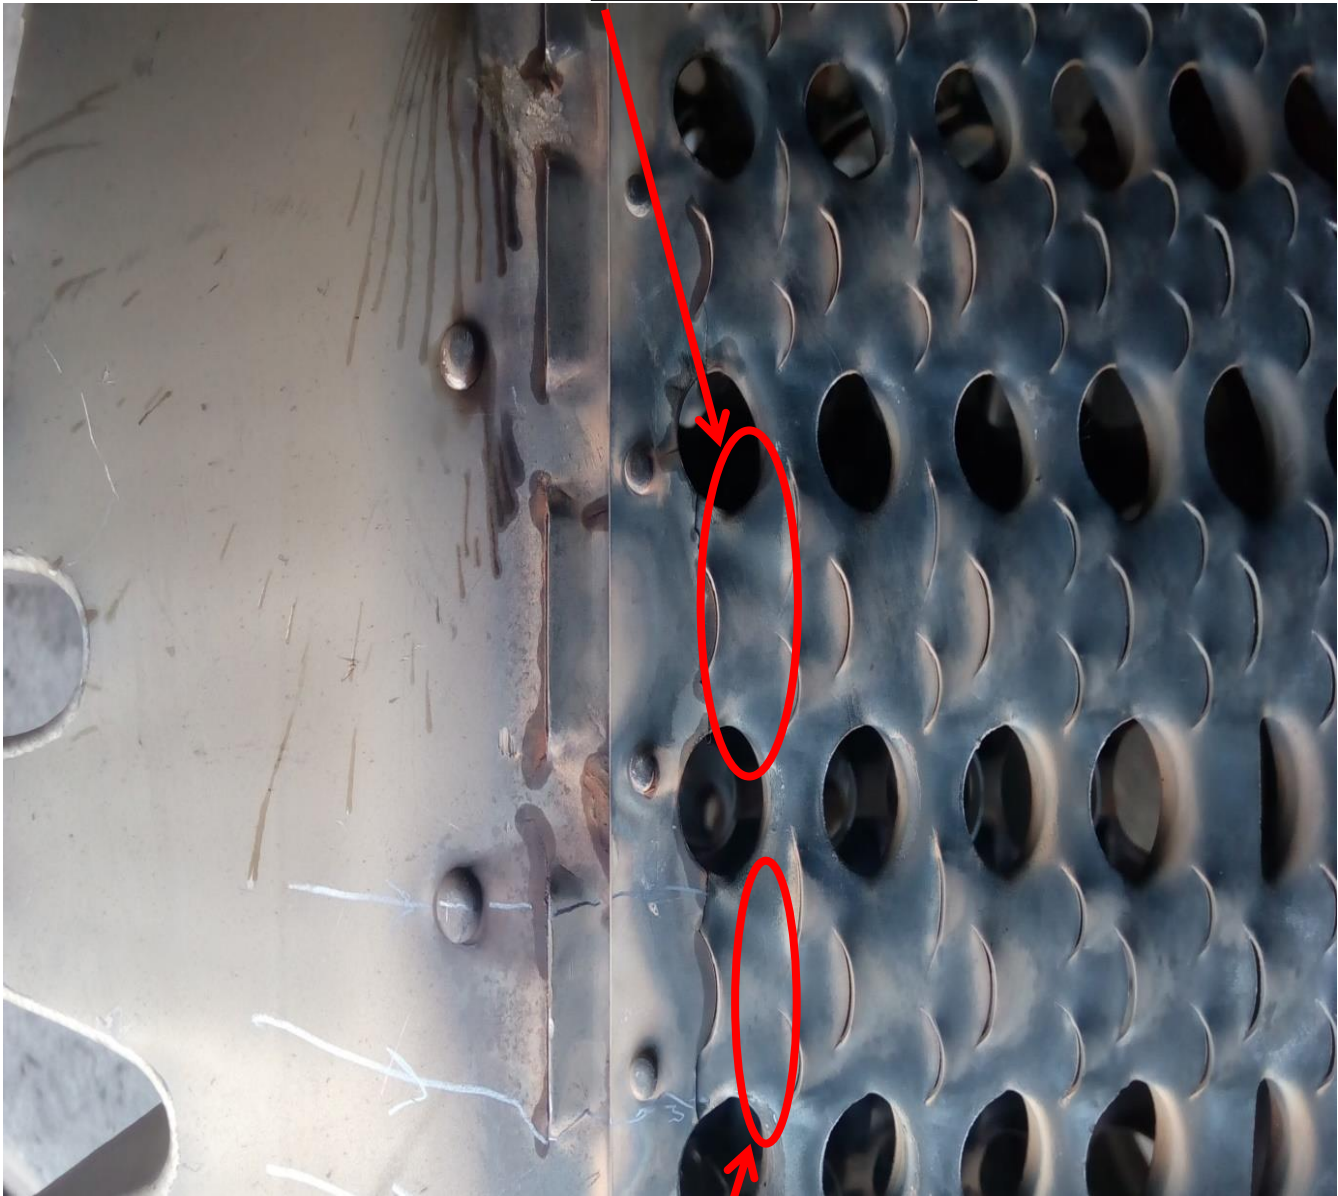
CRACKS FROM THE BAFFLES

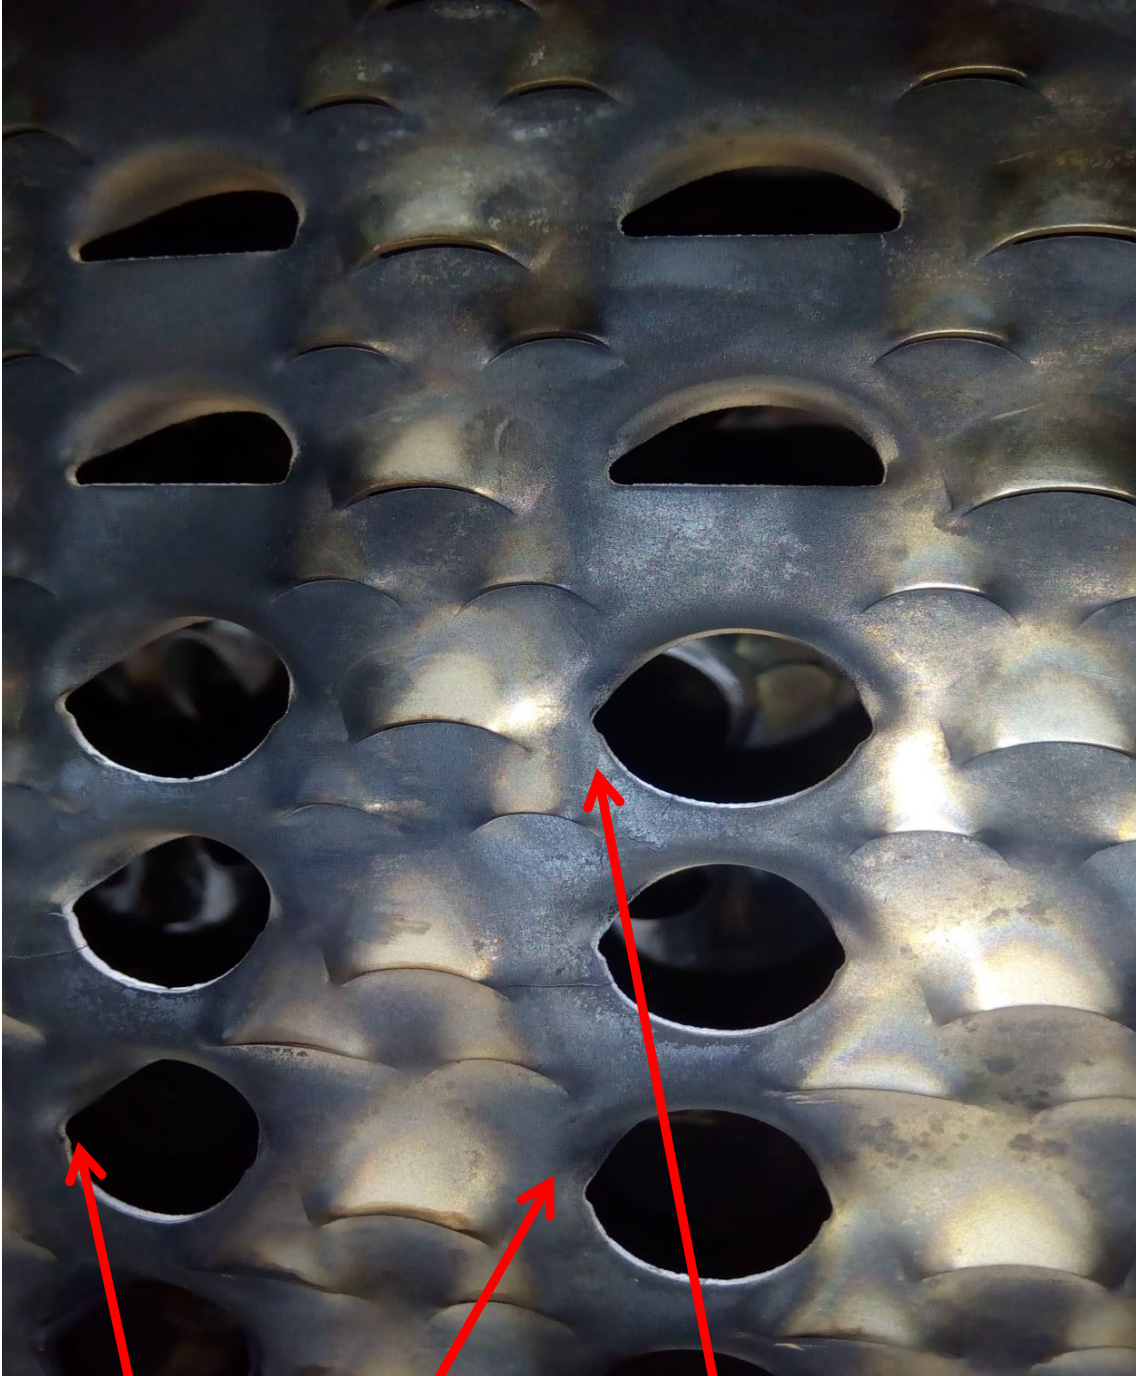
Appendix 27: Photos of Defects on the Combustion Liner

CRACKS ON COMBUSTION LINER AND BURNED OUT

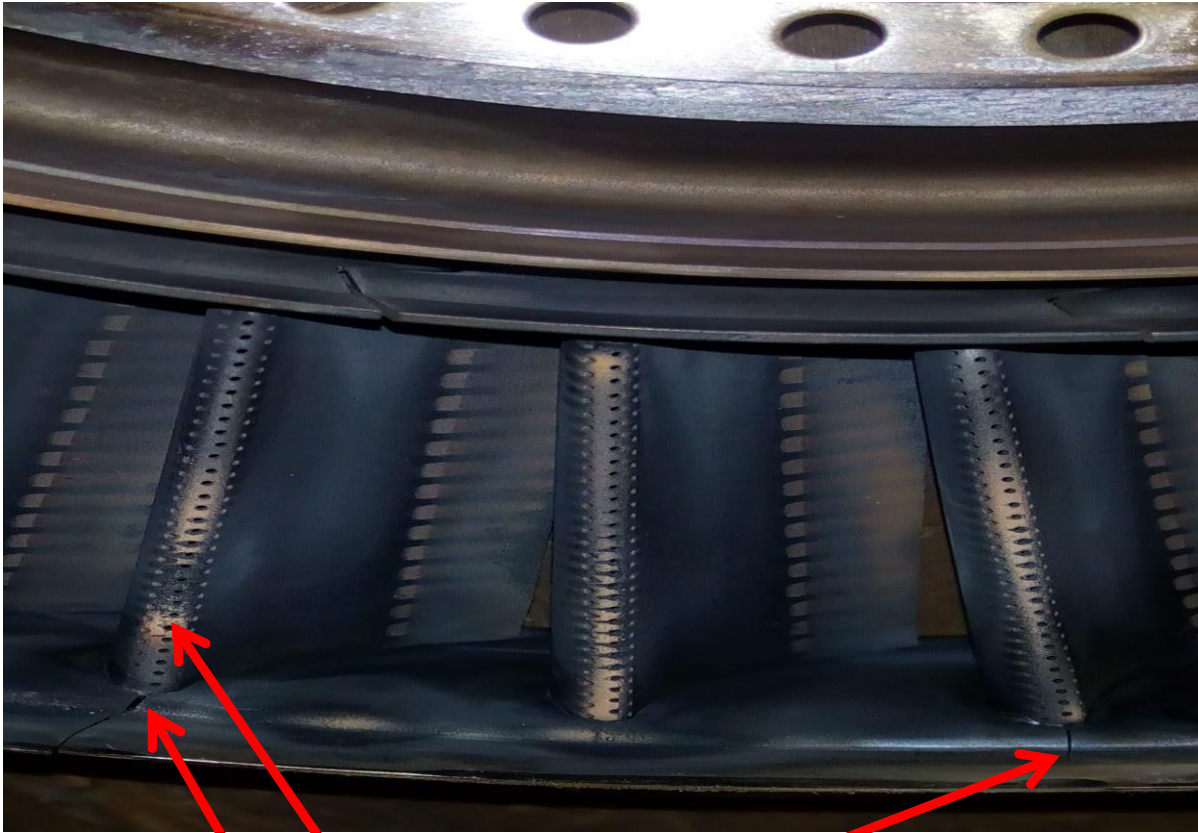
Appendix 31: Photos of Defects on Stage Two Nozzle

CRACKS AND BURNOUT VIEWED FROM FRONT AND SIDE

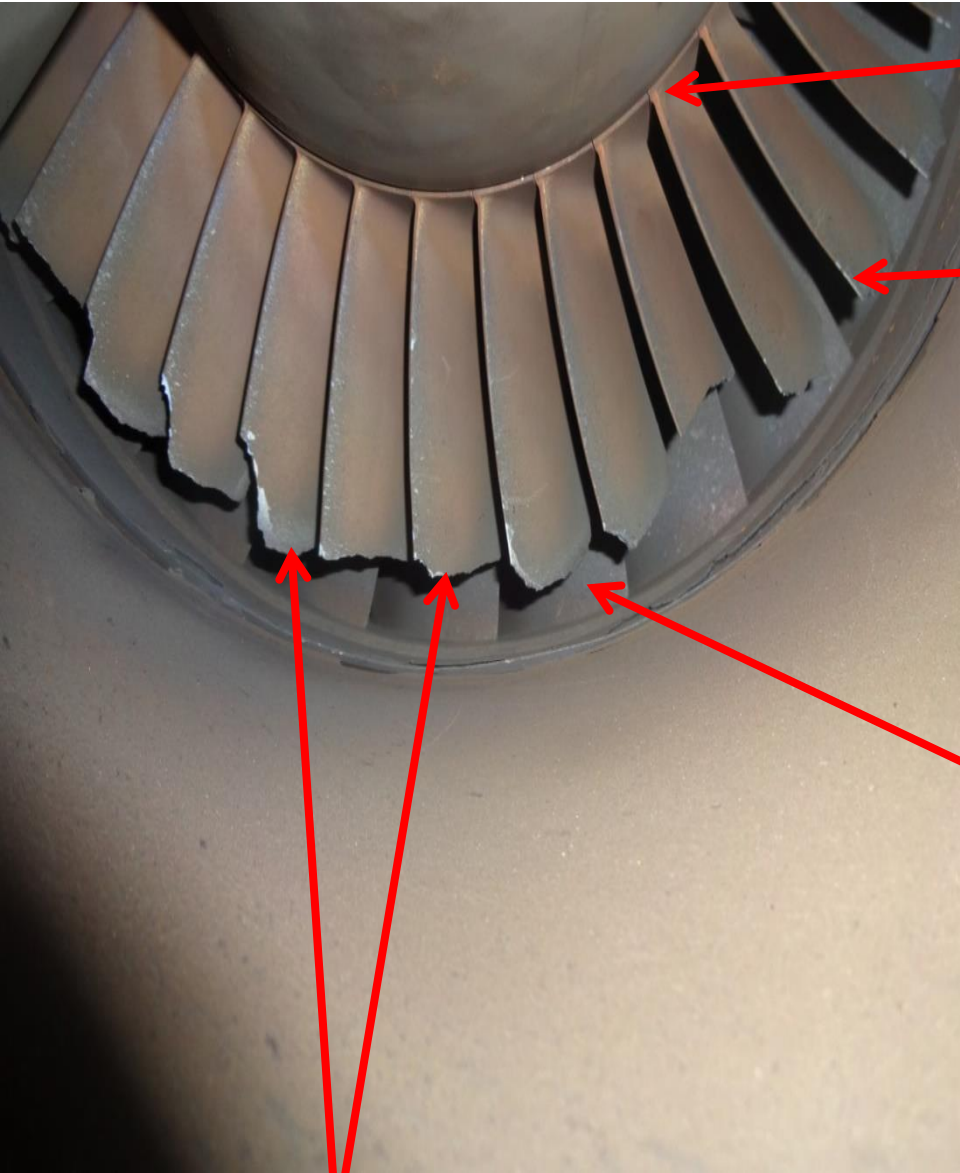
Appendix 34: Photos of the broken Free Turbine Blades

BLADE ROOT

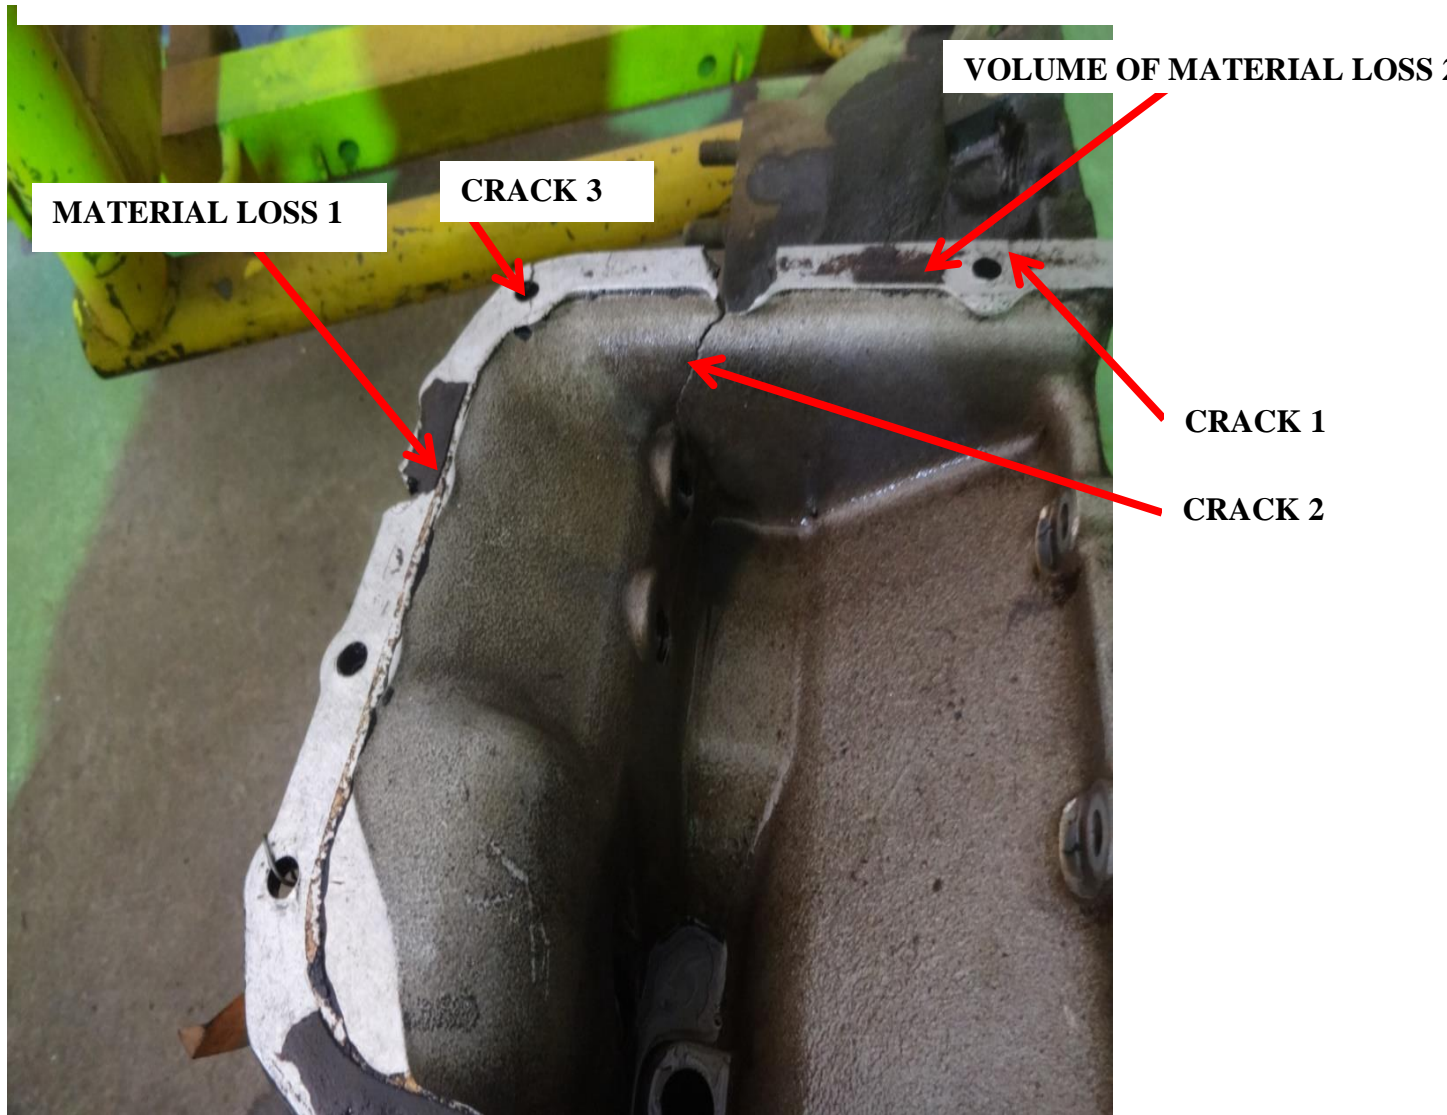
Appendix 44: Photos of Oil Sump Crank Case Mating Surfaces (Interior surface)

- 1) Crack 1 Length is 5.00 mm
- 2) Crack 2 Length is 22.00 mm
- 3) Crack 3 Length is 6.00 mm
- 4) Material Loss 1 Length is 8.00 mm and Depth of 5.00 mm
- 5) Material Loss 2 Length is 25.00 mm and Depth of 20.00 mm
