PROBLEMS ASSOCIATED WITH FLAT ROOFS  
AS A MAJOR CONCERN IN THE MAINTENANCE  
OF GOVERNMENT BUILDINGS: A CASE  
STUDY OF PUBLIC BUILDINGS IN  
NAKURU AND ELDORET //

A thesis submitted in partial fulfillment  
of the requirement for the degree of  
MASTER OF ARTS IN BUILDING MANAGEMENT

1987

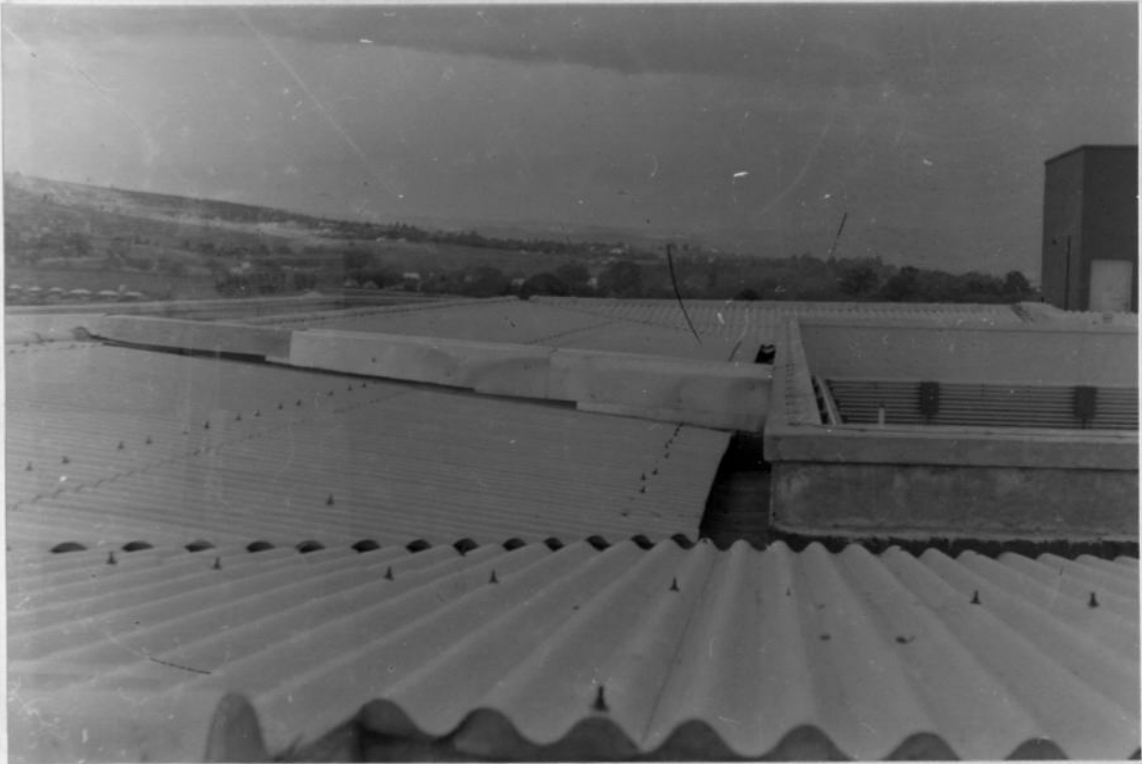
These measures are aimed at reducing or doing away with flat roofs. What these maintenance teams have decided to be doing is to construct pitched roofs on top of the problematic flat roofs. At the edges the parapets are either extended upwards or new ones built where they never existed. This move ensures that the false low pitched roof is hidden from any observer. This in effect amounts to having two roofs instead of one doing the same thing. As a method of solving roof problems it is both costly and wasteful. For example one of this renovative repairs was carried

out to a roof of 609 square metres at a cost of Shs. 345,784.00. During the same year a 536 square metre flat roof was repaired with roofing felt at a cost of Shs. 109,784.00<sup>7</sup>. If all the leaking roofs are to receive this renovative repair apart from losing any advantages they may have had as flat roofs they will cost quite a lot of money. Already three of the quoted roofs have been accorded these types of renovative repairs as recently as 1983/4 government financial year<sup>8</sup>. The other flat roofs mentioned might receive pitched roofs as soon as money is available to the maintenance teams. With the cost of materials and labour going up frequently pitched roofs on flat roofs will be very costly indeed in future. Plate 1.1 shows a section of a false pitched roof.

PLATE I FALSE ROOF OVER A FLAT ROOFED BUILDING

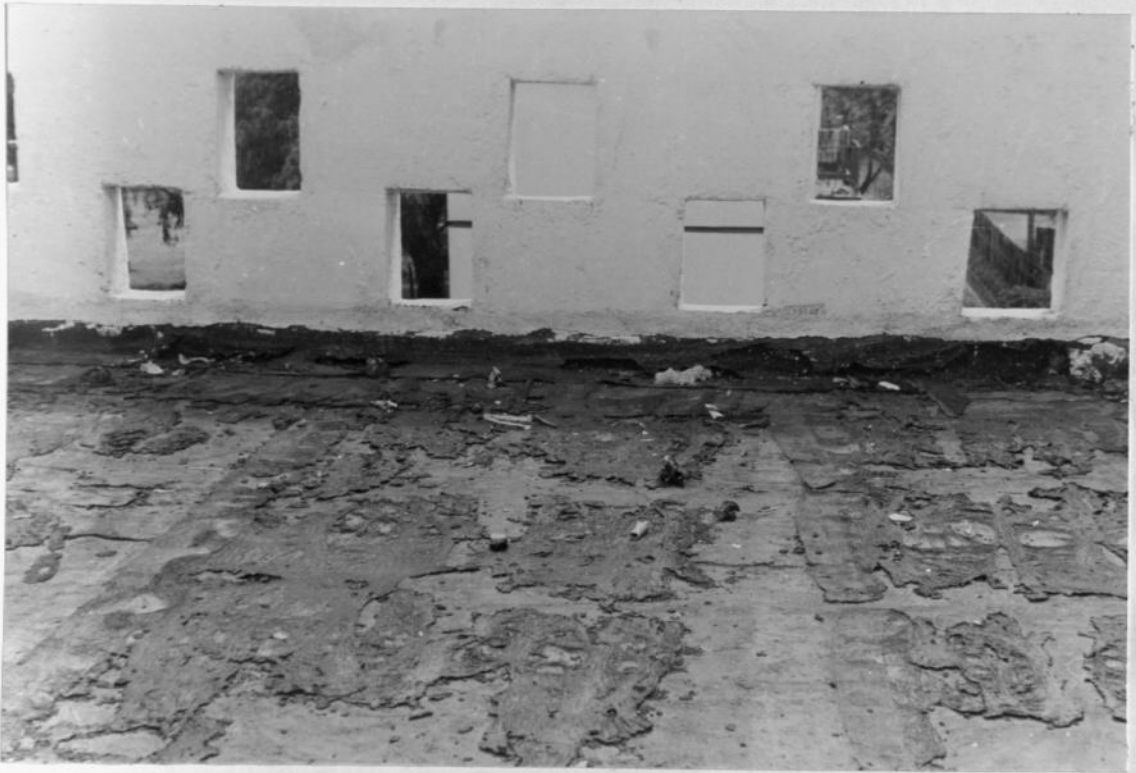
Despite the dangers existing in using bituminous roofing felt without a protective finish the number of unprotected felt roofs was very high. In all cases the felt had not been on the roof for more than four years and repairs were common. The performance of such roofs starts by being temporarily good but sooner or later total weathering renders the roof useless as a watertight structure.

At the time of the study the roofs which were unprotected against the weather had defects at that particular time or had their leaking spots repaired prior to the visits. However, none of the repair work instituted involved making the roof reflective. Infact the new patch applied was left as black as the other sections. The potential defects of an unprotected felts could be seen all over the roofs visited, worn surfaces, worn upstands, lifting of joints or even at the sections surrounding the outlets. This means that defects are only prevented temporarily. If ponding occurs at any place the consequential drying and evaporation stresses occur immediately and speedily increase with failure resulting thereafter. Plate II shows the effects of the sun on unprotected roof surface.

PLATE II BUILT-UP FELT ROOF SHOWING THE EFFECTS  
OF EXPOSURE DUE TO LACK OF REFLECTIVE FINISH

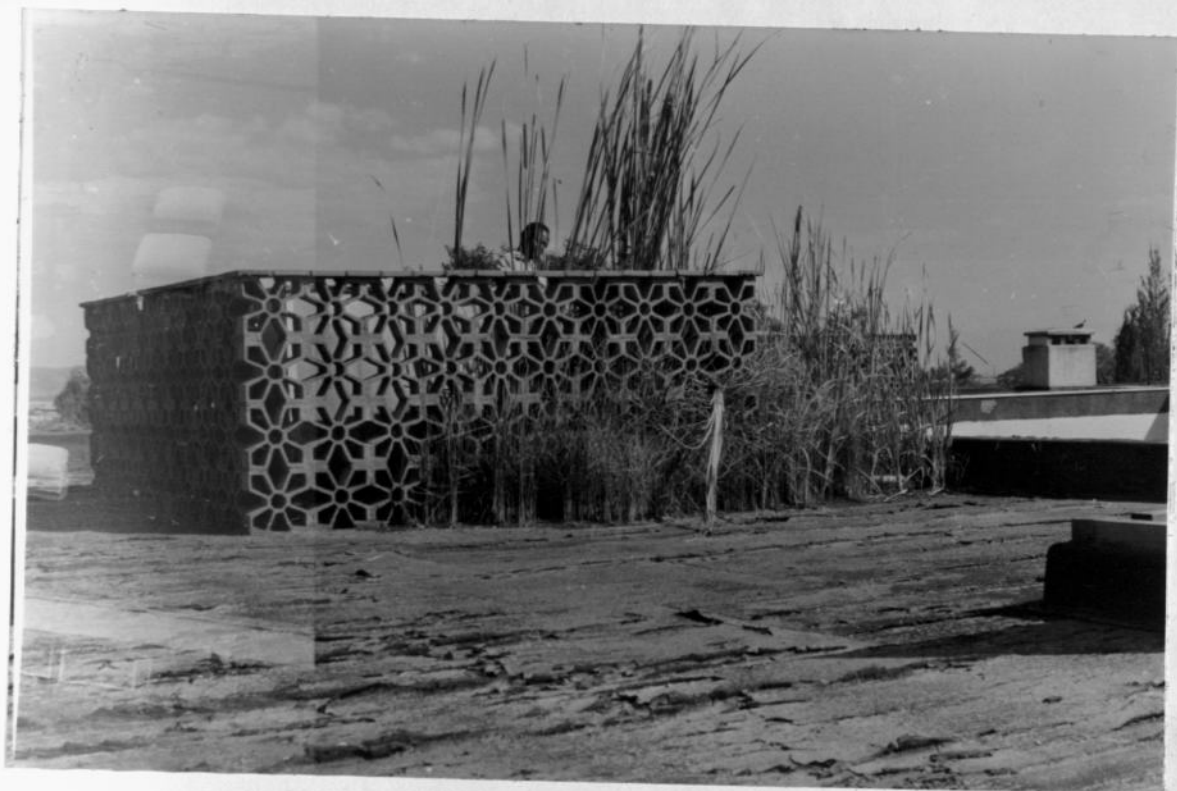
There were a few cases where one building was taller than the adjacent ones. In such an arrangement it was observed that there was a tendency of people throwing rubbish onto the lower roof. Some of this rubbish may interfere with the efficiency of the outlets.

The ground vegetations of the locality of the building have a part to play in causing roof problems. Where the grass happens to be covering the ground sparsely the winds will carry more dust than where the ground is thickly covered. Winds, especially miniature - cyclones, will sweep up a lot of dust from the bare ground patches or any cultivated areas and deposit it on any nearby roofs. In one case a building was found to have very strong plants which had germinated on the roof. This roof had a thick layer of dust around the outlet; unfortunately the roof storage tank had leaked for a long time thus enhancing the growth of wild plants on the roof. Plate 3 shows the results of prolonged dust accumulation on roof. Dust accumulation is also enhanced by the presence of dusty roads nearby.

PLATE III WILD PLANTS GROWING AROUND A BLOCKED  
OUTLET LONG FORGOTTEN BY THE MAINTENANCE  
TEAMS

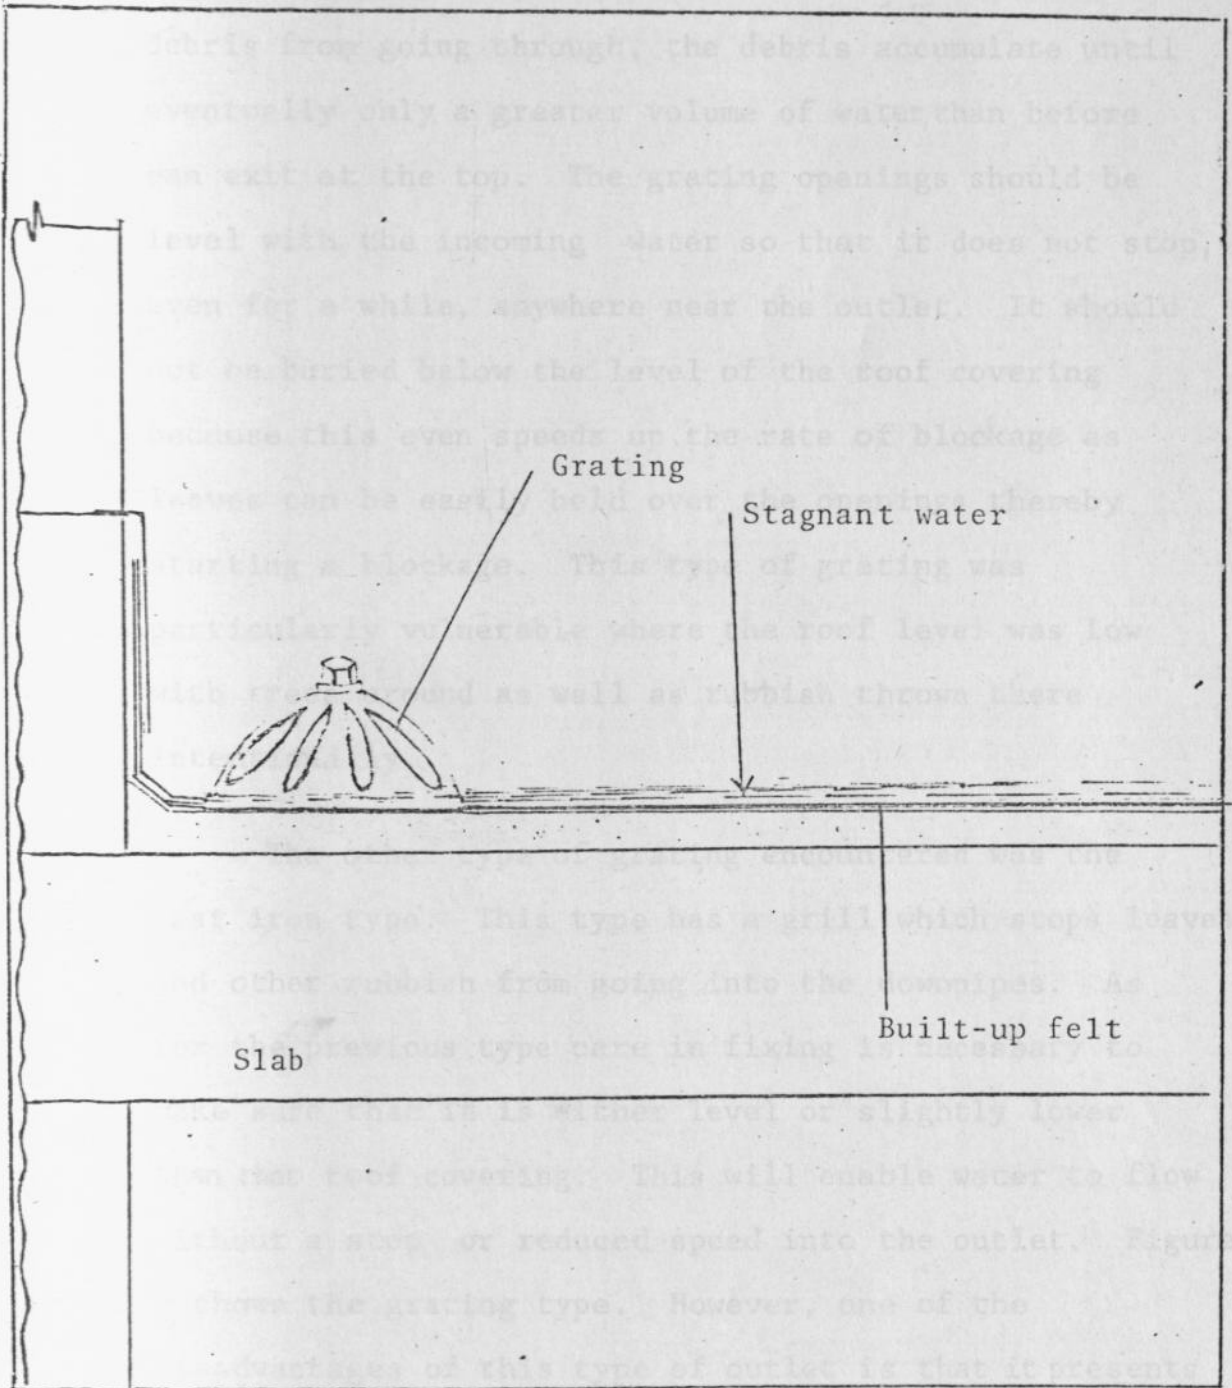
FIGURE 8 WRONG FIXING OF GRATING: WATER LEVEL IS FORCED TO RISE FOR WATER TO FLOW INTO THE DOWNPIPE

debris from going through, the debris accumulate until eventually only a greater volume of water than before can exit at the top. The grating openings should be level with the incoming water so that it does not stop, even for a while, anywhere near the outlet. It should not be buried below the level of the roof covering because this even speeds up the rate of blockage as leaves can be easily held over the openings thereby starting a blockage. This type of grating was particularly vulnerable where the roof level was low with trees around as well as rubbish thrown there intentionally.

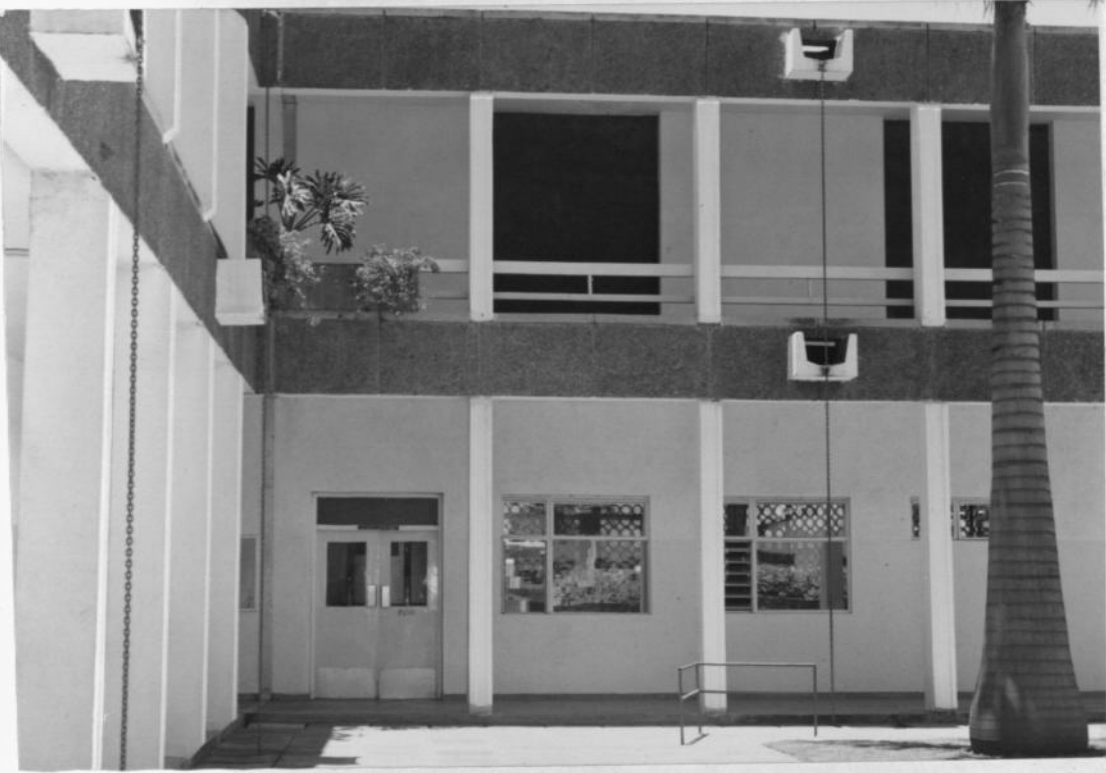
A rare method of discharging water from the roofs was encountered in two buildings. This was the use of a chain as a downpipe. The chain was fixed to an iron round piece in the outlet hole and then cast into a concrete channel at the base. Since this chain was an open water way it did not require a grating. It could not get blocked. This eliminated one of the major causes of roof problems; that is, of ponding as a result of outlet blockage. The chain discharges all the water

PLATE IV A CHAIN ACTING AS THE DOWNPIPE  
TO A FLAT ROOF

which finds its way to the outlet hole. However, it has limitations. Of the buildings which had chains as downpipes the tallest was a two-storeyed structure. The chains looked out of colour with the rest of the structure. And since it is external and would splash water on any part of a building by it, it cannot be hidden inside a column or a duct. This would tend to limit its positioning to verandahs and balconies. One of the roofs with this type of outlets had leakage problems but from ponding caused by inadequate slope. The other roof had a good slope and though maintenance attention to it was as rare as for other buildings no accumulation of debris was noticed near the outlets. Plate IV shows the 'chain downpipe'.
