**TITLE: EVALUATION OF THE PERFORMANCE AND
SUITABILITY FOR USE OF VARIOUS FLOORING MATERIALS
IN STUDENTS' HOSTELS;**

**CASE STUDY OF THE HOSTELS IN THE UNIVERSITY OF
NAIROBI (MAIN CAMPUS) AND KENYATTA UNIVERSITY.**

**A PROJECT PAPER SUBMITTED IN PART FULFILMENT OF
THE**

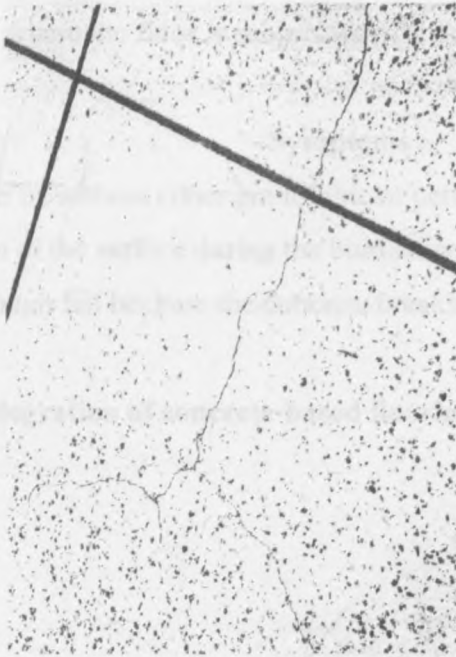
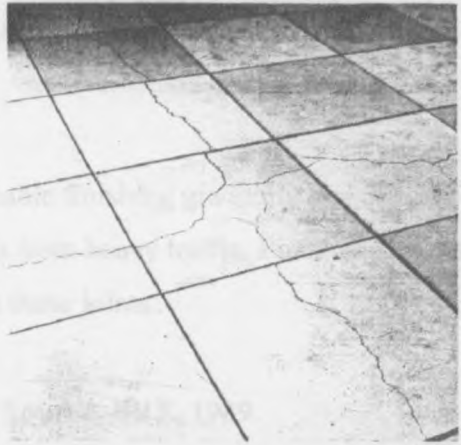
Figure 2.10, Floor cracking, pitting and breaking up in dense in-situ concrete floor finishes.

Photos 1, 2 & 3 Cracking of dense, in situ, floor finishes.

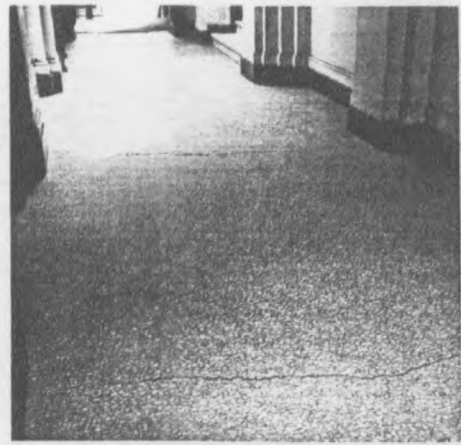
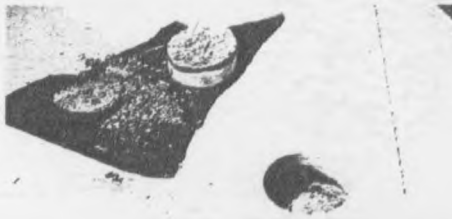
Photos 4 & 5 Cores drilled from a granolithic floor topping showing poor compaction and a high percentage of voids.

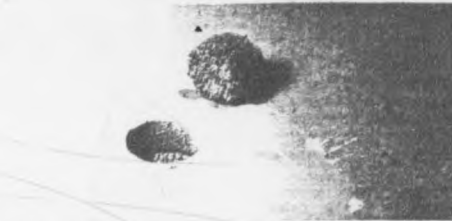
Photo 6 Good core sample from an area in sound condition.

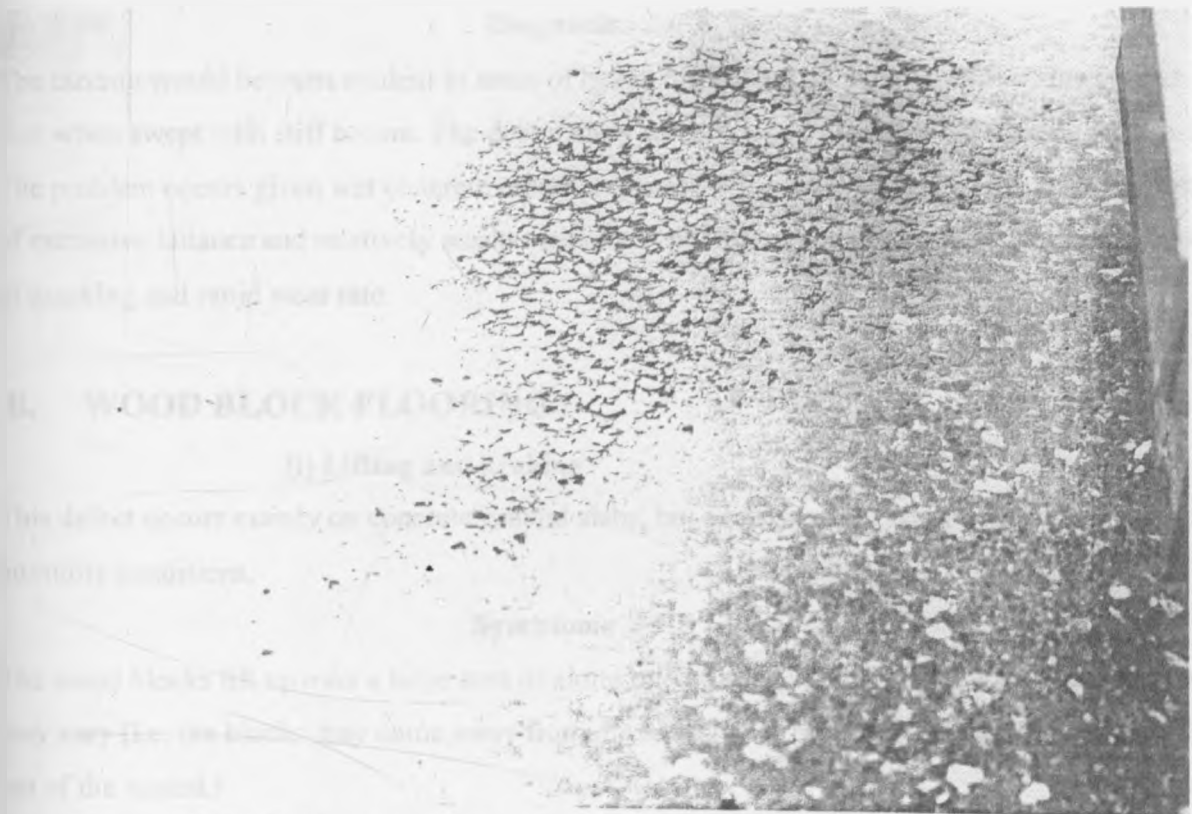
Figure 2.20 Disintegration of concrete-based flooring, Source, BRE, 1989.

Photo 1 Breakdown of terrazzo finish at a buffet checkout caused by a combination of wear and spills of milk and other food stuffs.

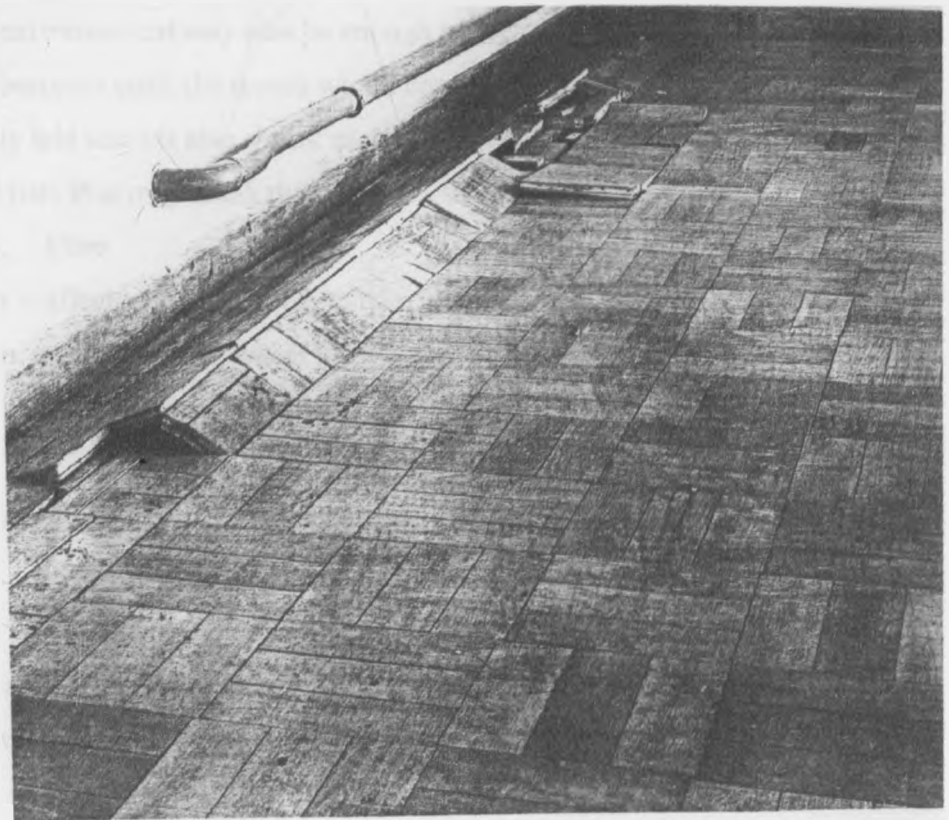
Figure 2.30, Lifting & Arching of Wood blocks. Source, Building Research Establishment, BRE, 1989.

Photo 1 The lifting and arching of the blocks is caused by construction water, use of the building, leaks and flooding or an inadequate damp proof membrane.

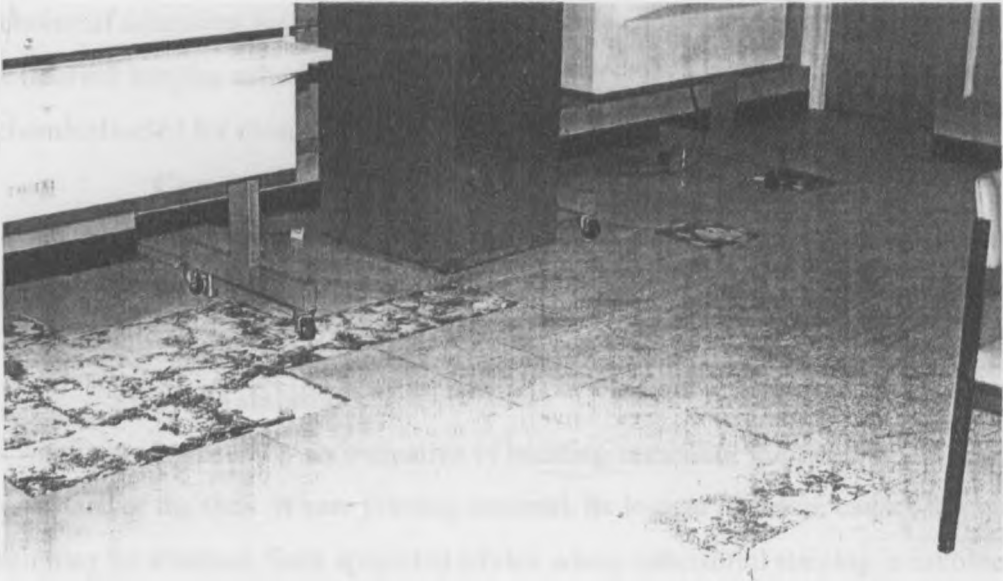
Photo 2 Lifting plastics tiles over defective damp proof membranes (see also 7.2.13)

It's essential to establish the source of water reaching the tiles and eliminate its presence in future. Where possible the cleaning should be restricted to wet mopping.

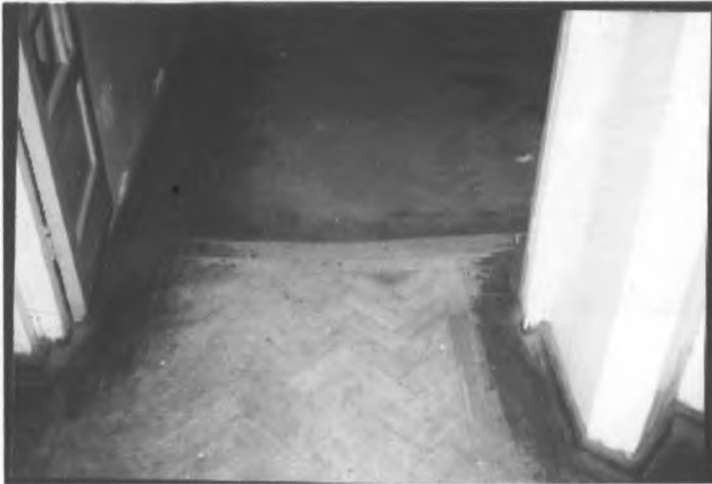
Plate 4

PLATE 4. Uneven traffic wear on parquet in corridors, LSHRH.

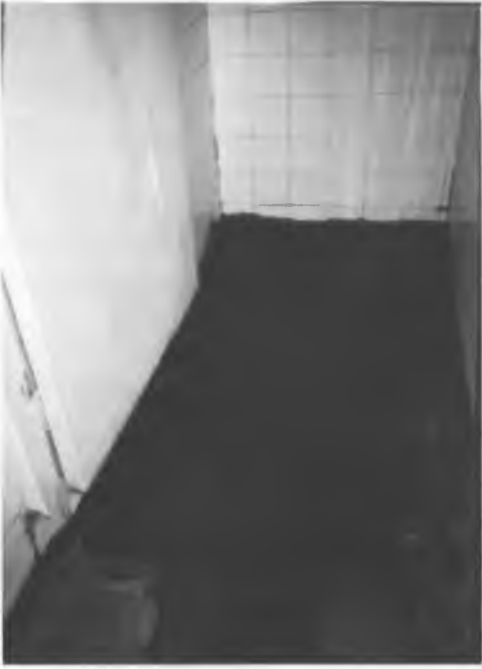
Plate 10

PLATE 10. Degradation of screed in Washrooms, Rwenzori/prefabs.

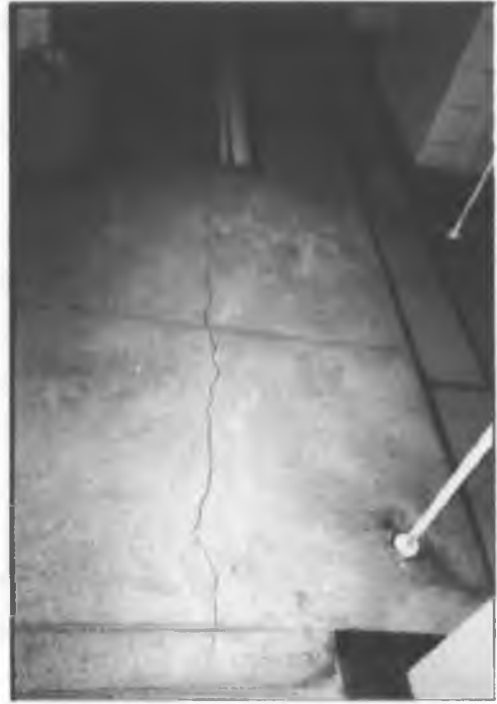
Plate 11

PLATE 11. Mild cracks on old terrazzo paving, Old Aberdares.

Can be carried out by cutting away and relaying and polishing, but not by filling cracks

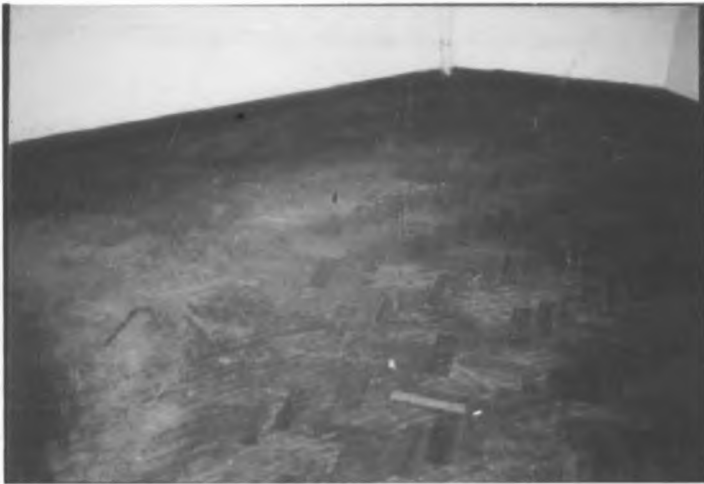
Plate 12

PLATE 12. General degradation of parquet in common rooms, TV Rooms; Lower State House Roads Hostel, Halls 9 and 12.

Consist of removal of damaged blocks. The new blocks replaced, sanded and polished.
