Building Research Establishment Digest

Prevention of decay in external joinery

An increasing number of reports of 'wet rot' in external joinery, particularly in new houses, suggests that the factors responsible are not as widely understood as they should be. This Digest examines the causes of decay and makes recommendations as to its prevention.

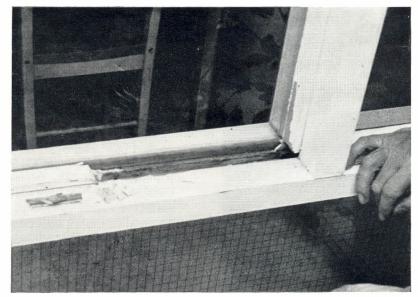
Fig 2

Outer glazing bead nailed—not glued or sealed. Result—free moisture penetration.

Grooves machined for outer glazing bead run right through mullion/transom joint. Result—void for collection of moisture

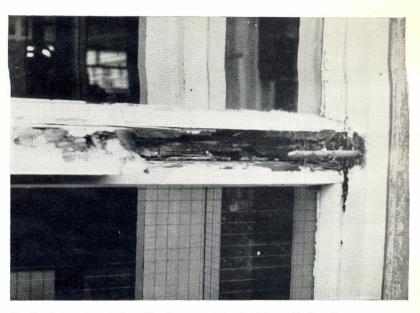
Fig 3 External part of mullion/transom joint held by nail. Result—water penetrates freely once the paint film is broken. Failure through decay began after three years' service

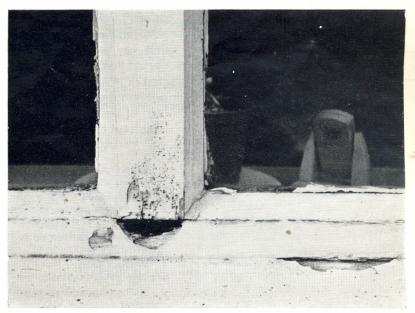
Fig 4 Gap left beneath tenon in joint between stile and cill or, in this case, between lower rail of main frame and base of mullion. Result—void for collection of moisture and eventual decay

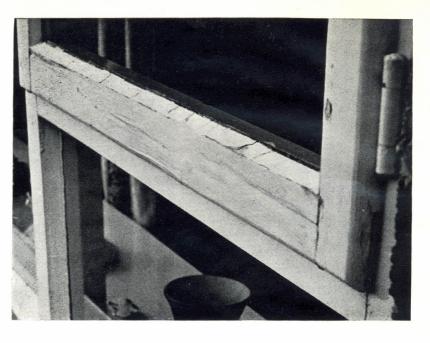
Fig 5 Cupping of paintwork and putty failure associated with decay in lower rail of an opening light

It is important that all decayed wood should be cut out and paint stripped from adjacent areas so that damp, but not rotten, timber can be given a chance to dry out. If decay is extensive the entire window unit may have to be replaced. Wood exposed by cutting should be treated liberally with preservative, again allowed to dry, then given a coat of primer. Depending on their size, holes should be made good with stopper (see above) or primed timber, suitably shaped. Another coat of primer should be applied to the new surface, followed by undercoat and finishing coats.
