Wall of Dry Dock at Port Florence.

FAILURE OF DOCK PROOFING DOOR.

FAILURE OF DOCK.

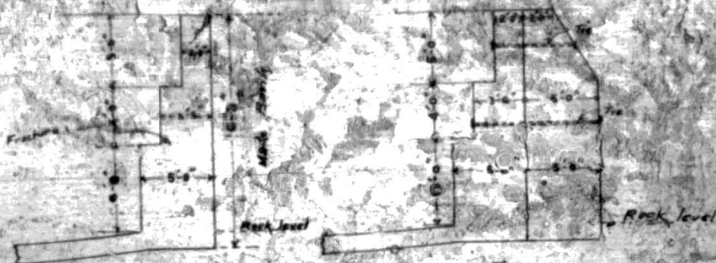
Fig 1

I have the honor to report for your information that I received a telegram on Saturday the 21st instant from the Superintendent of Way and Works who was at Port Florence that the dock wall had failed. I at once called for the report and in forwarding it have little to add beyond remarking that there can be doubt the failure is due to abnormal pressure of water and the saturation of the sand found at the back of the dock wall.

The dock was raised dry on the 17th April.
During the night of the 18th or early in the morning of
the 20th the south wall of the dock for a distance of
110 feet from the entrance moved inward towards the dock
about 6" in the worst place. A large crack extended
along the level of the lowest water through which a con-
siderable amount of water poured. On examination of
the collapse I at once ordered that the water should be
let into the dock so as to equalise the pressure and
prevent total collapse; this was done and no further
movement has taken place. The figure (1) will show
the section of the wall which moved forward and figure
(2) proposed means of strengthening.

The causes of collapse are at present doubtful, the section of wall in figure (1) is quite capable of bearing the pressure of the water tank at its back. However owing to heavy rains a large quantity of water may have drained off the hill behind the dock and collected in a mass behind the wall thereby giving a pressure equal to still water. To withstand this the wall will have to be ~~etc~~ thickened as shown in figure (2). The same thing may happen to the north wall so that will have to be strengthened in the same way. For this about 20,000 cu. ft. of concrete will be required at a cost of 18 annas a ft. which is 3,600. A heavily timbered excavation will be required behind the wall, and the total estimate for repairs will not be much under 8,2,000. It will take from three to four months before the dock can be used again if everything goes satisfactorily. It is impossible to make a true estimate of the cost until the trench is dug and the causes of collapse are more apparent.

So that as it may be necessary to face the repair which must go on at once and the Engineering Department is now preparing a design and arrangements to do so. No provision has obviously been made to meet an expenditure of this sort and it must go in under the provision made for general head "Maintenance".

The occurrence is unfortunate in that it will somewhat delay the completion of the "Clayton Hill" which was to have been built in the dock while we must now do so on a slip the provision of which was not contemplated. The strengthening of this dock will call for a considerable quantity of cement more than arranged for and an amount is now being ordered with a request that a society be sent out early.
