**UNIVERSITY OF NAIROBI**  
**FACULTY OF ENGINEERING**  
**DEPARTMENT OF CIVIL & CONSTRUCTION ENGINEERING**

**PAVEMENT EVALUATION OF KAMPI YA MOTO -  
ELDAMA RAVINE - KAMWOSOR B77 ROAD**

**MSC THESIS**

**NOVEMBER 2023**

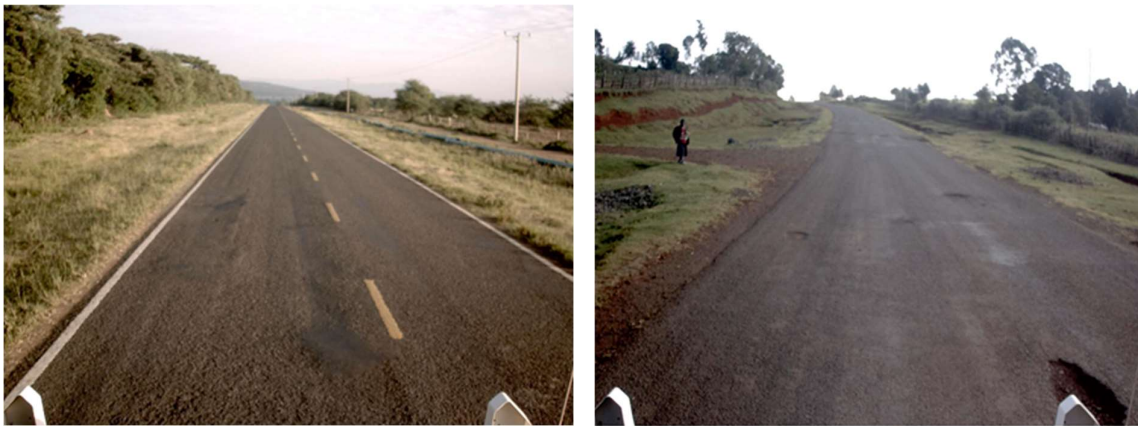
The minor distress observed that did not reflect on the structural state of the road included bleeding of the asphalt concrete (AC) surface, as depicted in Figure 4-1. The road also exhibits several major distresses, including potholes, eroded edges, block cracking, depression, rutting, lack of shoulders, and poor drainage, as illustrated in Figures 4-2 and 4-3.

*Figure 4-1: Minor distress (bleeding) and lack of drainage system on Kampi ya Moto-Kamwosor Road (source from the field)*

Based on field observations, as shown in Figures 4-1, 4-2, and 4-3, it was concluded that the surfacing distresses were caused mainly by drainage issues. There were sections noted with water oozing through a poorly bonded pavement layer. The visually surveyed surfacing distresses were found at kilometres 3, 14, 55 to 67, and 72 to 79.5.

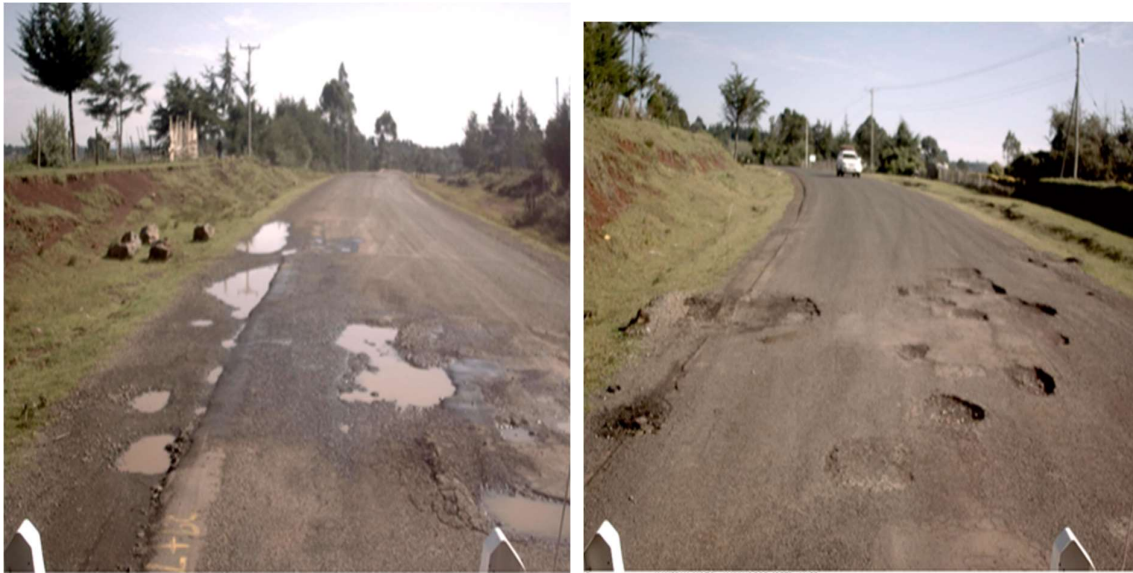
*Figure 4-2: Major distress and lack of defined system. (source from the field)*

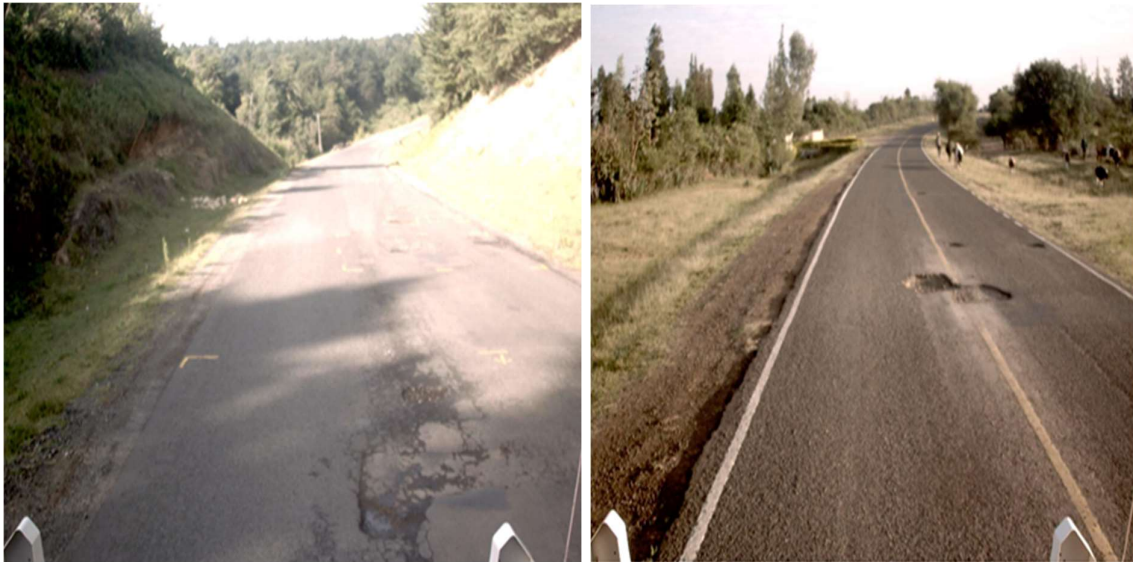
*Figure 4-3: Major distress on Kampi ya Moto - Kamwosor Road (source from the field)*

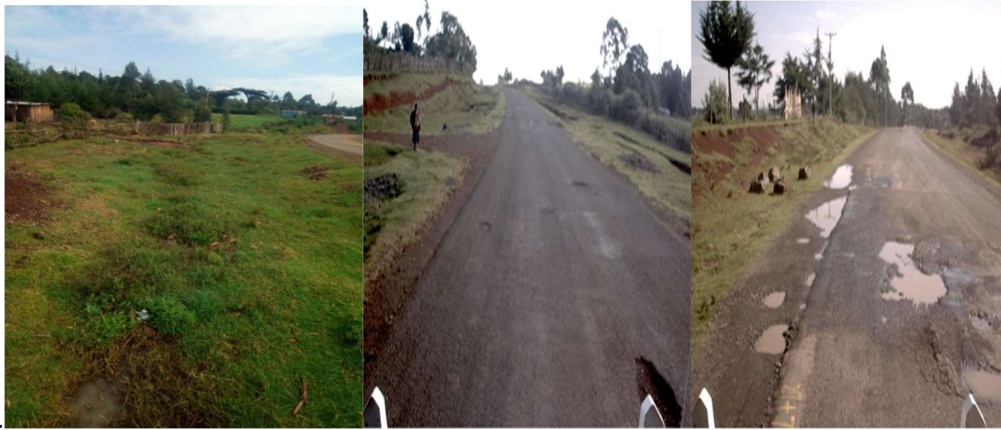
After conducting a visual and surface condition survey, it was discovered that the road lacked proper drainage, which was deemed necessary. The drainage condition for the entire road was found to be very poor and was therefore labelled as undefined. During the visual survey, certain sections were observed to lack longitudinal drainage, which caused water to alter its course and flow above the road carriageway. This resulted in water seeping into the pavement structure, weakening the underlying layers. Figure 4-4 depicts the undefined drain condition of the road carriageway as a result of the investigation conducted in the field. The road's drain condition was categorized as BAD, which likely contributed to the deterioration of the pavement structure.

Figure 4-4: Sections with no drainage channels (Sourced from the field)
