**A WATER QUALITY, BIODIVERSITY ASSESSMENT AND COMMUNITY
PERCEPTION ANALYSIS OF RUNGIRI RESERVOIR, KIKUYU,
KENYA.**

**A Project Report Submitted in Partial Fulfillment of
a Master of Arts Degree in Environmental Planning and Management,
in the Department of Geography of the University of Nairobi.**

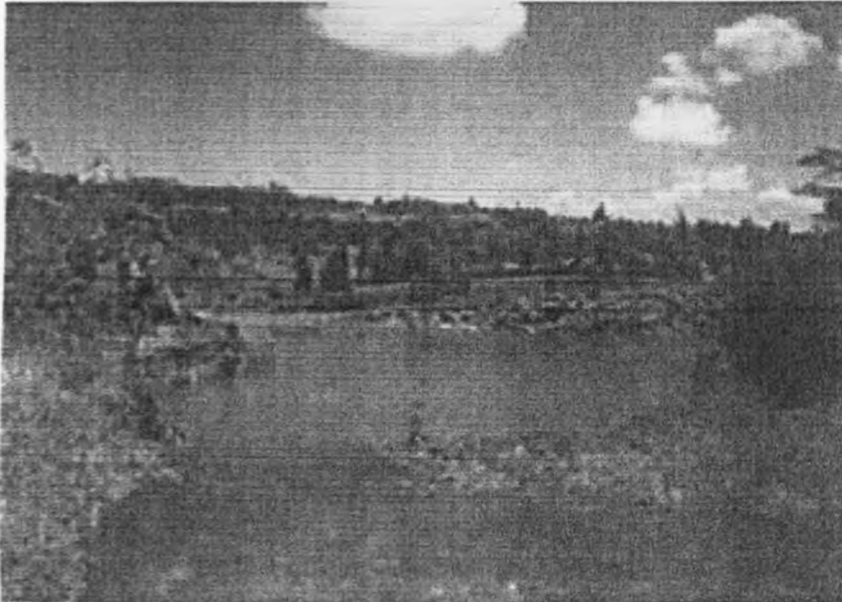
Plate 1: Rungiri reservoir as seen from the southern end.

Rungiri reservoir came into being when water through underground seepage and runoff filled the disused quarry in the early 1990's. Notice how green the water is. (Source: Researcher 2003).

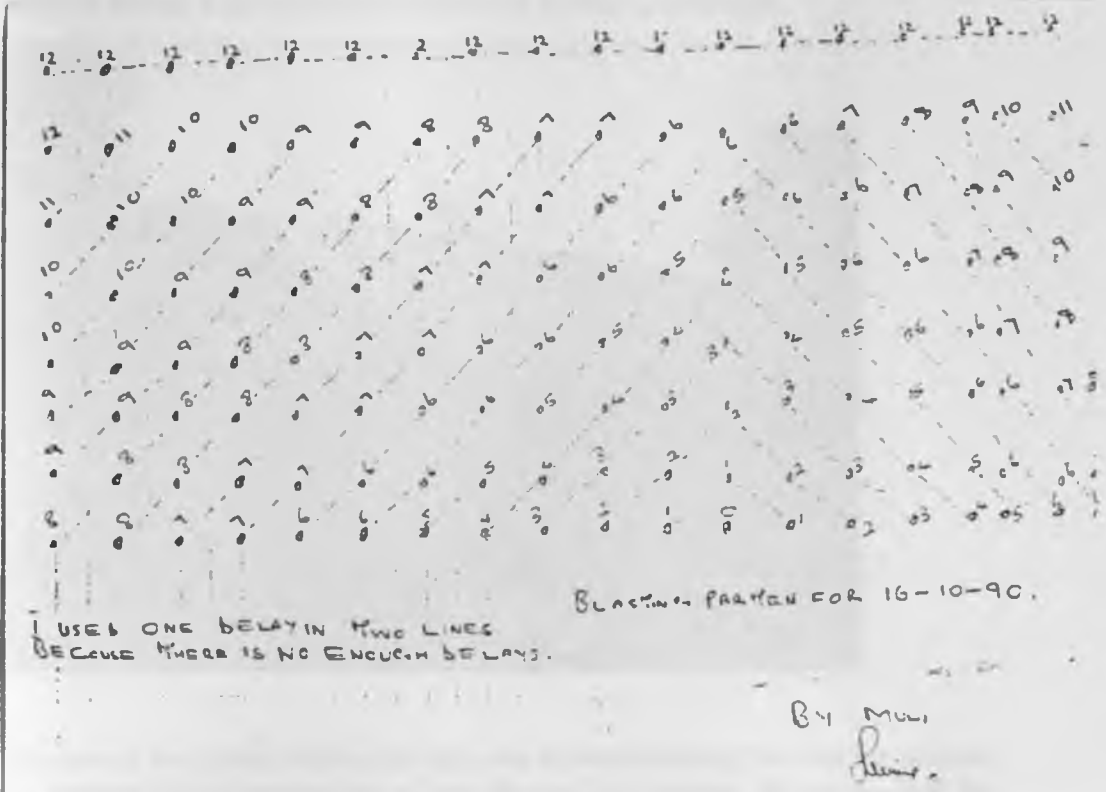
Figure 2.04: Example of a pattern used during the blasting process
Source: Mines and Geology department, Ministry of Environment and natural Resources

- Type of explosives,
- Type of rock. The wave moves faster in the hard rock than in soft rock,
- Length of the explosive column in relation to hole diameter,
- Distance from the hole,
- Number of priming points,
- Relationship of detonation velocity to wave propagation velocity of the rock.

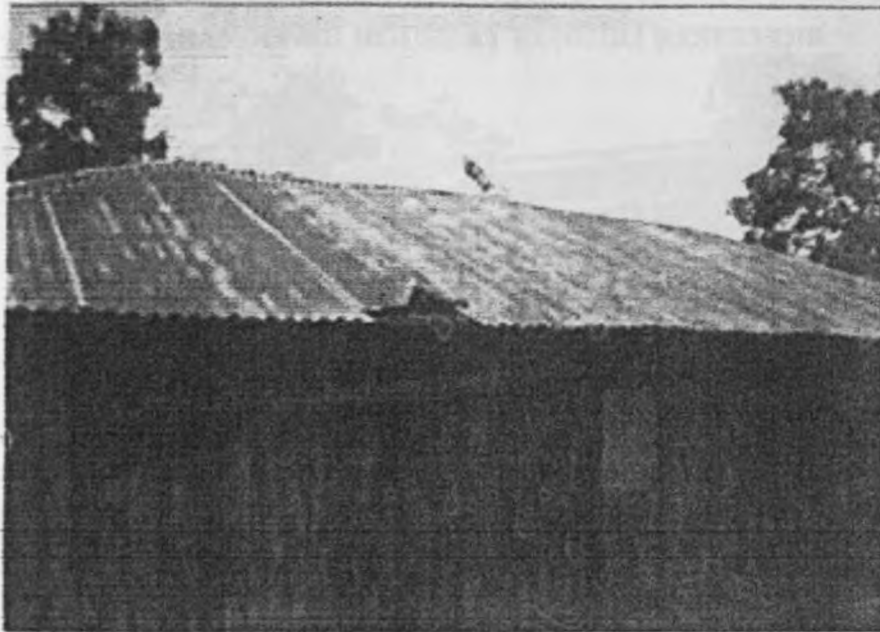
PLATE 3: ROOF TOP DESTRUCTION BY FLYING STONES

This is one of the houses whose roof tops was destroyed during the blasting process. Many patches like this are evident all over the roof. It is located 200 metres from the Rungiri Reservoir in the eastern direction. However, even though the owner would like to renovate the house, she cannot do so because she will be destroying the only evidence that qualifies the house for compensation, eleven years after quarrying (Source: Researcher 2003).

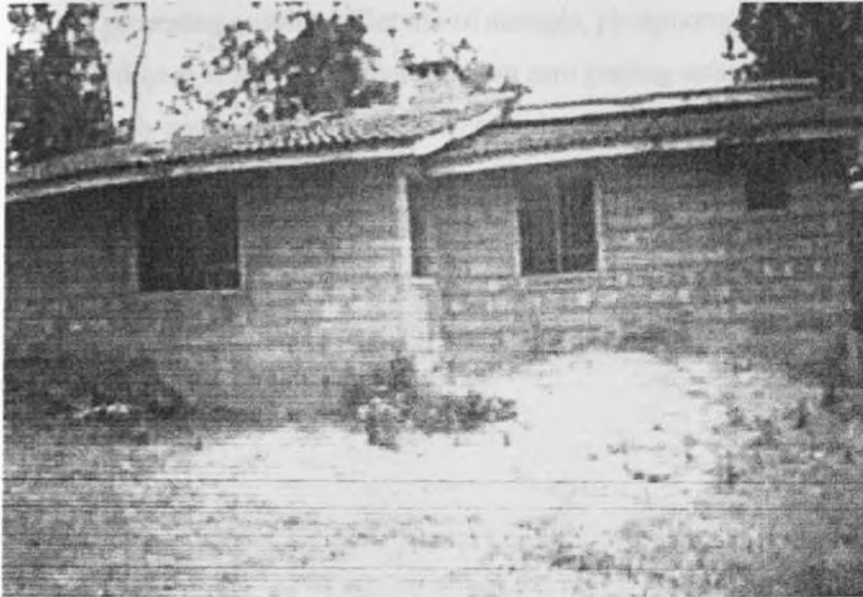
Plate 4: THE ABANDONED HOUSE AT RUNGIRI RESERVOIR

This house 5 metres away from the Rungiri reservoir and in the northern direction was near completion when the blasting process began. Unfortunately, there was no EIA done to recommend that the residents be moved away temporarily and be compensated for any damages accrued as a result of the blasting. The owner is yet to receive compensation for the damage. Until then, this house remains as evidence as to how poor governance and failure to implement rules and regulations can slow down development (Source: **Researcher 2003**).

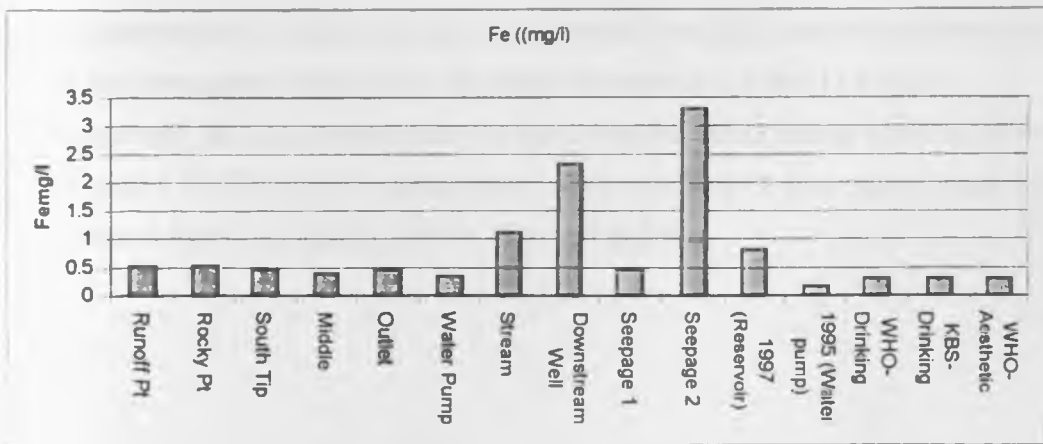
Figure 4.05: Iron concentration pattern

All sampled water had iron concentration above the recommended WHO and KBS concentrations of 0.3 mg/l with reservoir water seepage having the highest amount of iron concentration measuring up to 3.3mg/l. The reservoir had a mean iron concentration of 0.468 mg/l whereas the community water supply had a concentration of 0.35 mg/l slightly higher than the recommended values (Figure 4.05). This concentration seemed to have increased since 0.169 mg/l in 1995.

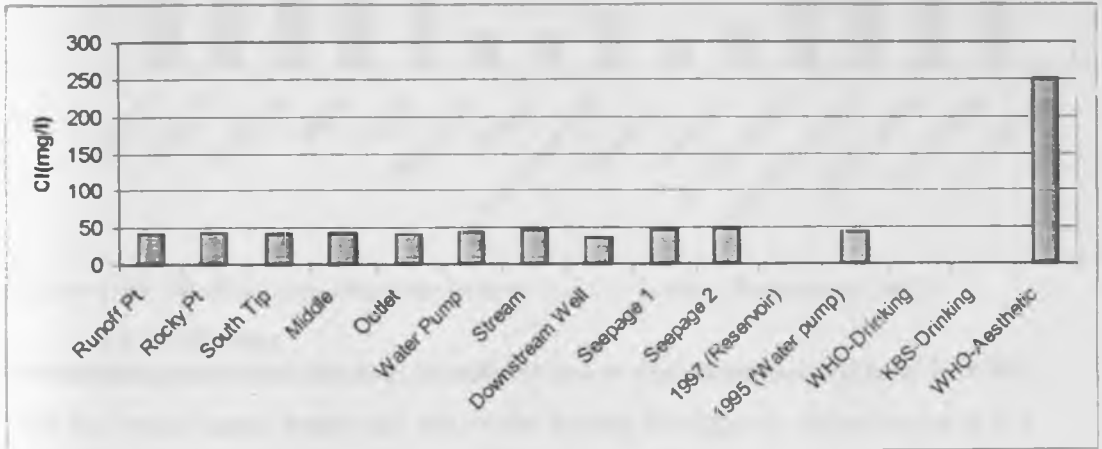
Figure 4.13: Chloride concentration Pattern Source: Researcher 2003

2003. The values are far beyond the recommended 0.2-0.5 mg/l WHO level or the 0.1mg/l KEBS standards for drinking water. Details of the concentration pattern are as shown in figure 4.13.

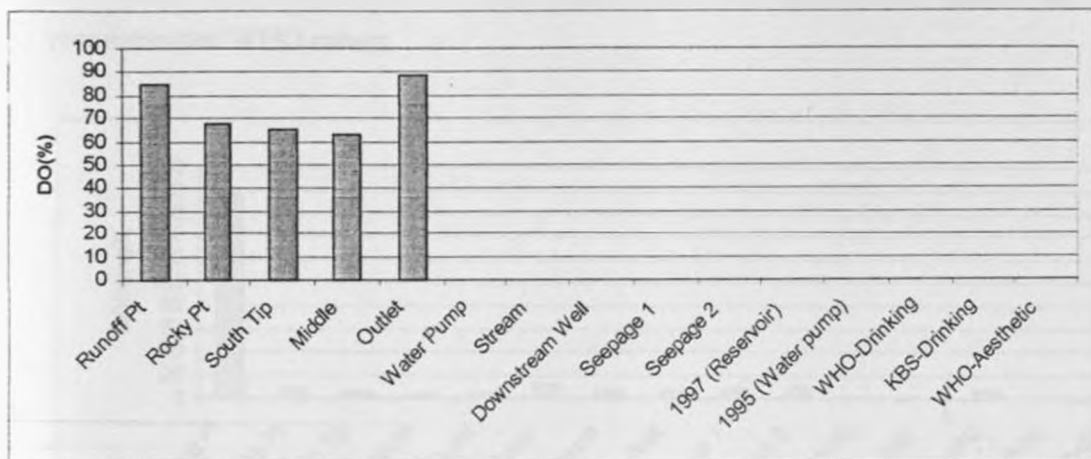
Figure 4.20: DO concentration pattern

4mg o₂/ L which means that the reservoir is adequately aerated to support aerobic life including fish. The dissolved oxygen concentration pattern is as shown in figure 4.20.
