University of Nairobi

Department of Civil and Construction Engineering

Pavement Evaluation of Mbagathi Road, Kenya.

A thesis submitted in partial fulfillment for the Degree of Master of Science in Civil Engineering in the department of Civil and Construction Engineering, University of Nairobi.

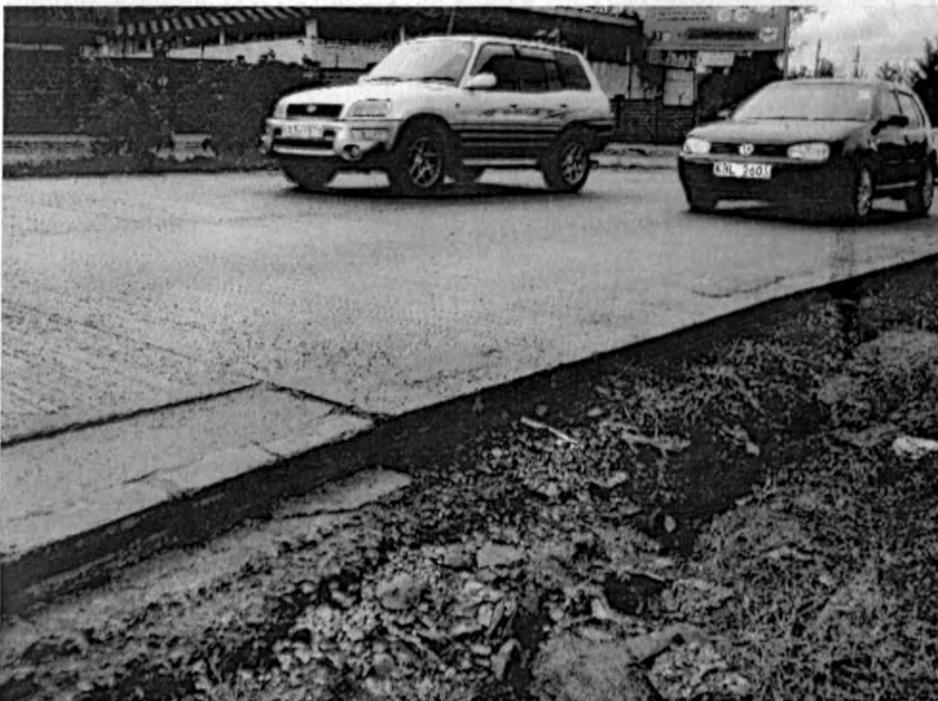
Fig. 1.1: Pavement cracking of concrete slabs at Mbagathi Way

- Cracking of pavement slabs as shown in Figure 1.1.
- Widening of the joints due to infiltration of particulates and water into joints as shown in Figure 1.2.
- Ponding of water was observed in a section next to the bridge due to rains and poor drainage.
- Damaged kerbs and polished outer lanes on sections of the road as shown in Figure 1.3.

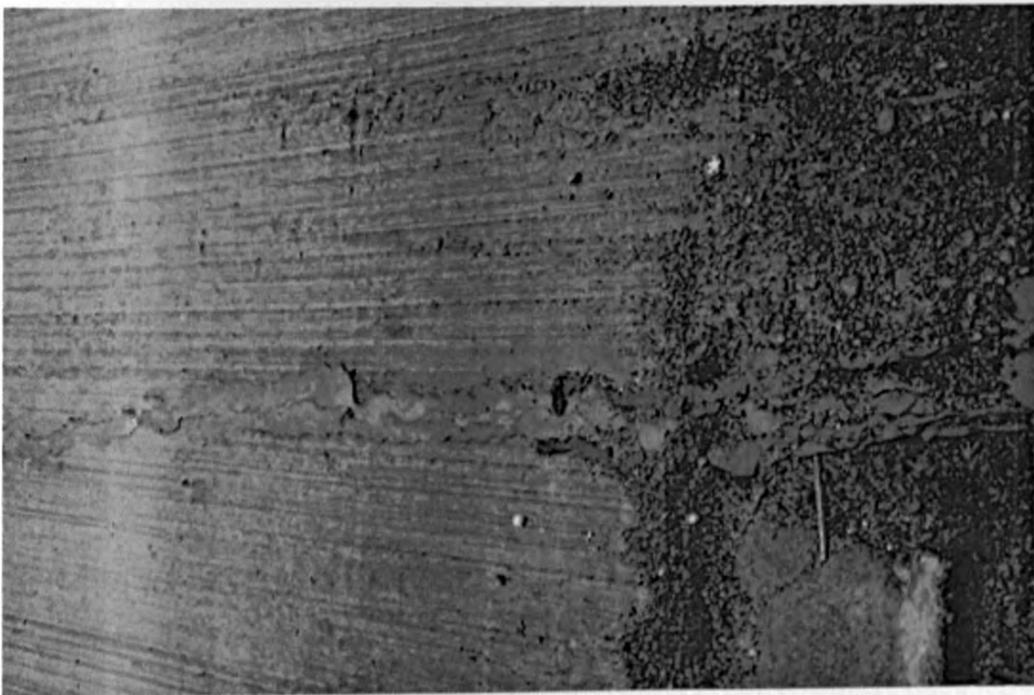
Fig. 4.28: Recurring crack on epoxy sealed crack

The percentage of cracked area = 5% as at December 2011. This area has since been patched by January 2012 as illustrated in Figures 4.27 and 4.28.

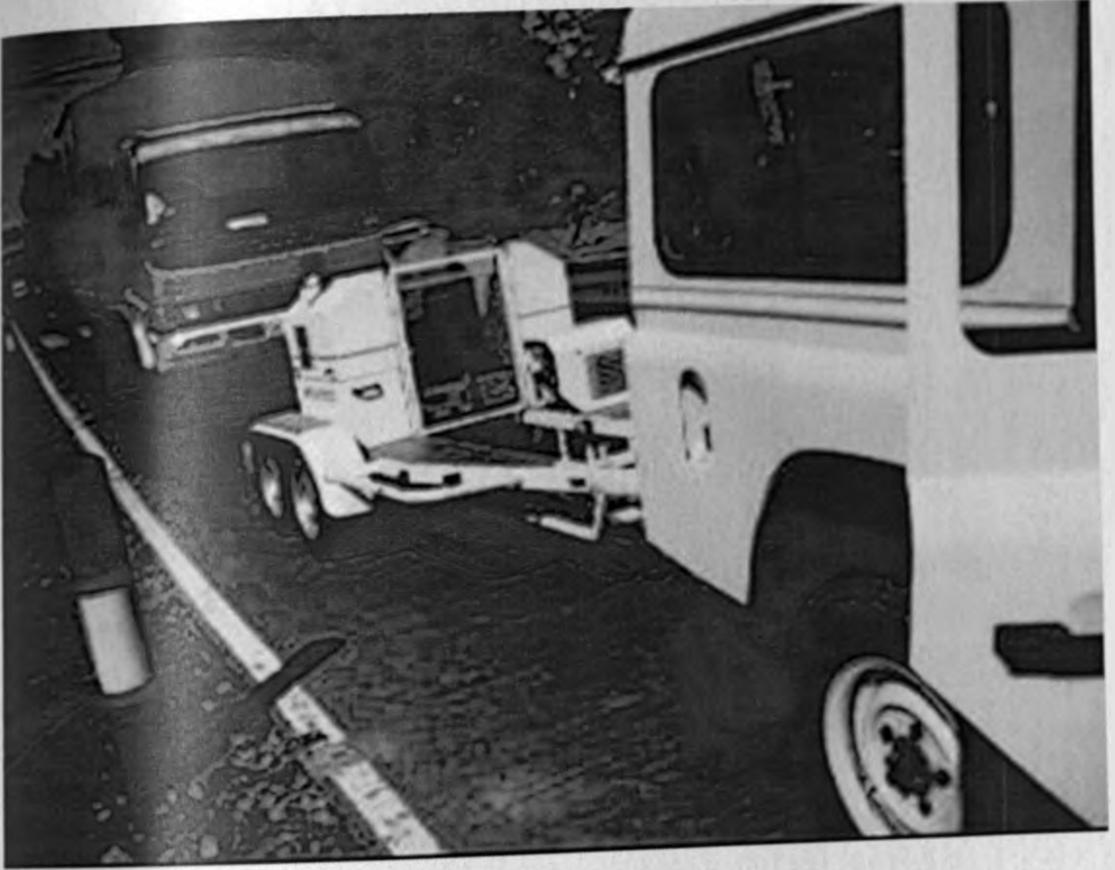
Falling Weight Deflectometer set up used during the research
