NILE RIVER BANK EROSION AND PROTECTION

**NILE RIVER BANK
EROSION AND PROTECTION**

Produced by the
Nile Basin Capacity Building network
(NBCBN-SEC) office

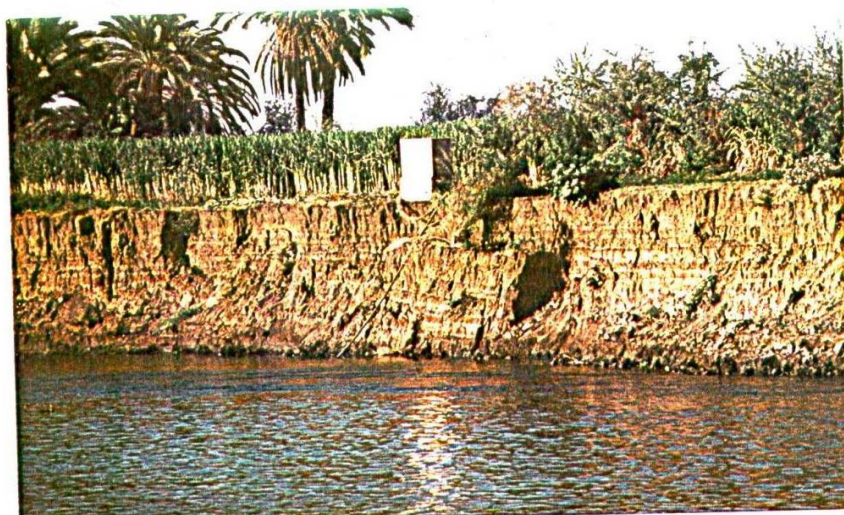
Figure 2- 1:Typical Bank Erosion at Luxor

Recorded Previous works in relation to the Nile River generally could be observed in two reaches based on the scale of bank erosion. The first reach is the part of the Main Nile downstream the High Aswan Dam (HAD) while the second reach is that part between Khartoum and third cataract. After the construction of HAD the downstream river reaches responded in a different manner. The river velocity influences Nile Bank Erosion in Egypt. As the river changes its flow pattern, the location and the riverbank erosion extent also change. **Figure 2.1**, shows typical bank erosion at Luxor.

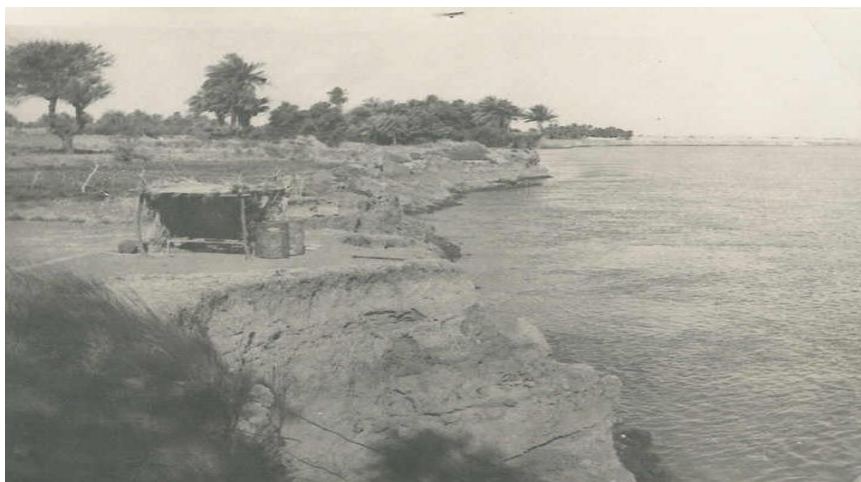
Figure 2- 2: Very Severe Bank Erosion Dongla – Merowi Third Reach

With respect to bank erosion, the Nile reach in Sudan can be divided into four reaches. The first one is between Khartoum and the fifth cataract. Second reach is from the fifth to the fourth cataract. Third reach is between the third cataract and fourth cataract. The last reach is from the fourth cataract to HAD Lake. The first and the third cataracts are reported to have noticeable bank erosion. The large and rapid drop of the water level and the high velocities are the main reasons for bank erosion of the Nile in Sudan. Figure 2.2 shows typical severe erosion in the third reach.

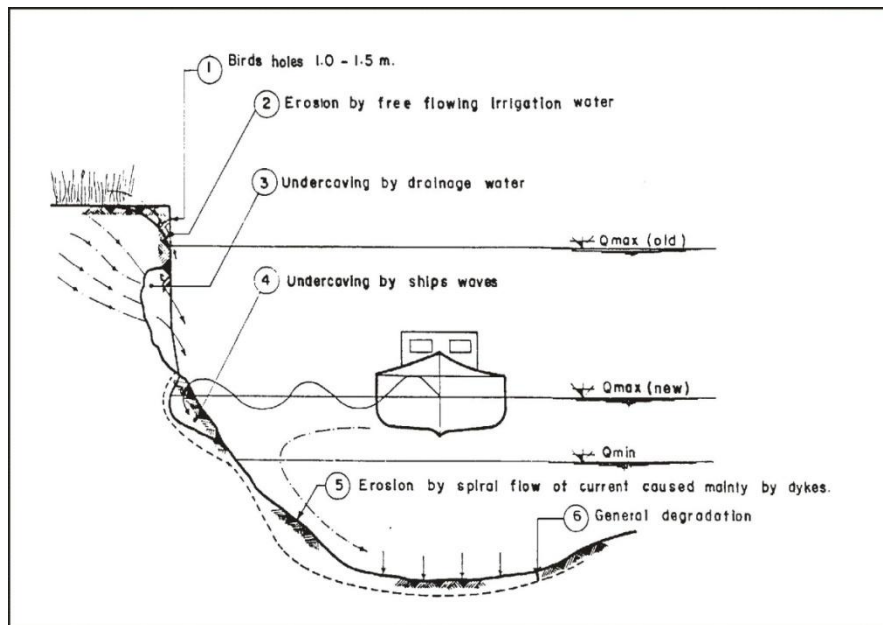
Figure 2-3: Drainage Water Caused Under Caving During HAD Construction

- ❖ **Seepage**. Seepage flow through the bank soil usually happens as a result of increasing pore water pressure within the soil. Drainage water causes under caving of the banks as shown in Figure 2.3.

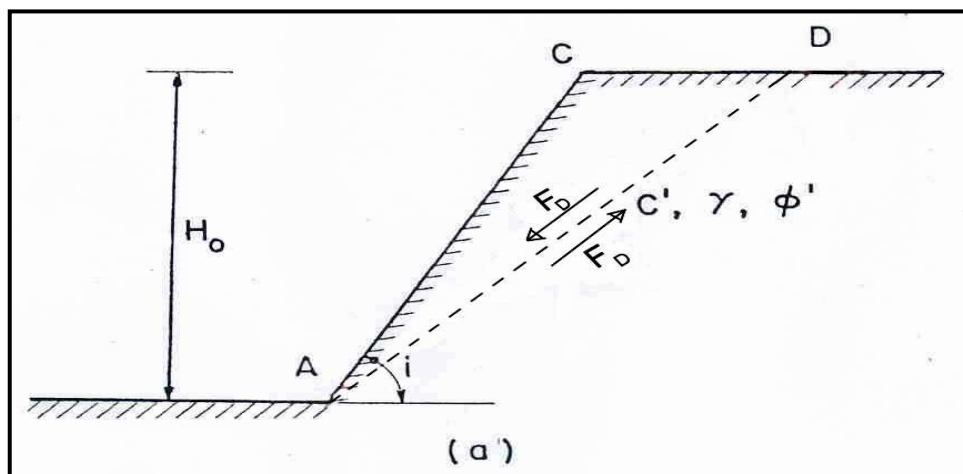
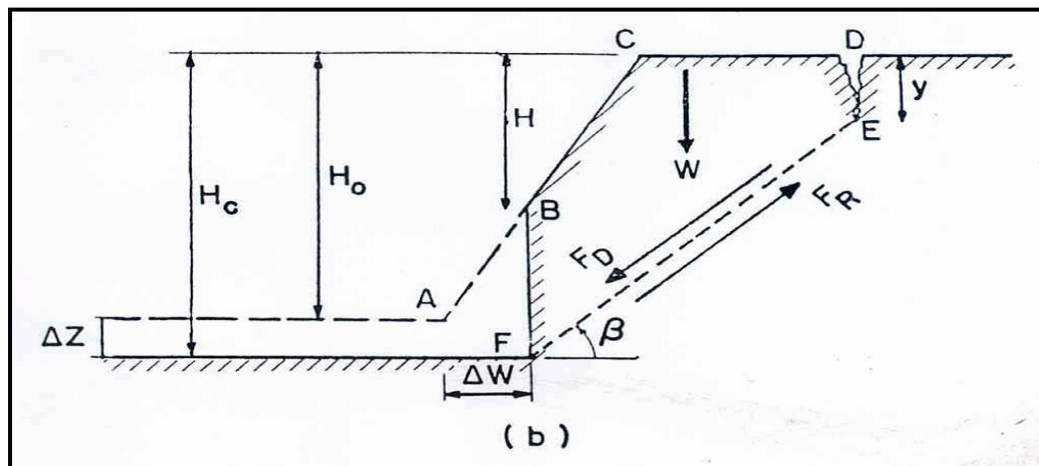
Figure 2- -4 a): River right bank at failure b) Parallel bank retreat

As given in Figure 2.2a,,for intensive deep tension cracks the bank geometry of Figure 2.2b should be used in the analysis which is known as parallel bank retreat. Mass wasting, sloughing and head cutting on vegetated or barren banks are some of the mechanisms of bank failure. Bank erosion process is either mass failure of the bank (block failure) or direct erosion of the bank material. Cohesive soil shrinkage is sole factor responsible for tension cracks development. This process is more pronounced at the outer bank in river bends.

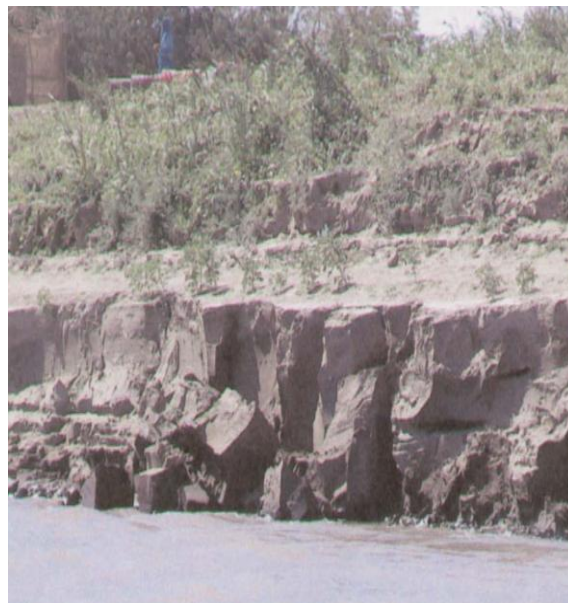
Figure 3-6 : Bank erosion – failure as a beam type in Northern State (Karima – Dongla Reach)

The digital camera was used to document the different types of bank erosion along the Nile (Figure 3.6 and Figure 3.7). The recognition of bank erosion types will help in suggesting the protection measures.

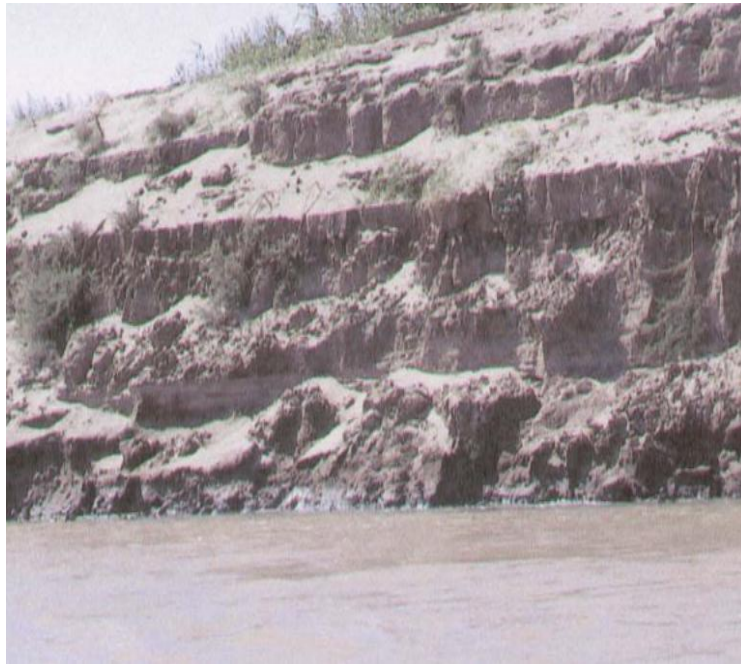
Figure 3- 7: Bank erosion – Sliding failure type in Northern State (Karima – Dongla Reach)

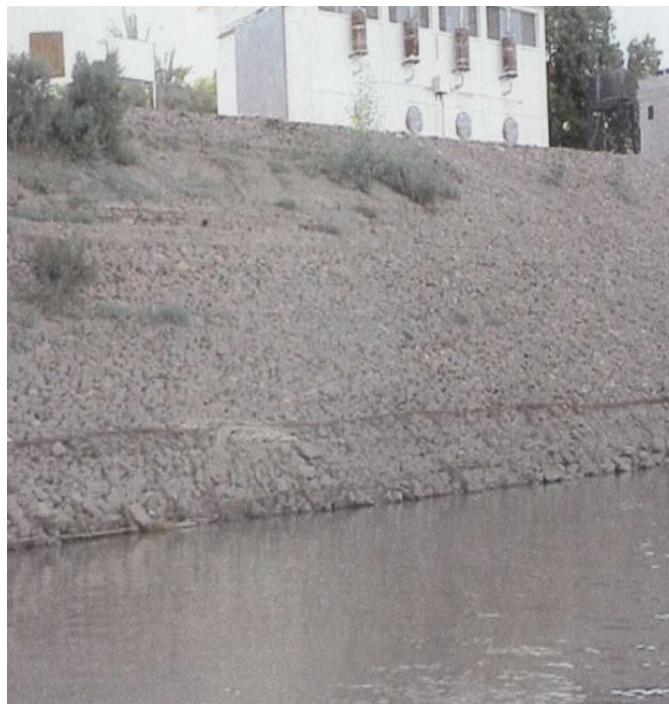
Figure 3- 8: Protection of pumping station at El-Gaba –Northern State by rock and cement

It was observed that the Nile banks consist of cohesive layers of varying thickness resting on sandy bed. The main protection methods are rock riprap Figure 3.8 and stone pitching (revetment) are commonly used in Northern Sudan.

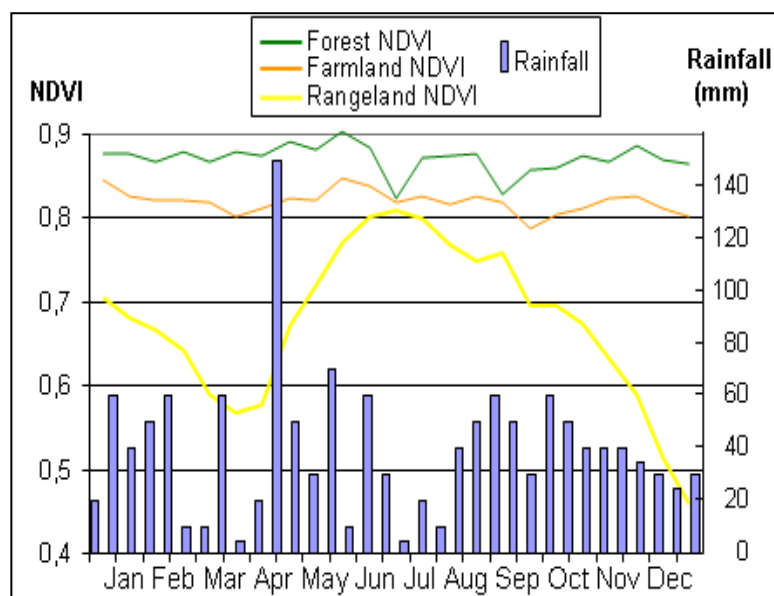
Figure 4-3: NDVI multi-temporal behavior of rangeland, farmland and forest in 2007 compared with rainfall

In the following paragraphs the dynamic behaviors of the some of the considered cover types are described in terms of NDVI variations throughout the year 2007. The multi-temporal NDVI behaviour of the sampled rangeland pixels in 2007 is represented in Figure 4.3 and compared with the contemporary rainfall data in Nyanza Region (source: FAO/GIEWS, 2009). The rangeland NDVIs show the typical natural trend of the spontaneous vegetation, as the curve follows the rainfall trend after a short delay. Whereas the farmland curve is rather more constant in the time as effect of the irrigation and/or farming practices, which tend to maintain a vegetated land cover also in the dry season. However, the farmland curve may be the result of the average behavior of many crops that can be differently scheduled along the year. The forest NDVI values, as expected, are also relatively constant throughout the year and always higher than the other cover types, Figure 4.3.

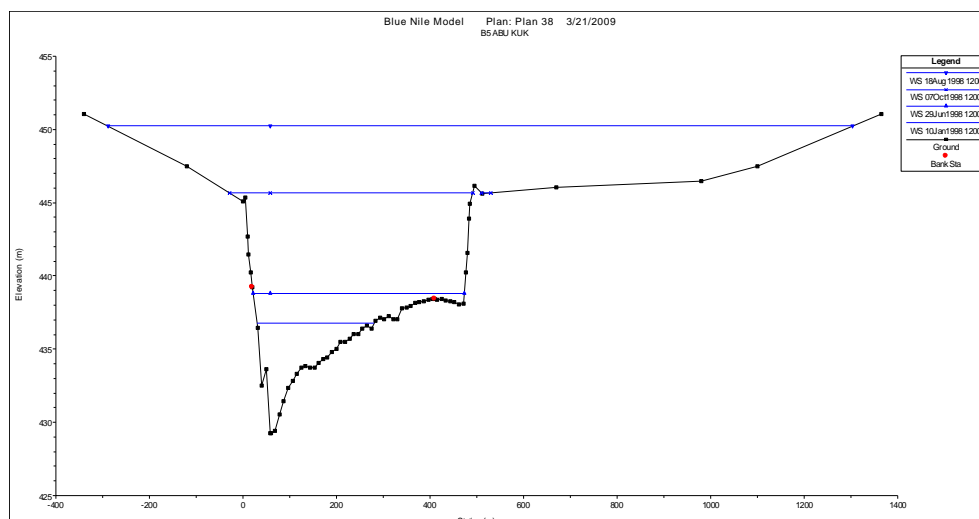
Figure 5-3a: Cross-Section with water surface elevations at different times in 1998

The Water surface elevation at peak time and during rising and falling limbs are superimposed on the channel cross-section as shown in Figure 5.3a. The velocity and shear stress hydrographs are shown in Figure 5.3b and 5.3c. The cumulative mass bed change with time for the cross-section is given in Figure 5.3d.

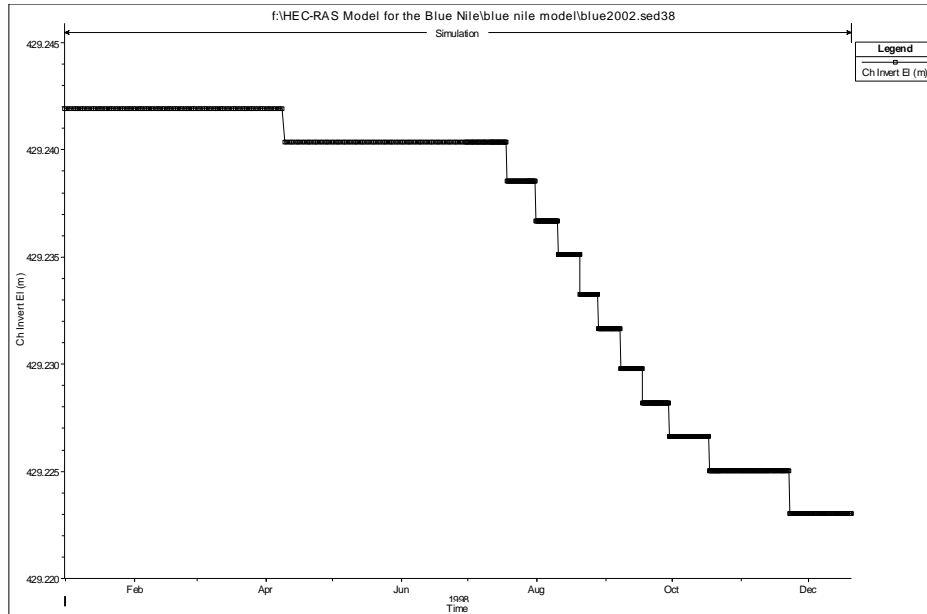
Figure 5-3b: Changes in channel invert with time

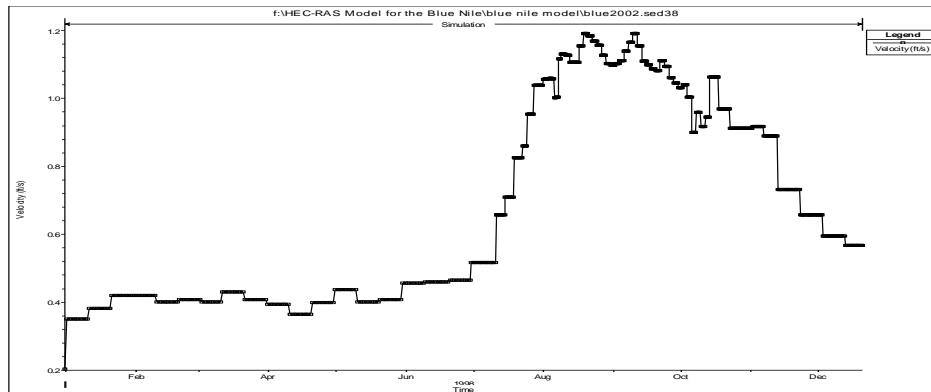
Figure 5-3c: Velocity variation with time

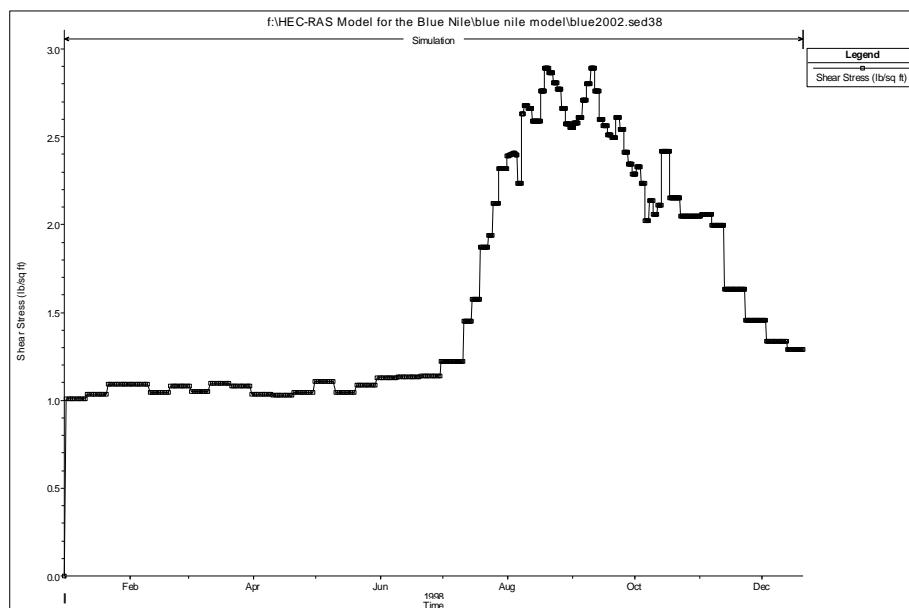
Figure 5-3d: Shear stress variation with time

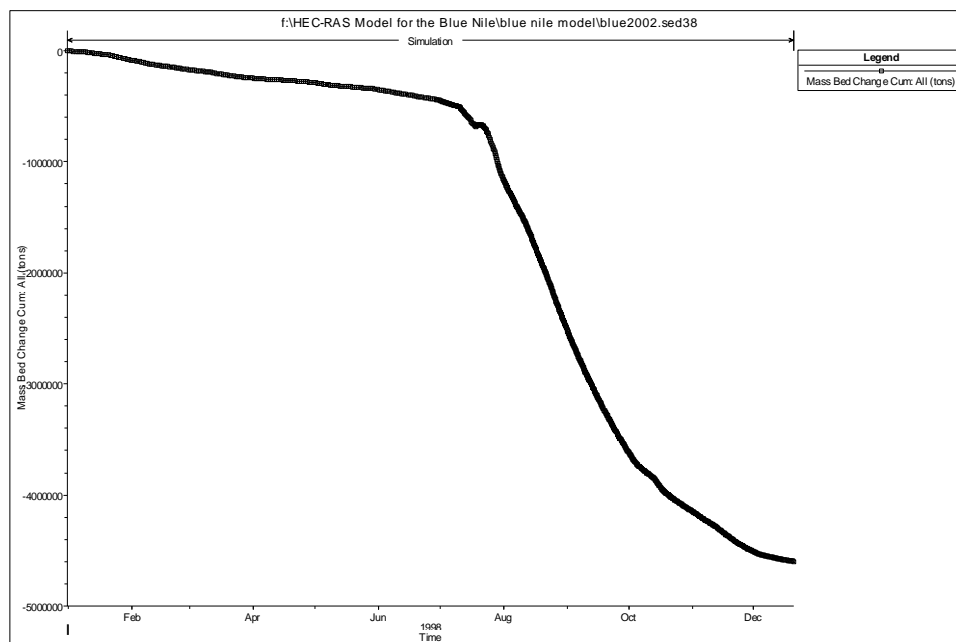
Figure 5-3e: Cumulative Mass Bed

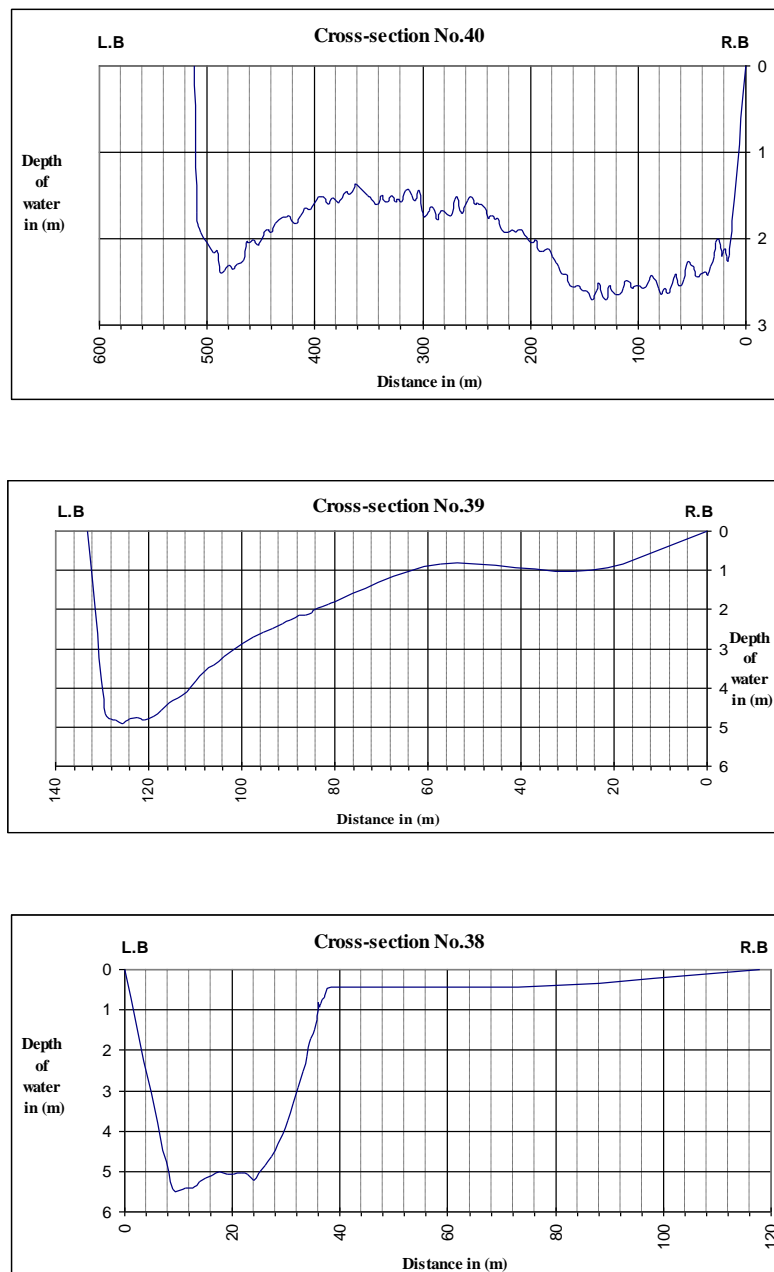
Figure 5-4: Cross sections showing erosion development near Khartoum

However the phenomenon can be depicted by GIS producing maps for determining erosion rate of banks and lateral shifts of natural channels. Such information is available at Tuti Island. Figure 5.10 represents a map of Tuti Island showing some bathometric levels at the confluence of the Blue Nile and the White Nile, produced by GIS technique.

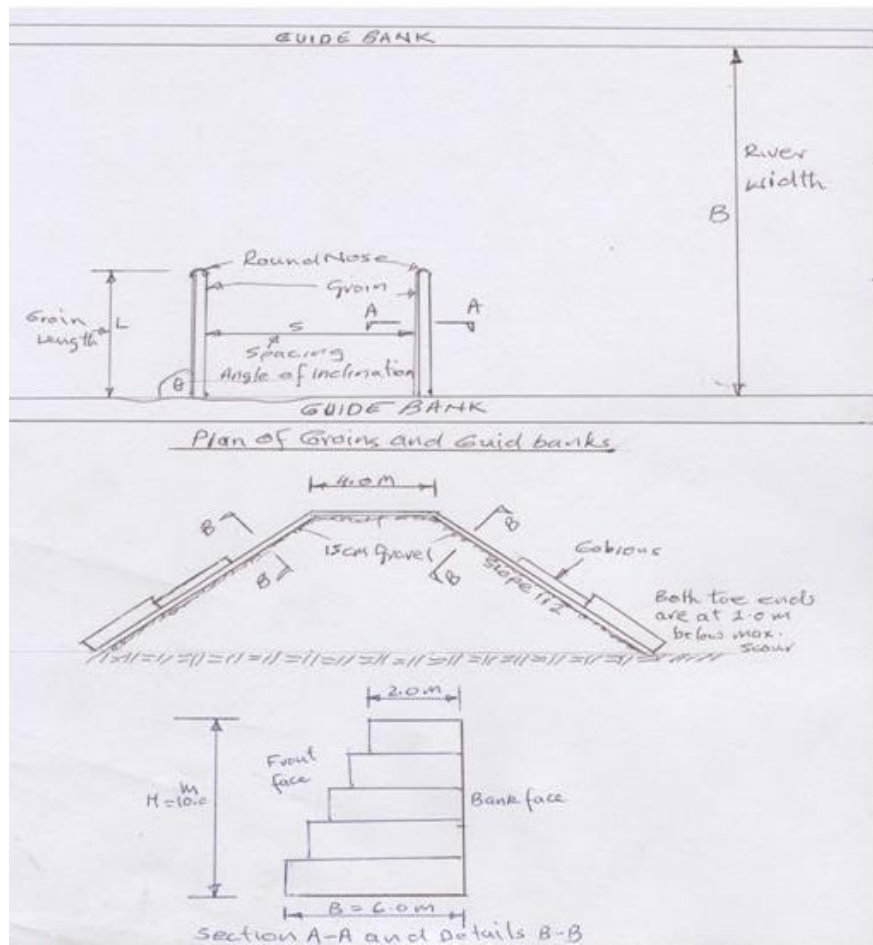
Figure 5-11: Transverse banks (Spurs or Groins)

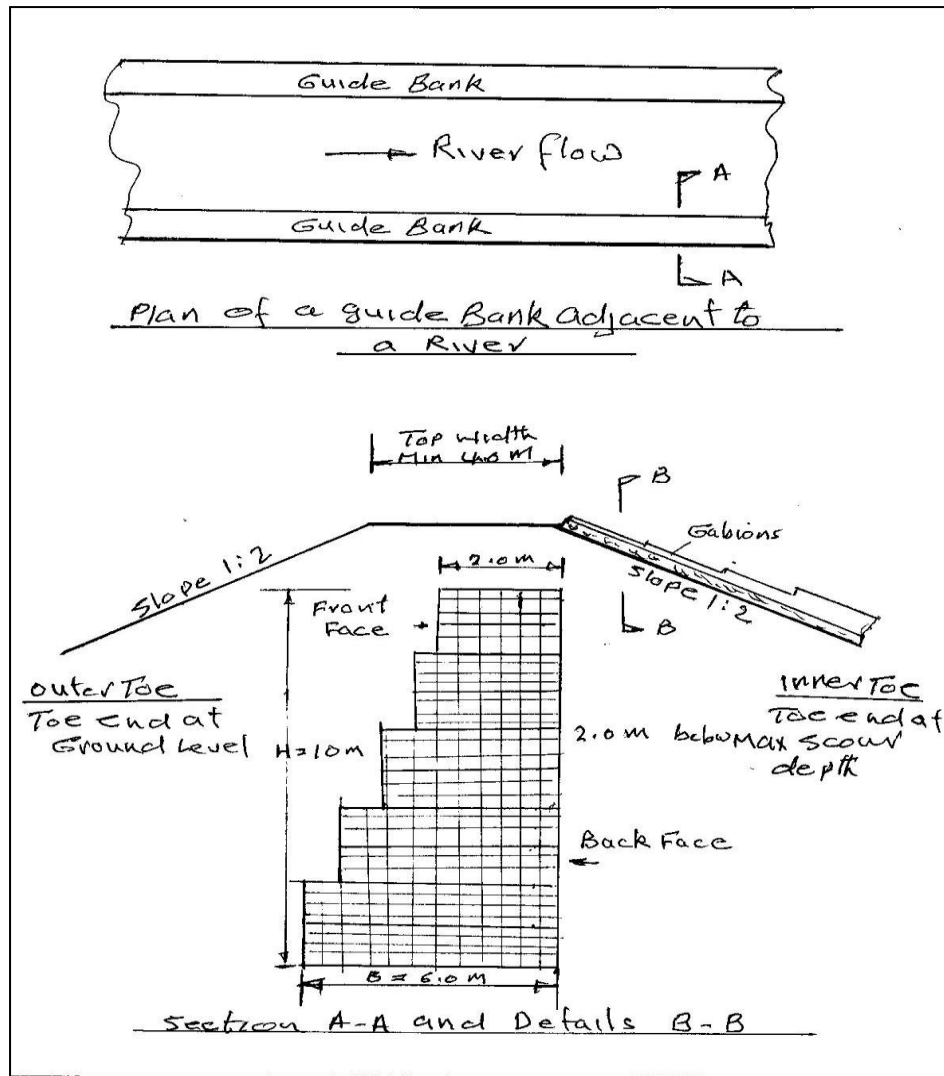
Figure 5-12: Guide banks adjacent to rivers

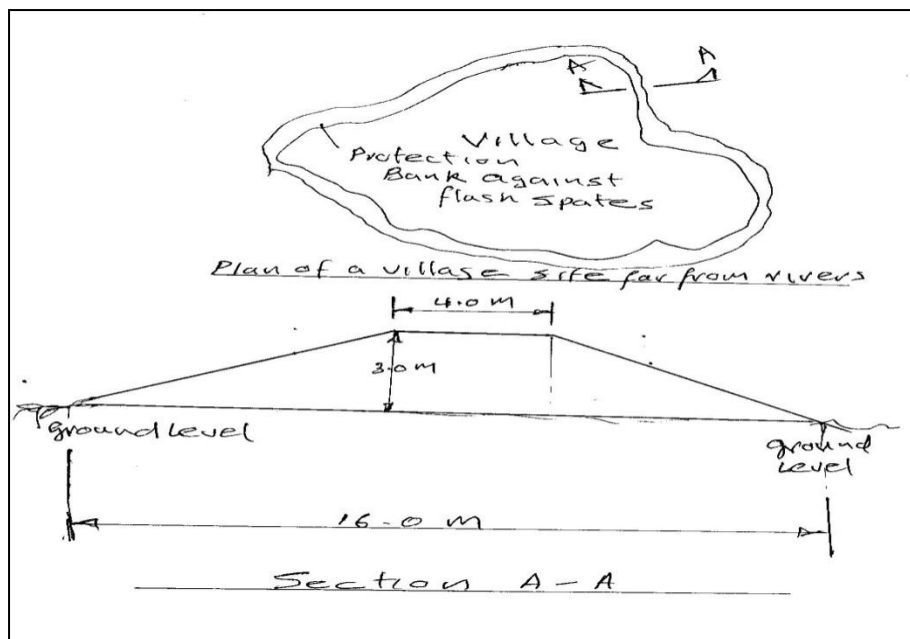
Figure 5-13: Earth banks

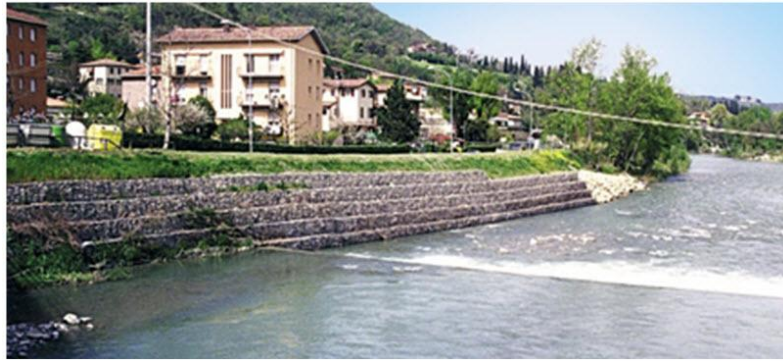
Figure 5-14: Typical guide bank gabion walls

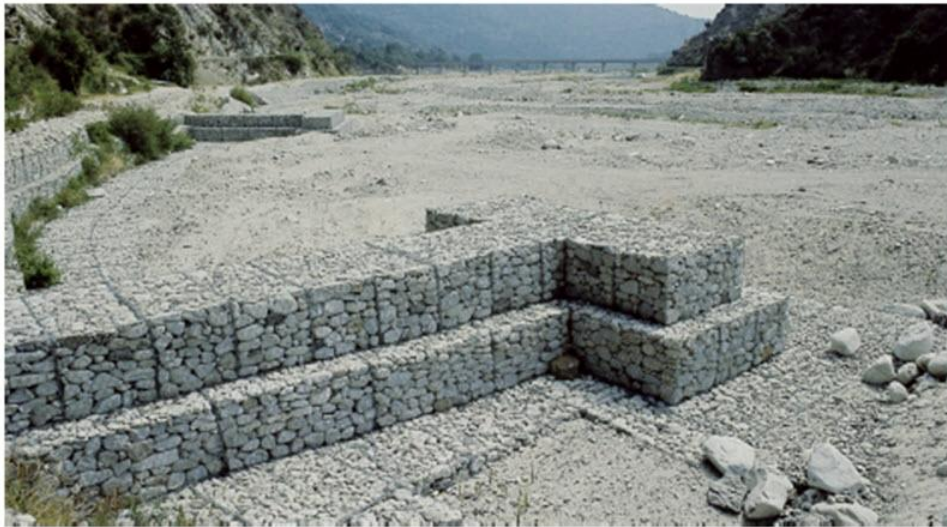
Figure 5-15: Typical gabion groynes in construction

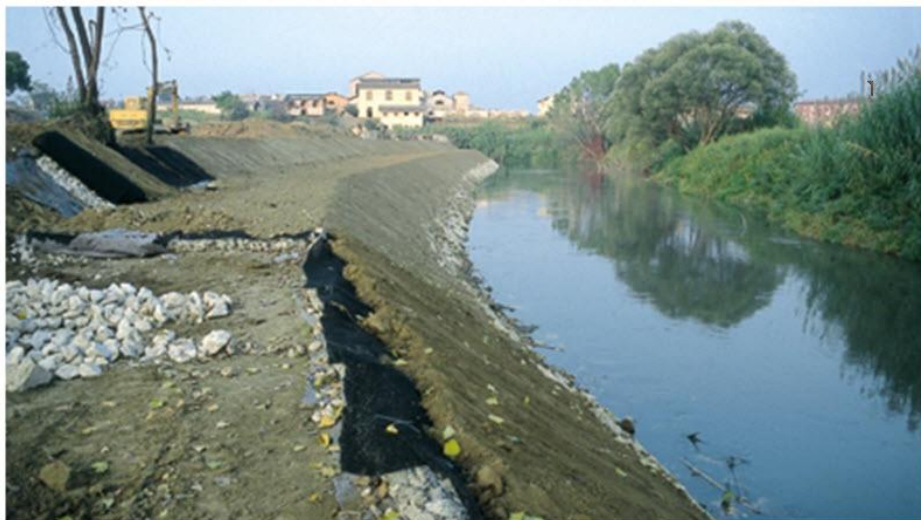
Figure 5-16: Guide bank failure

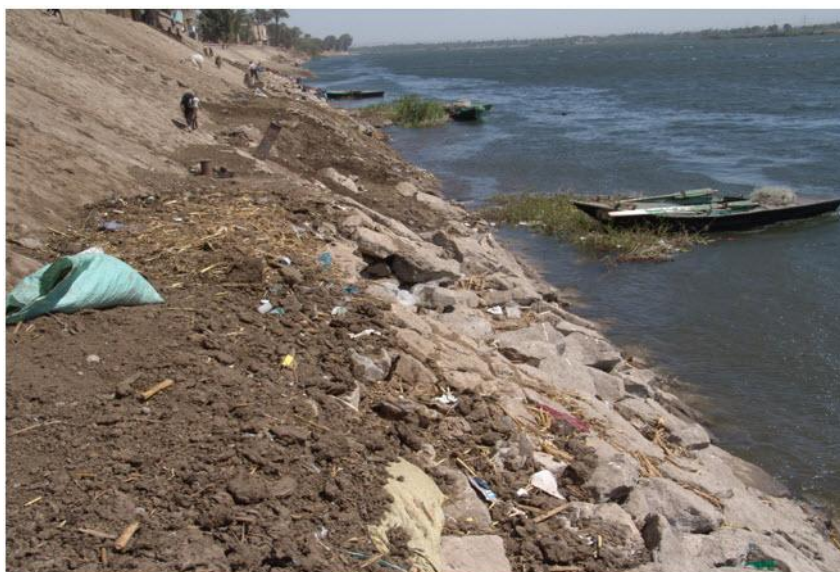
Figure 6-2: General view of bank toe protection

The geometric and topographic characteristics of Salam village consist of 4m wide road which separates the village from the western Nile River bank. The bank side slopes are 1:1 up to bank height of 3 m. There is 4m berm at bank height of 3m, followed by another berm of 1.5 m wide. This is followed by a side slope of 1:1 to 1m below the minimum water level. The bank was protected by stone pitching, which survived for a period of more than 15 years. Some holes with failure in some places appeared in the bank as shown in Figure 6.2.

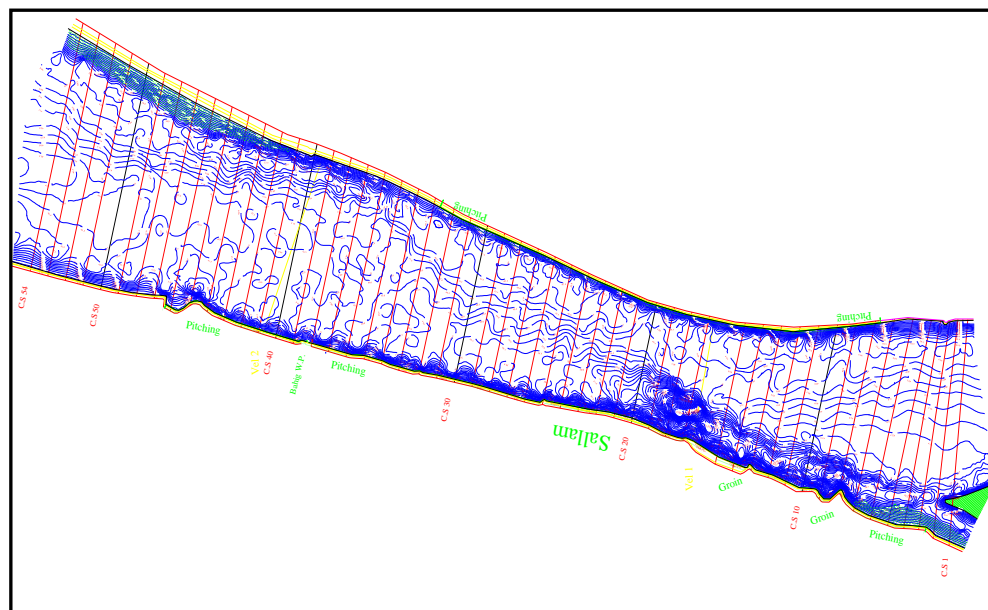
Figure 6-3: Contour map of surveyed area in 2008

- a) The three scour hole existed before 2003.
- b) The centre of the holes did not move until 2008.
- c) The scour depth almost did not change except for the third scour hole

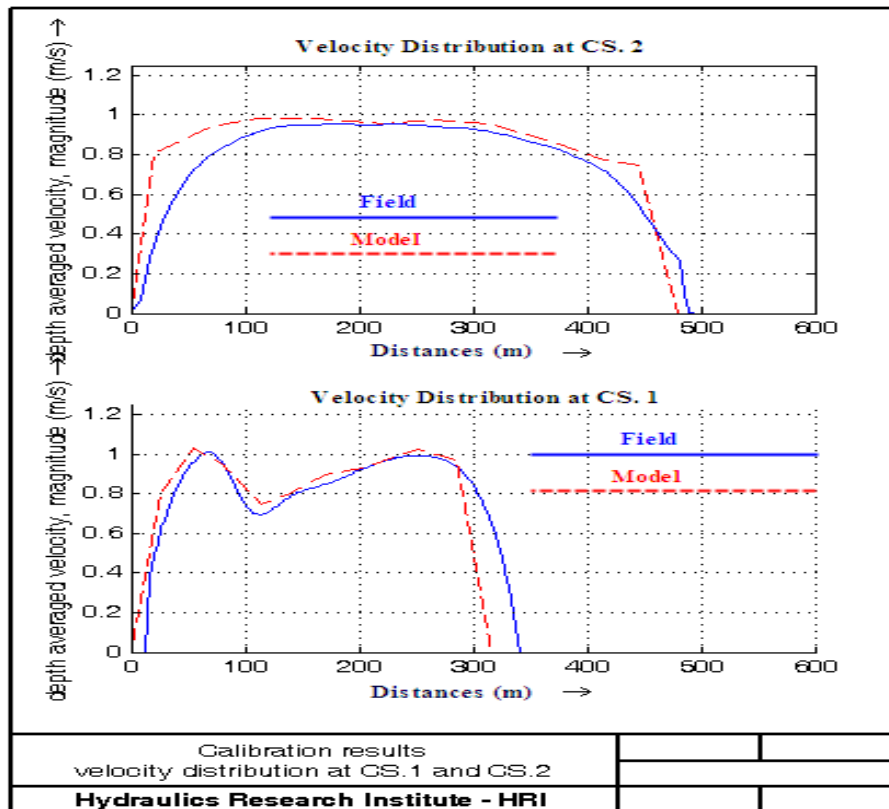
Figure 6-4: Measured and simulated velocity at Sections 1 and 2

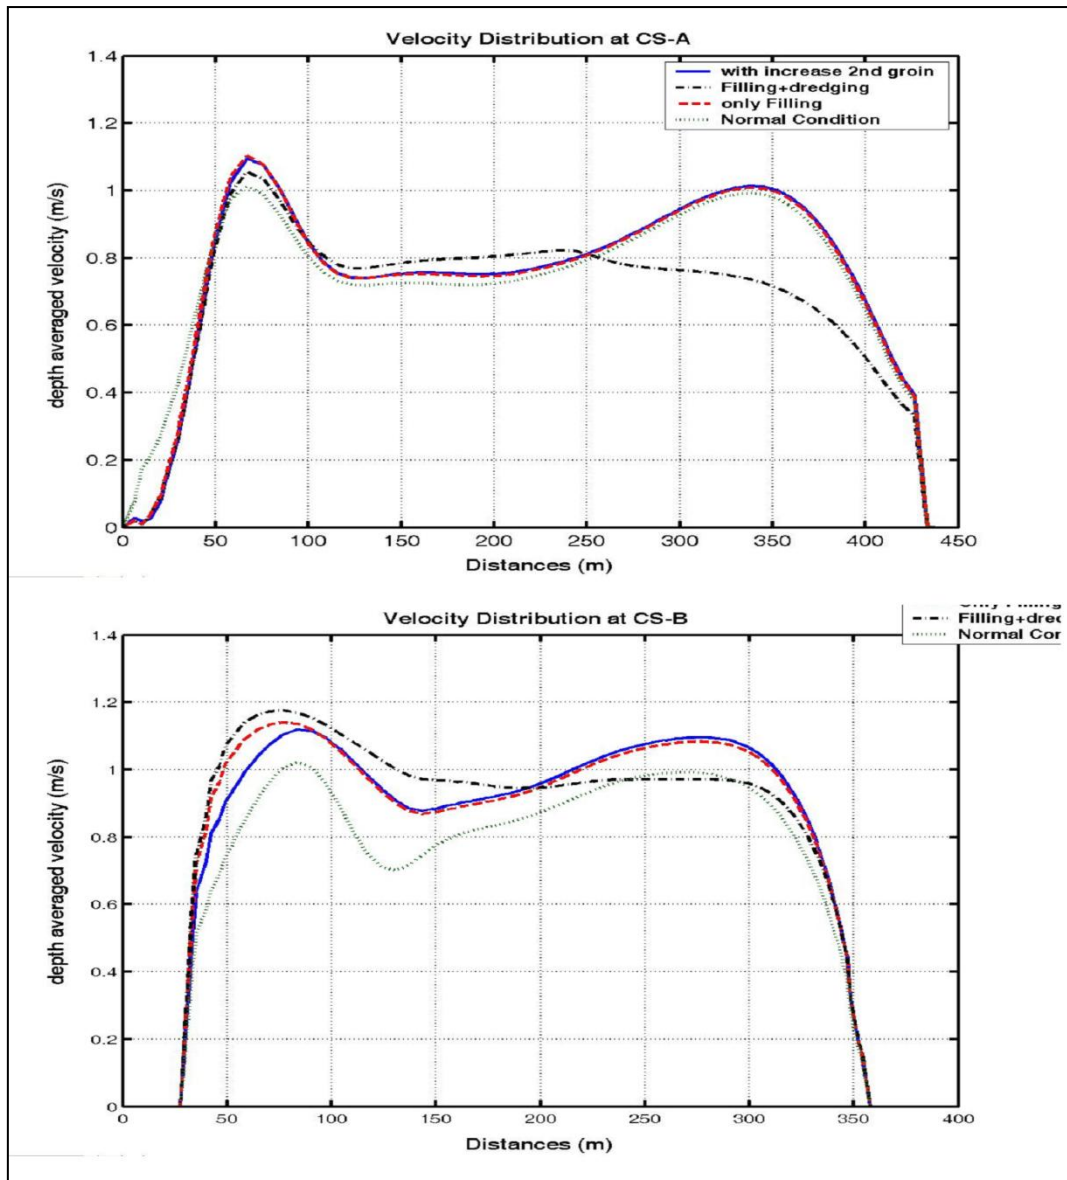
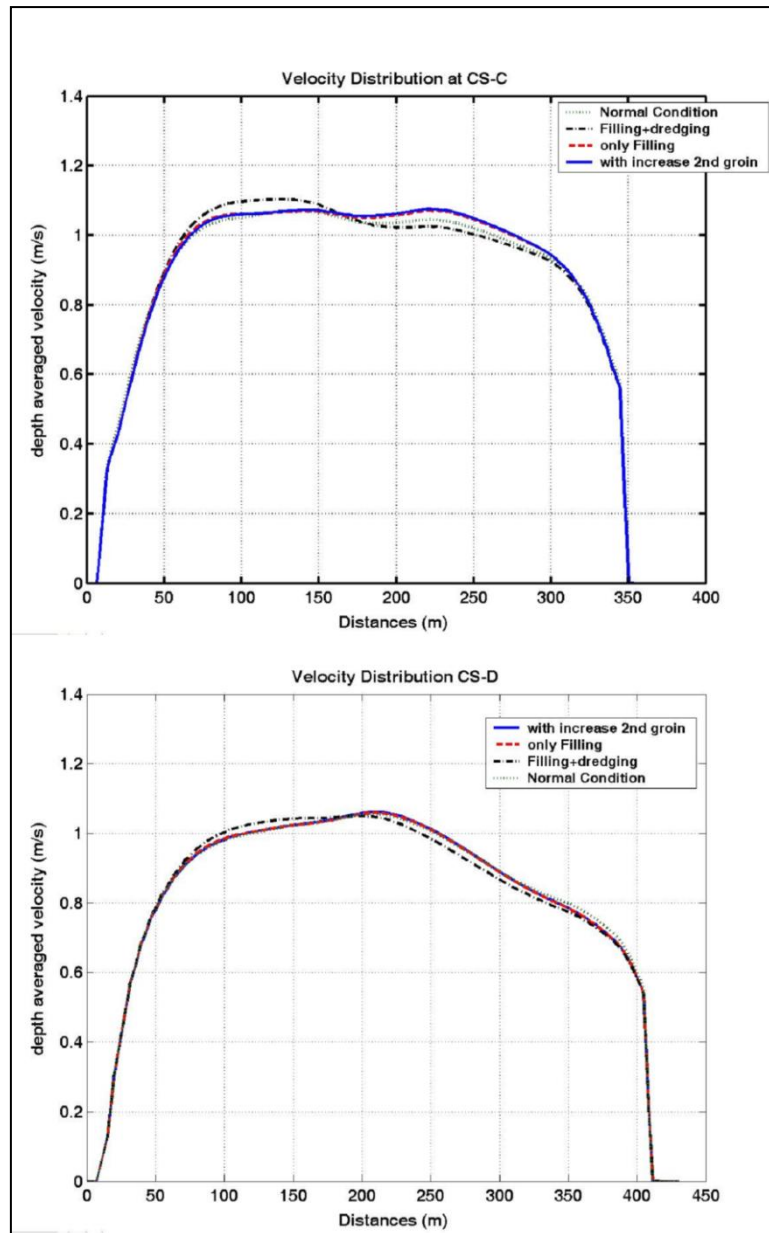
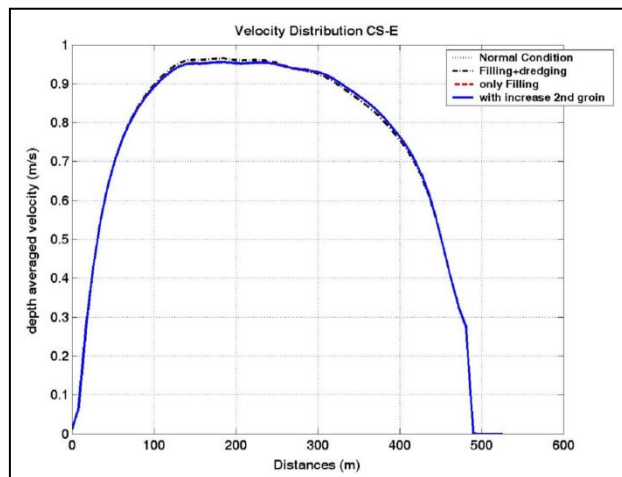
Figure 6-6a: Depth-averaged velocity for different scenarios

Figure 6-6b: Depth-averaged velocity for different scenarios

Figure 6-6c: Depth-averaged velocity for different Scenarios

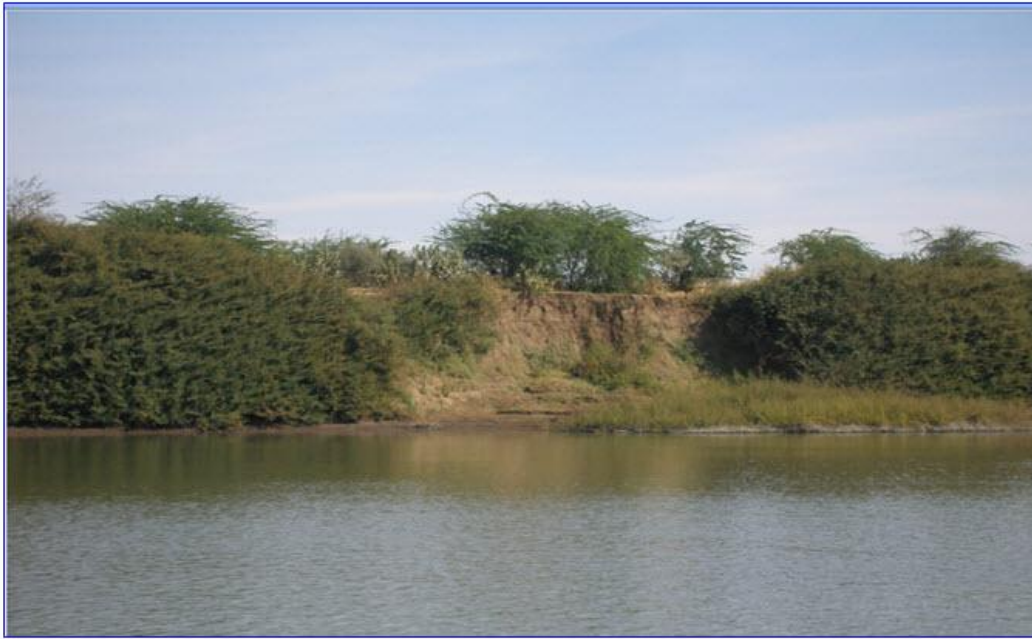
Figure 6-10: Erosion of the eastern bank upstream of the bridge site

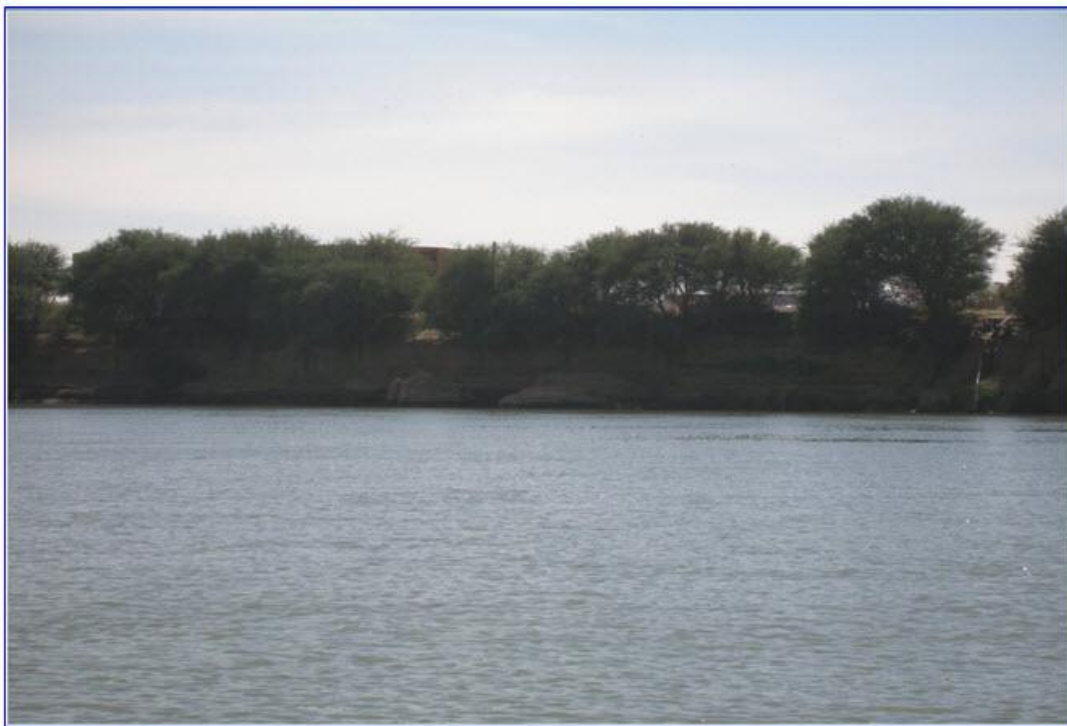
Figure 6-11: Erosion of the western bank upstream of bridge site

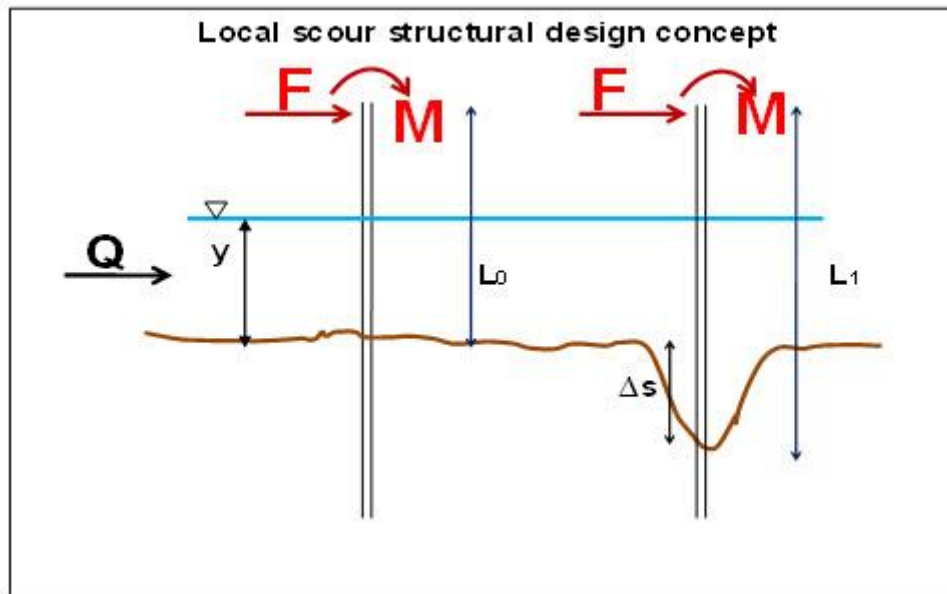
Figure 6-16: Local scour concept

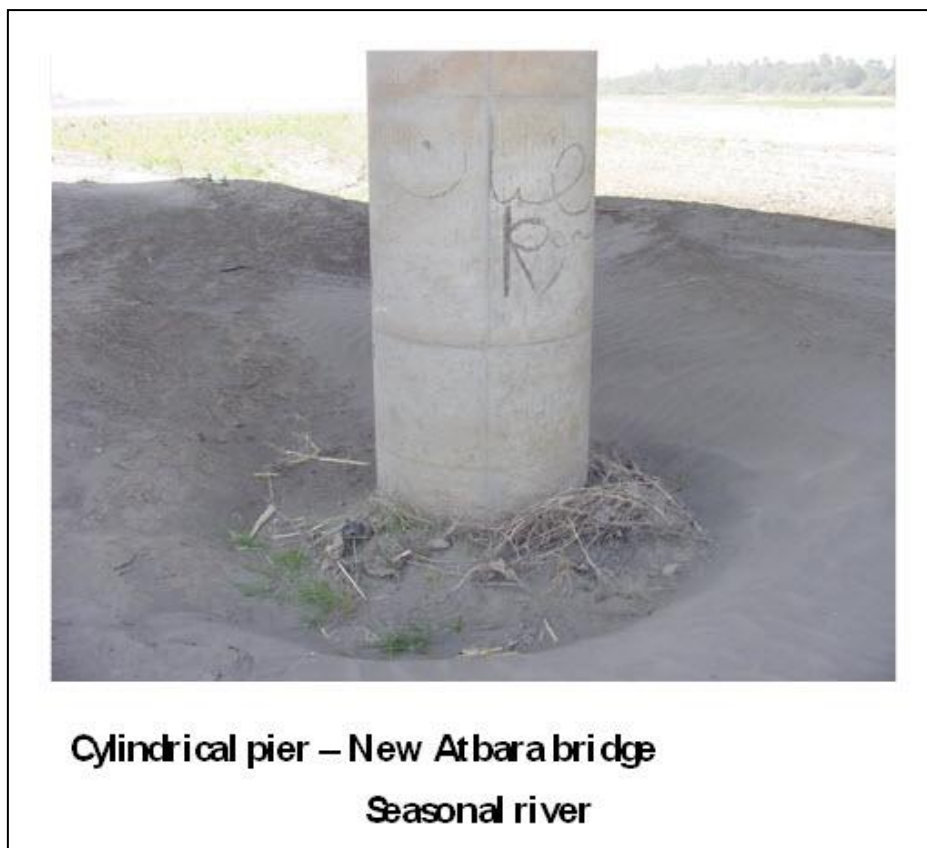
Figure 6-17: Live bed scour in the Nile River
