MSC CIVIL ENGINEERING (TRANSPORTATION ENGINEERING)

**NON-USAGE OF PEDESTRIAN FOOTBRIDGES IN KENYA: THE CASE OF
UTHIRU PEDESTRIAN FOOTBRIDGE ON WAIYAKI WAY**

**[A THESIS SUBMITTED TO THE SCHOOL OF ENGINEERING OF
UNIVERSITY OF NAIROBI]**

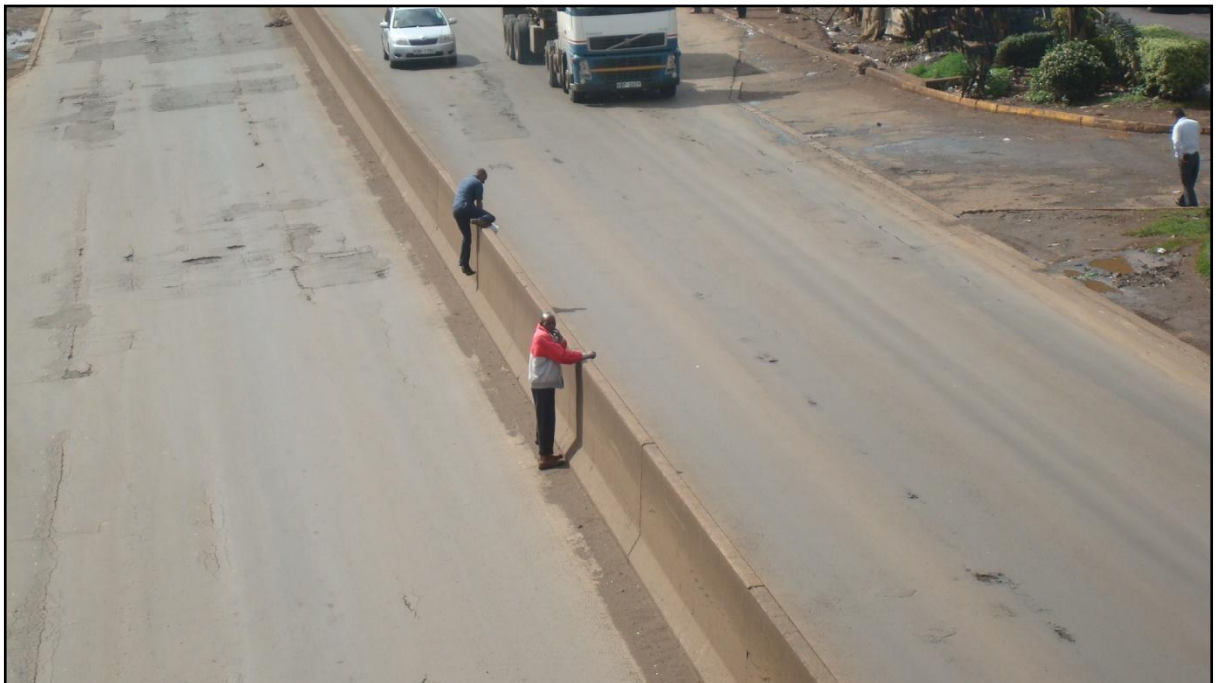
Picture 1: Road section at Uthiru showing pedestrians climbing over the barrier

On Waiyaki Way, a concrete barrier was provided along the trading centre which is about 1.2 m high to prevent pedestrians from crossing at grade. According to Kotahi, (2009) the barrier should be continuous, un-climbable and long enough to prevent people climbing over it. It was noted that although the barrier partly meets this specification, some pedestrians climb over the barrier as a way of crossing at grade. This is also collaborated by Zegeer, (1998) who recommends that the height of barrier should be high enough to prevent pedestrians from climbing over it. However, Zegeer, (1998) does not specify actual or minimum height (See pictures 1 and 2 showing pedestrians jumping over the concrete barrier). It has to be pointed out that the barrier also mitigates median cross-over collisions of vehicles for the divided carriageway.

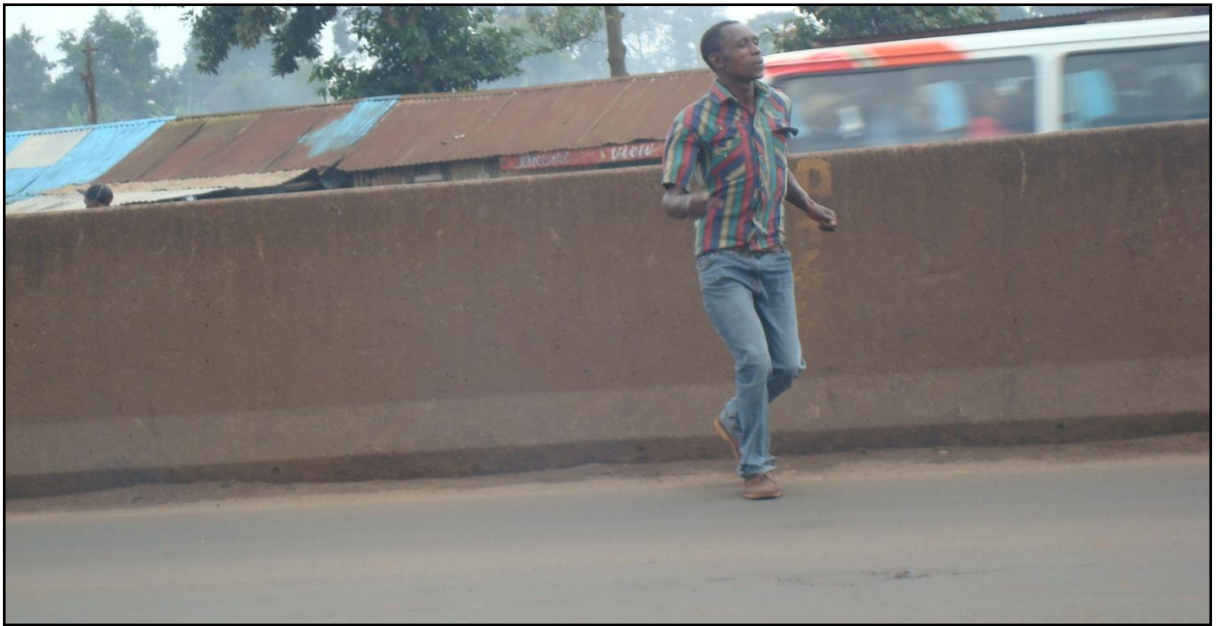
Picture 2: Pedestrians running across the road after climbing over the barrier

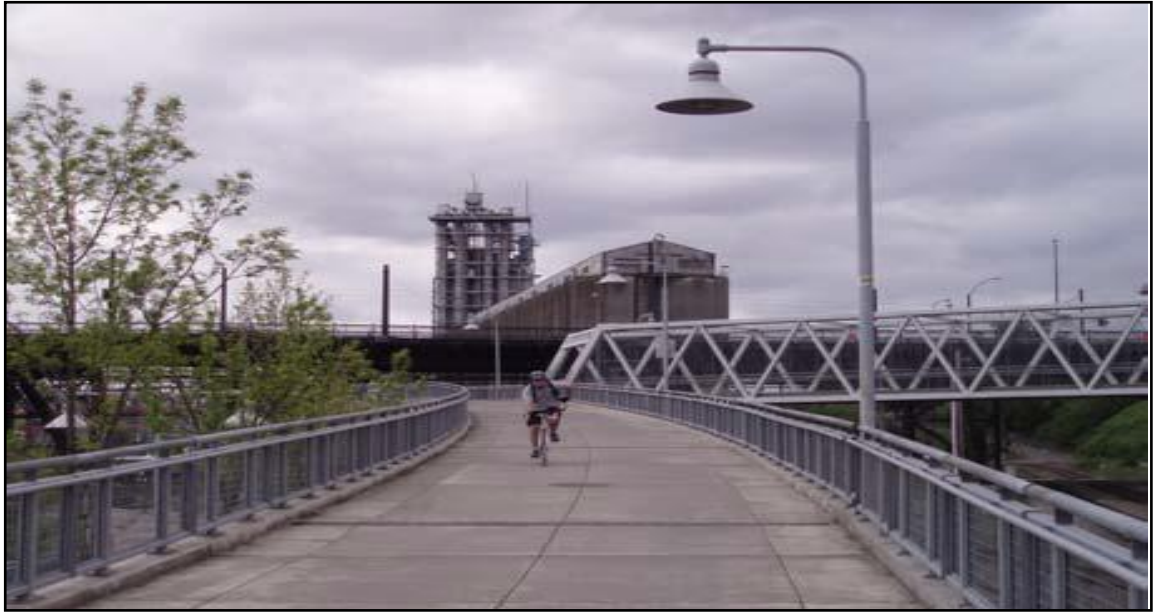
Picture 4: Pedestrian –Scale Lighting on Eastbank Esplanade-Rose Connector

Picture 4 shows a pedestrian footbridge which is wide enough to accommodate a relative number of pedestrians to pass through it without being congested. One of the requirements of the pedestrian footbridge is that it should be wide enough to accommodate the largest number of pedestrians observed during at peak hours. The minimum width of the pedestrian footbridge should be at least 2.4m (Kotahi, 2009). The current pedestrian footbridge width is 2.2m wide (effective width). It remains to be established if this meets the LOS C as prescribed according to Washington Metropolitan Area Transit Authority (2005).

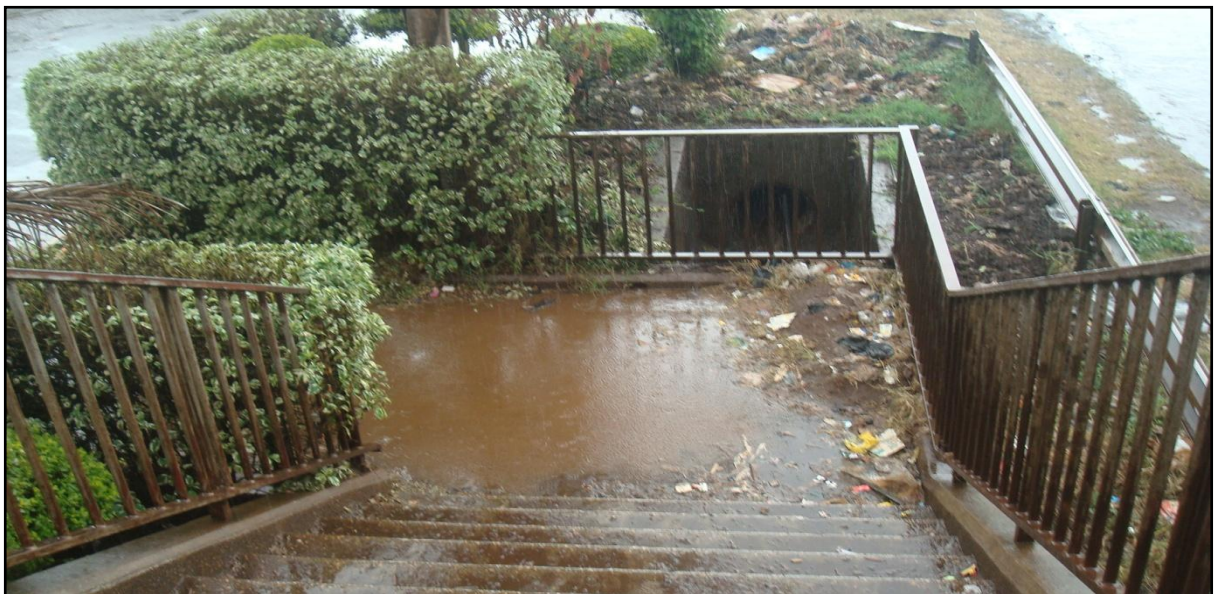
Picture 5: Southern end of Uthiru pedestrian footbridge with water

It was also observed that there is general lack of maintenance to the footbridge. The footbridge is not cleaned regularly as to ensure that it is quite attractive to pedestrians and at the same time drainage is improved. A site visit to Uthiru footbridge on 24th September, 2012 showed that lack of maintenance had an impact on pedestrian footbridge. One end of the bridge could not be used following the falling of rains on that particular day. It was noted that this part of the footbridge was not used by pedestrians due to the pool of water which accumulated because of rains. It is inevitable that during rainy season if all footbridge approaches are not properly drained, pedestrians would remain with no choice but risk themselves in crossing at grade (See pictures 5 and 6 for illustration of the problem).

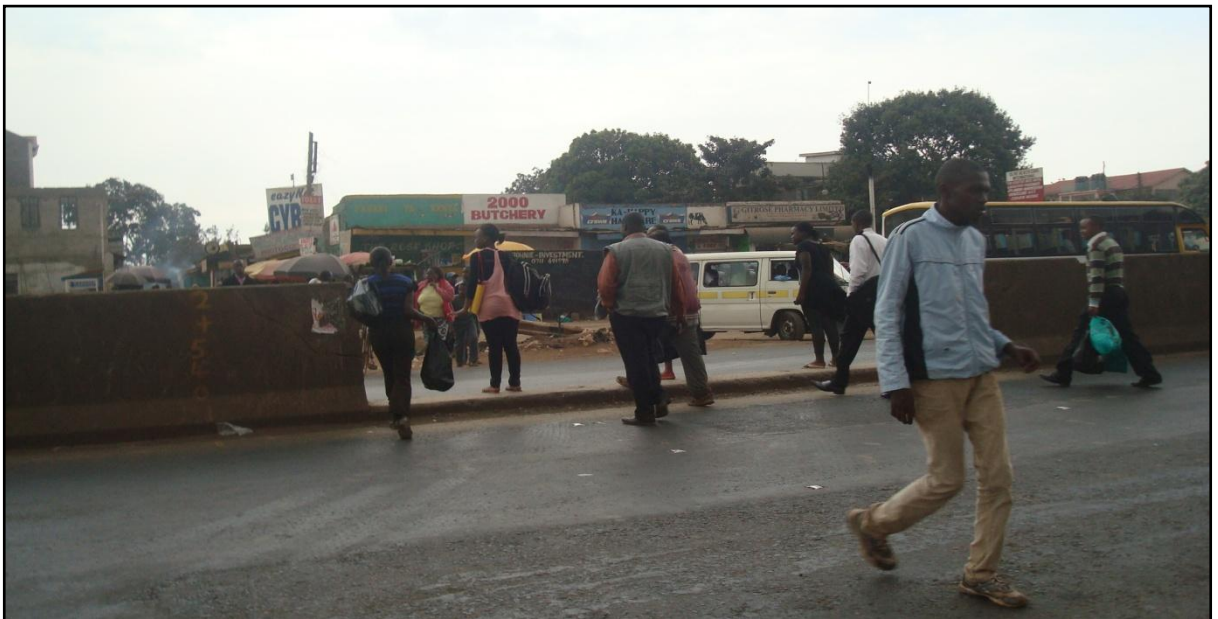
Picture 7: Safe crossing at 87 Estate Trading Centre

Picture 7 shows some alternative safe crossing points which were provided at trading centres to allow pedestrians to cross at grade. The barrier is broken intermittently to allow pedestrians to cross at grade in lieu of footbridges or tunnels. This is the case because a concrete barrier was erected from Uthiru to Rironi which is about 17 km. At randomly sampled points, it was noted there were no traffic calming facilities provided as to ensure that vehicles slow down for pedestrians to cross safely.

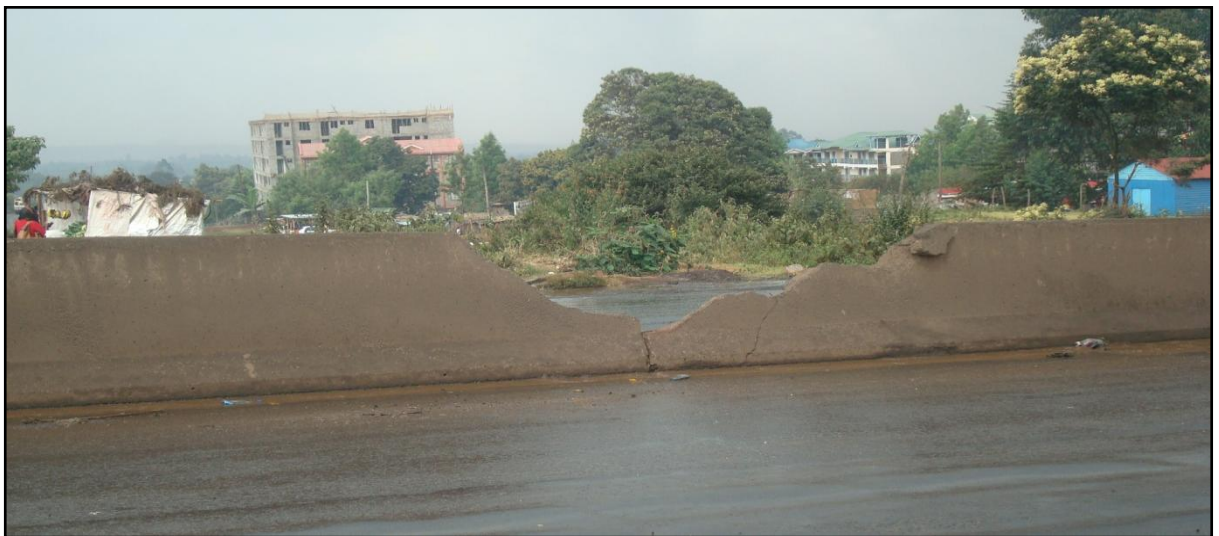
Picture 8: Broken barriers which can be used for grade crossing

In some cases, it was observed that the concrete barrier is damaged due to vehicular accidents. This gives alternative, undesignated and unsafe crossing points for pedestrians at grade. The barrier should be maintained to reinstate damaged sections (See pictures 8 and 9 for illustration of the problem).

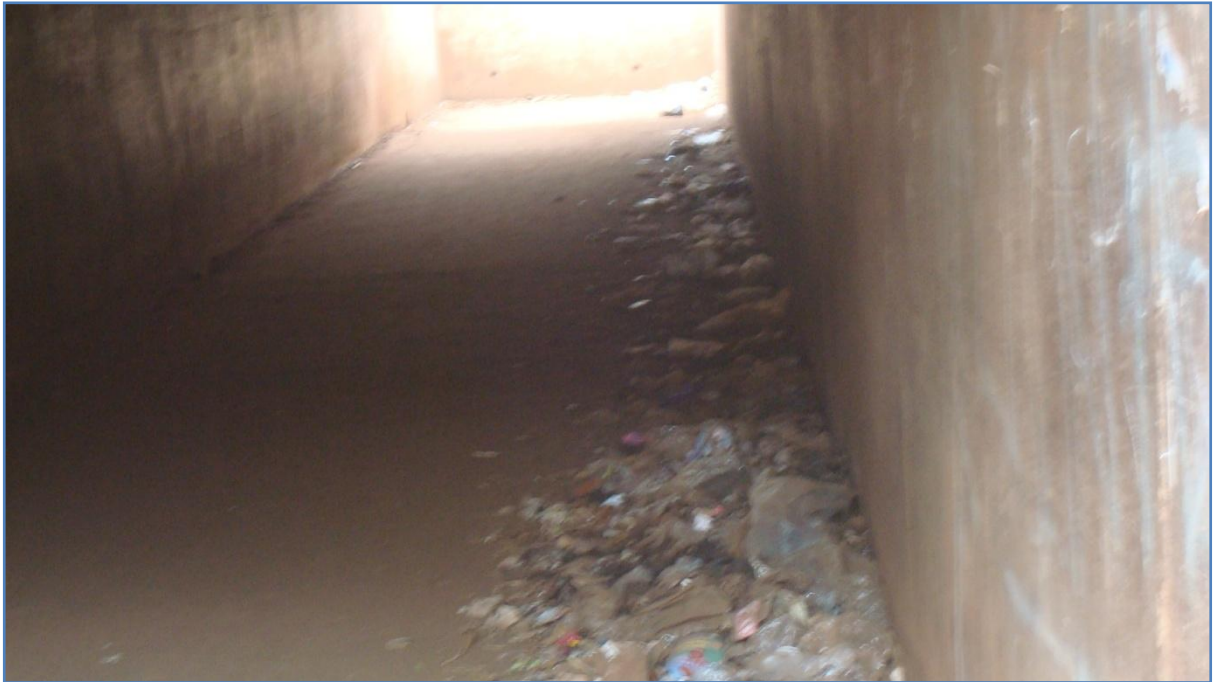
Picture 10: Mama Ngina Kenyatta Primary School Tunnel which is dark, unlit and with some rubbish

It was also noted that there are a number of tunnels which were provided in order to allow pedestrians to cross safely without pedestrian and vehicular conflicts. Two tunnels which are relatively close to Uthiru Pedestrian Footbridge are Mama Ngina Kenyatta Primary School tunnel which is located at 1.560 km and Kino Estate trading centre tunnel which is located at 1.960 km from Uthiru Footbridge. The problem with the tunnels is that they are not maintained on regular basis so that they are in good conditions all the time to be used by pedestrians. In some cases, the debris collects at the entrances and some rubbish is dumped in the tunnels and these demotivate pedestrians from using the tunnels. Accumulation of debris creates unpleasant walking experience to pedestrians (See Pictures 10 and 11).

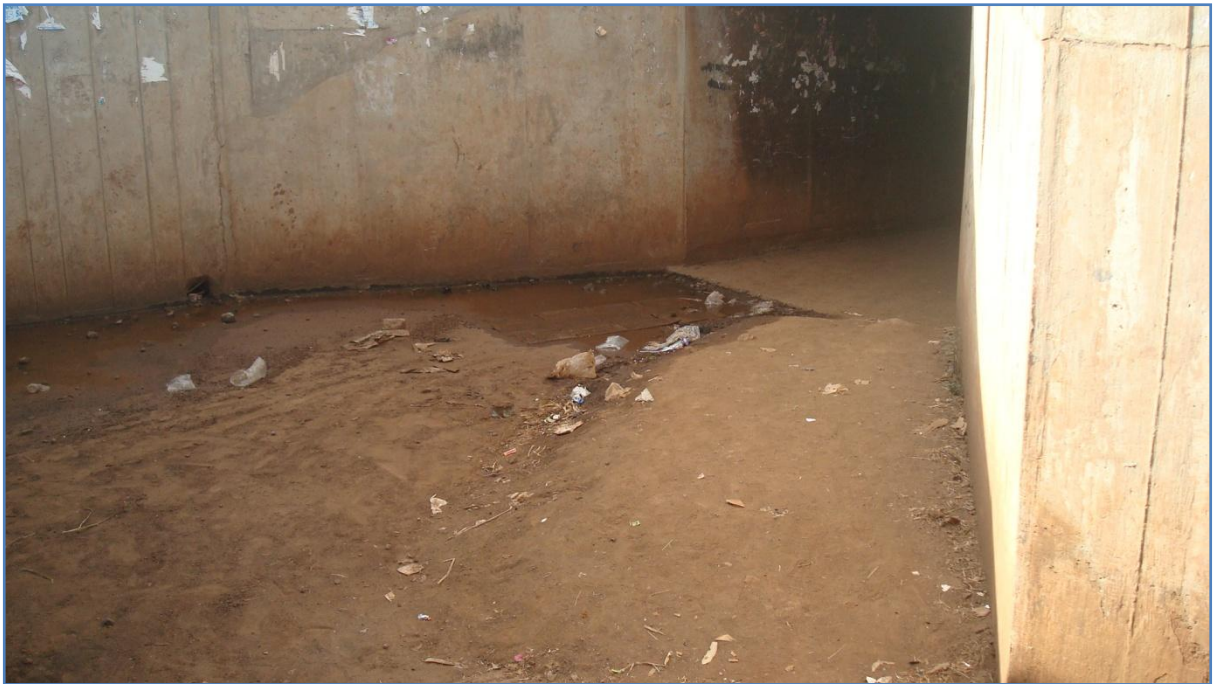
Picture 11: Mama Ngina Kenyatta Primary School Tunnel with debris at entrance

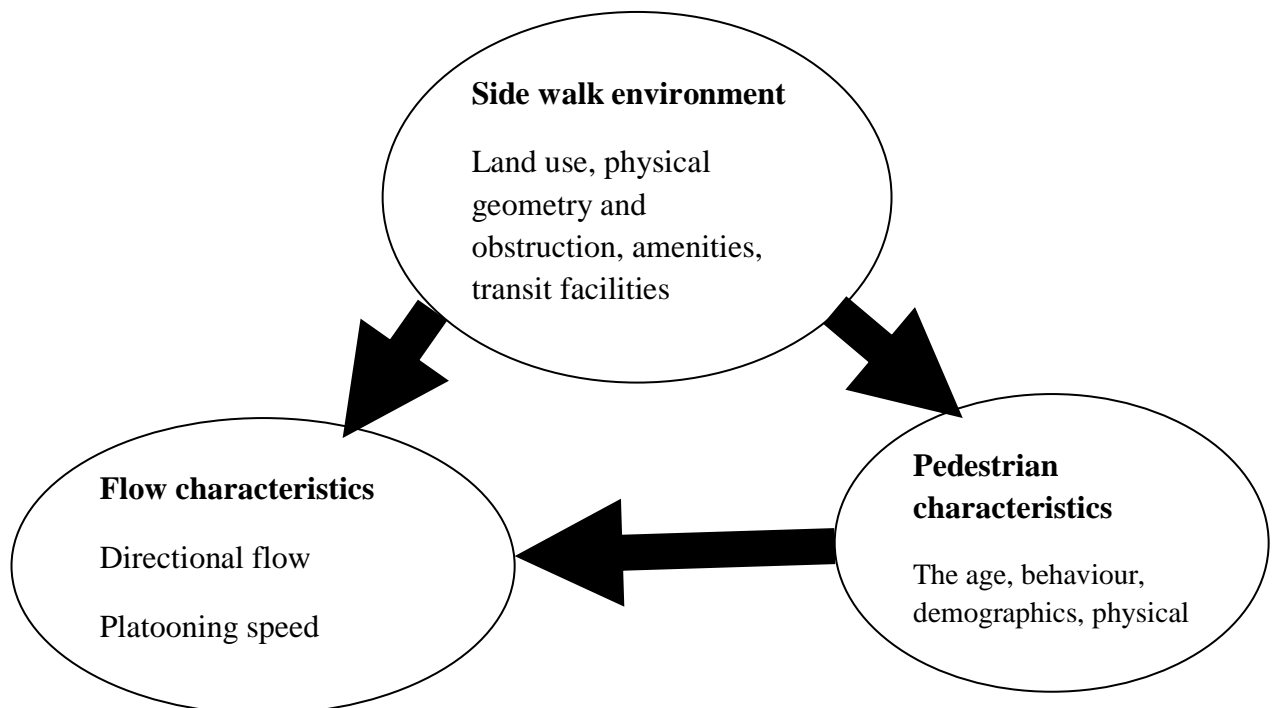
Figure 3: Relationship between the sidewalk, pedestrians and the flow

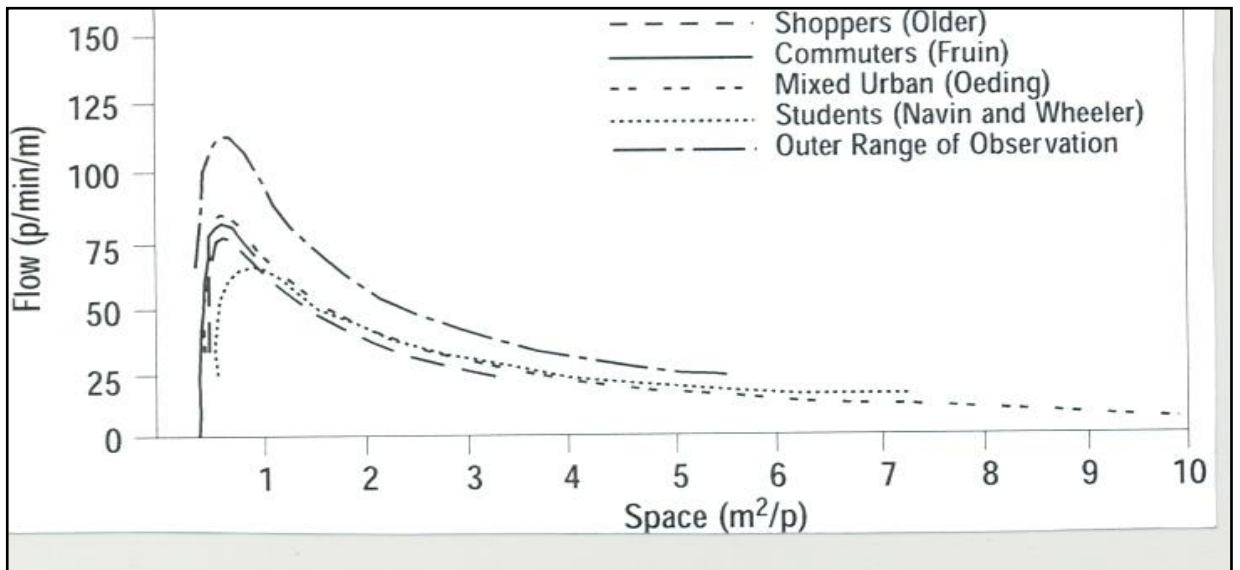
Figure 7: Relationship Pedestrian between Flow and Space

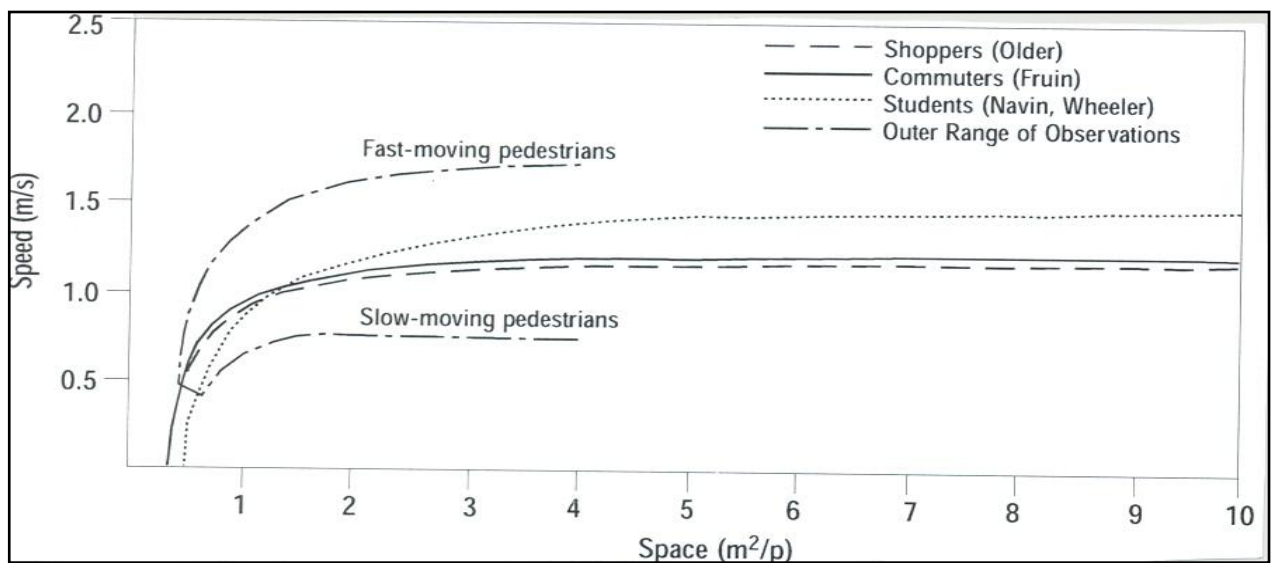
Figure 9: Pedestrian Speed- Space Relationship

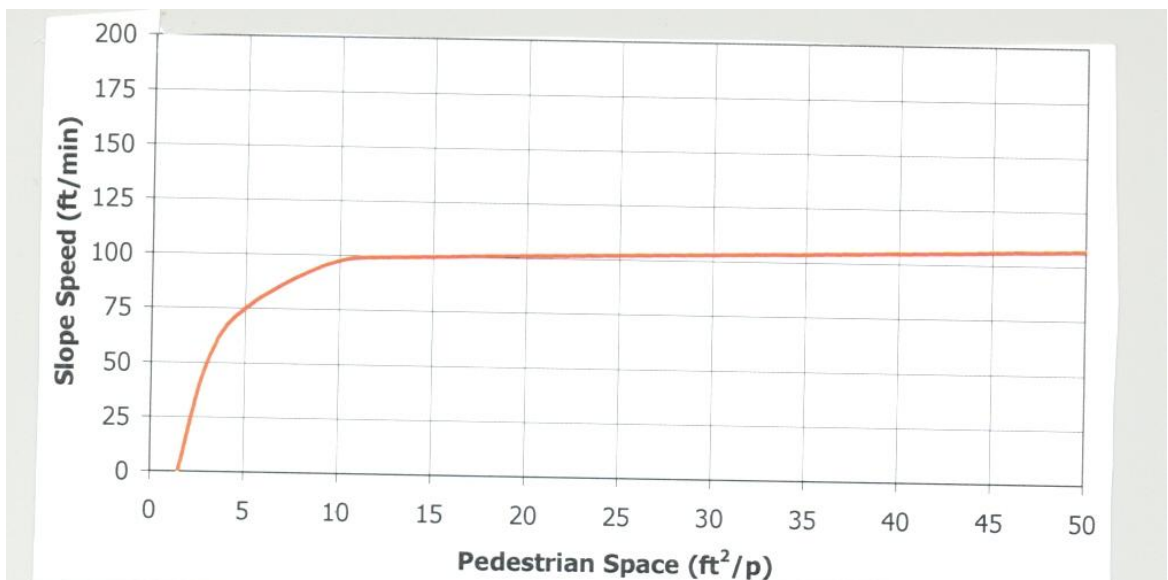
Figure 10: Relationship between ascending speeds and pedestrian space

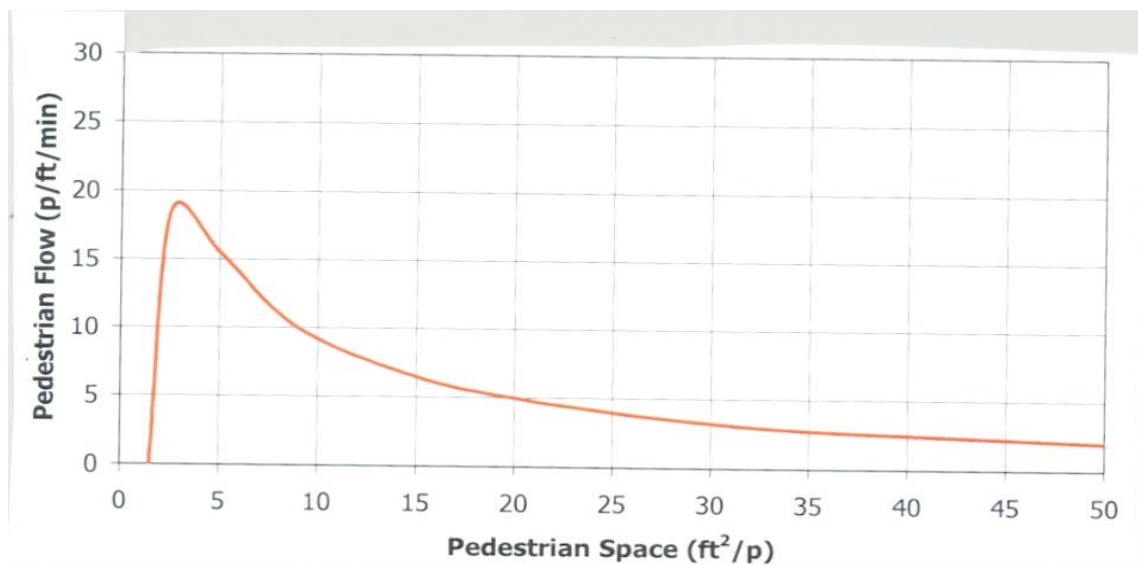
Figure 11: Relationship between Ascending Flow Rate and pedestrian space

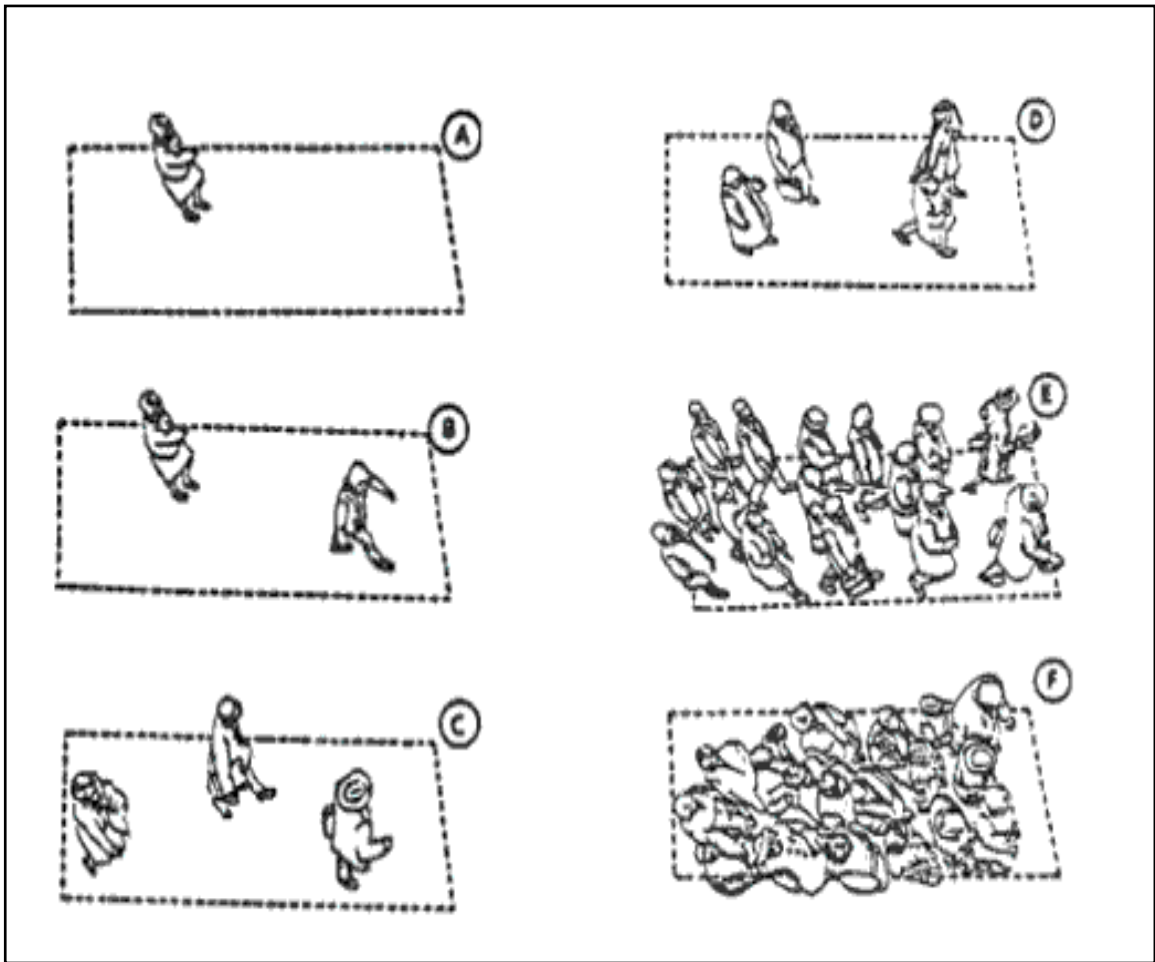
Figure 12: Illustration of Proposed Walkway Level of Service Thresholds.

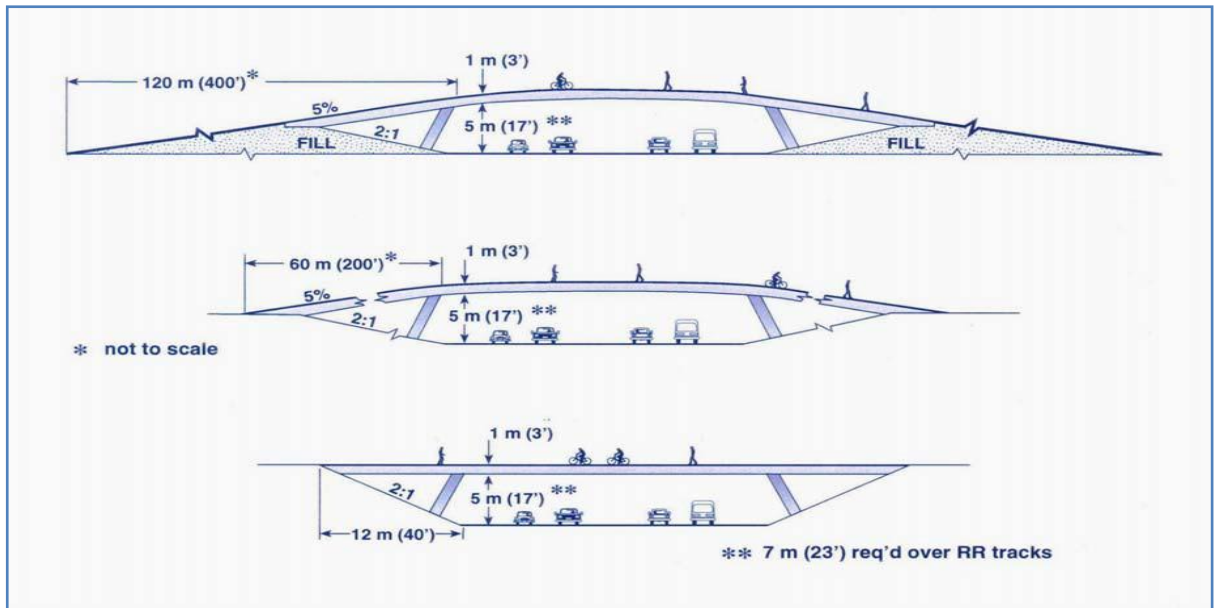
Figure 14: Showing Overcrossings Height in relation to ground level

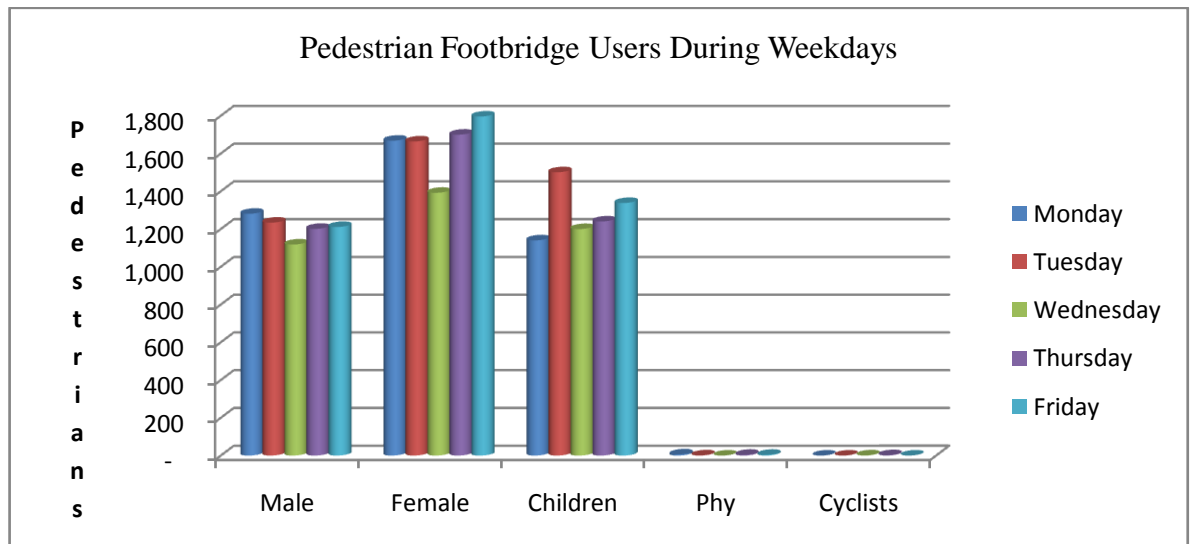
Figure 16: Pedestrian footbridge users during weekdays

In terms of the classification of type of footbridge users, it was observed that females used the footbridge most, followed by children and men respectively (Figure 16). The classification of children included those that are aged from 2 to 16 years and all students attending both primary and secondary school education. The least number of users were the physically challenged and the cyclists.

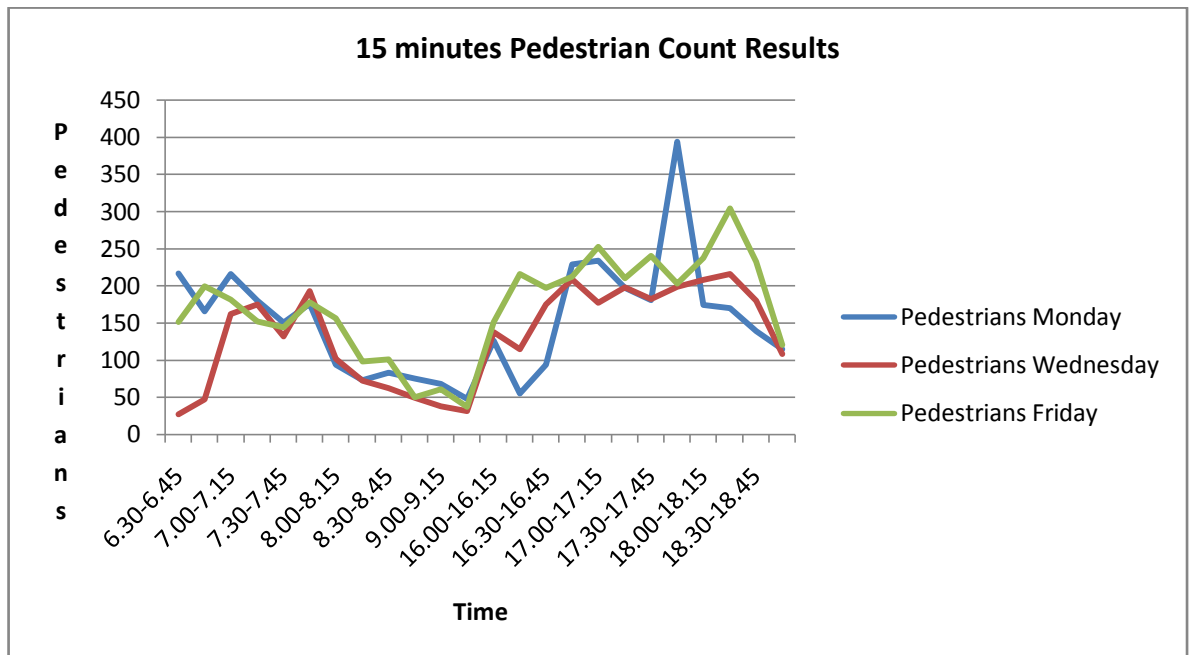
Figure 18: 15minutes Interval Pedestrians Count

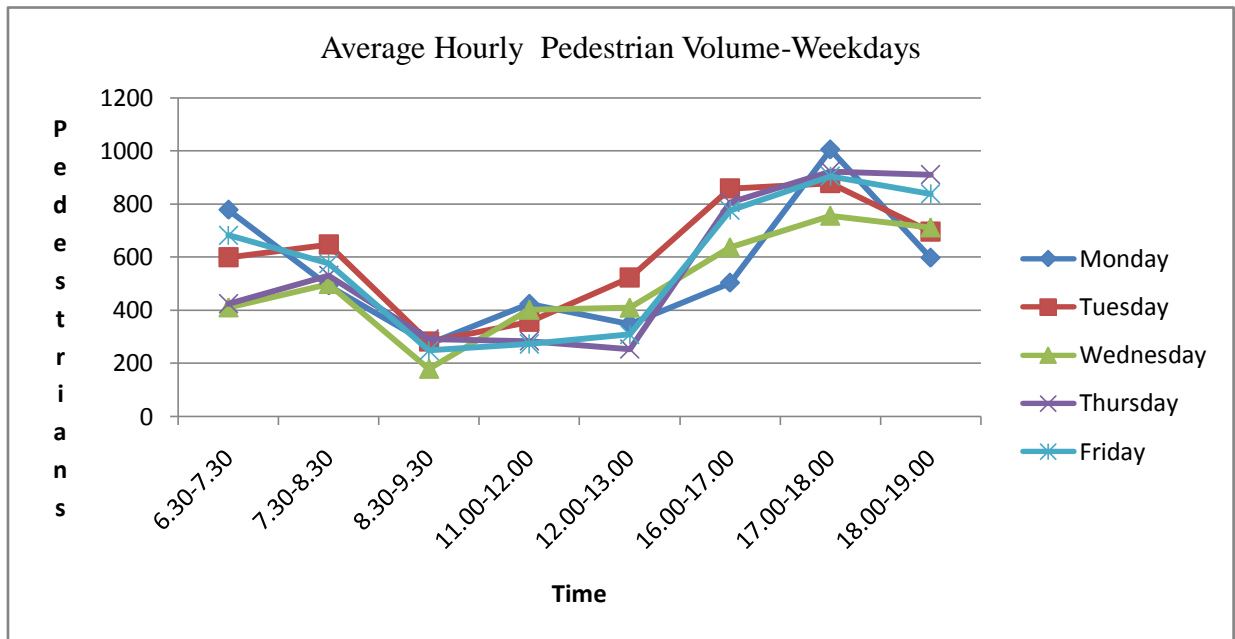
Figure 19: Average Hourly Pedestrian Volume for Weekdays

The average hourly pedestrian volume for the weekdays have been summarized in Table 15 and show the peak value of pedestrians being experienced on Monday from 17.00-18.00 as being 1,006 pedestrians. It was followed by 923 pedestrians which used the footbridge on Thursday from 17.00-18.00. The graphical presentation of average hourly pedestrian volume for weekdays thus from Monday to Friday has been depicted in Figure 19.

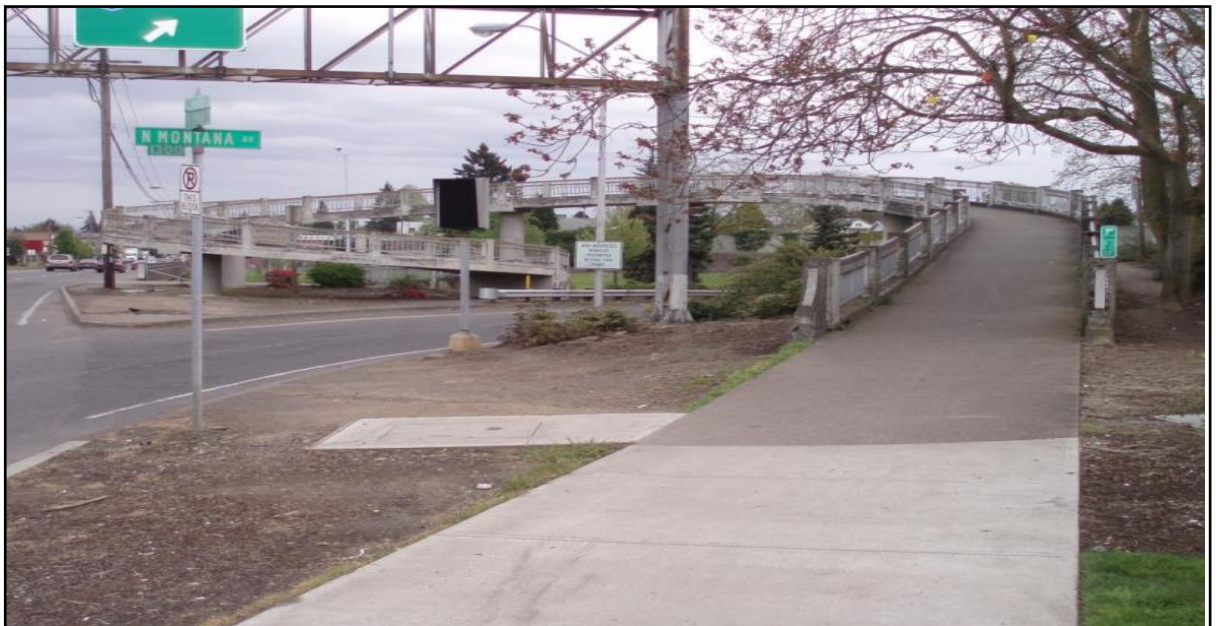
Picture 26: Pedestrian Overpass with ramp to cater for all users including the disabled

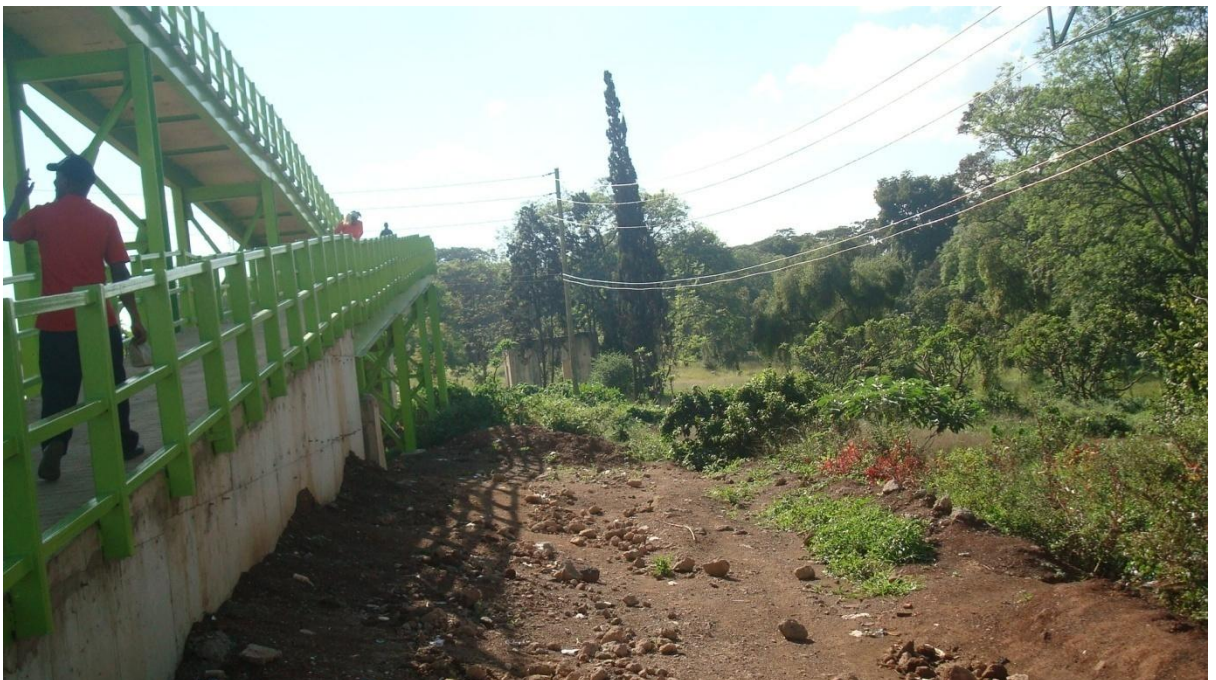
Picture 41: Ramp on Pangani Pedestrian Footbridge

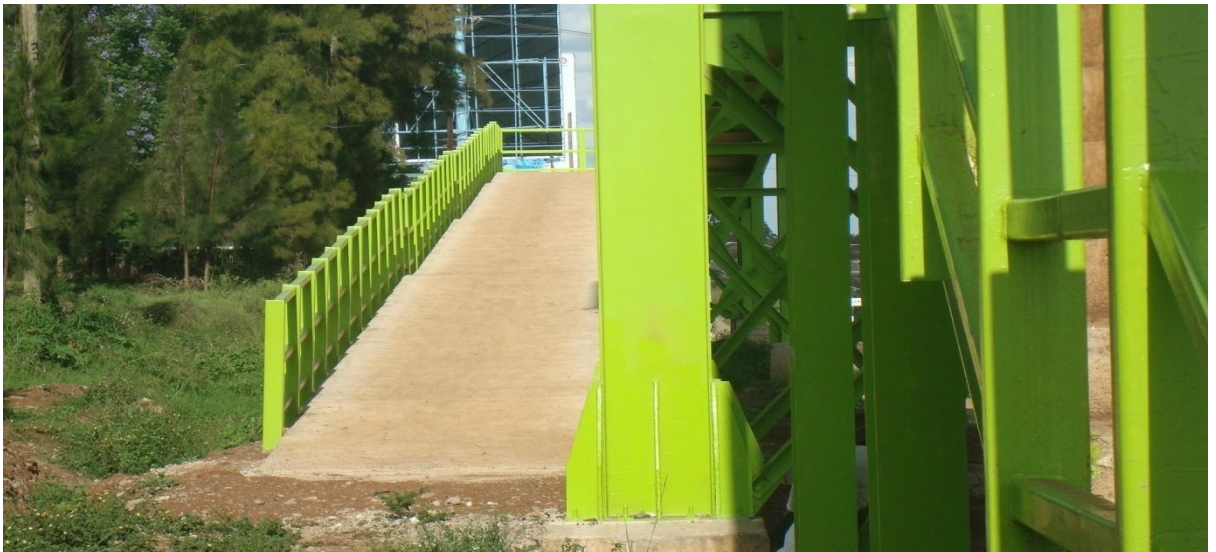
Picture 45: One approach on Muthaiga Pedestrian Footbridge with uncompleted walkway

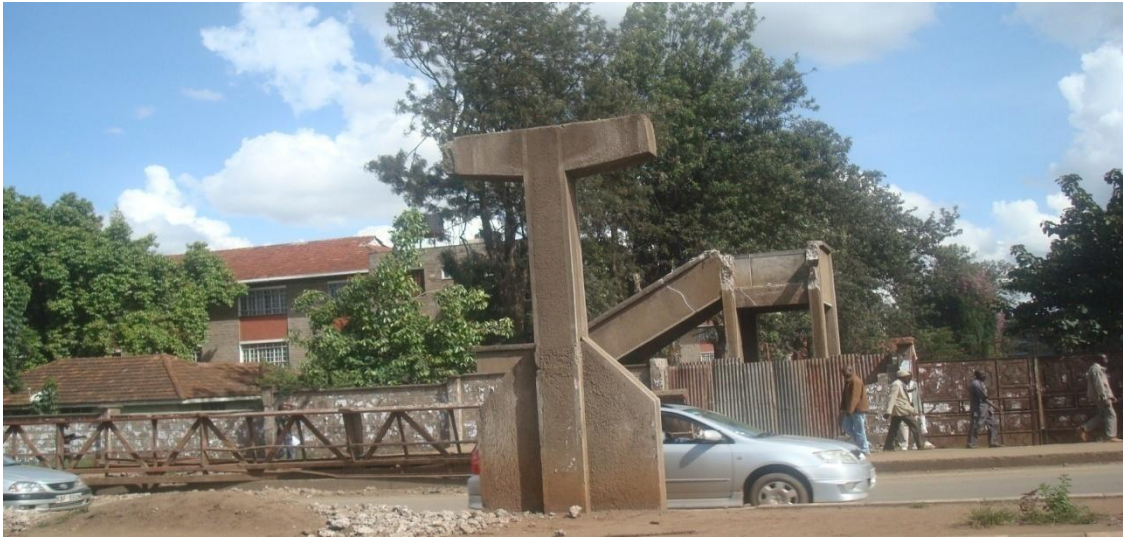
Picture 47: Damaged pedestrian steel footbridge

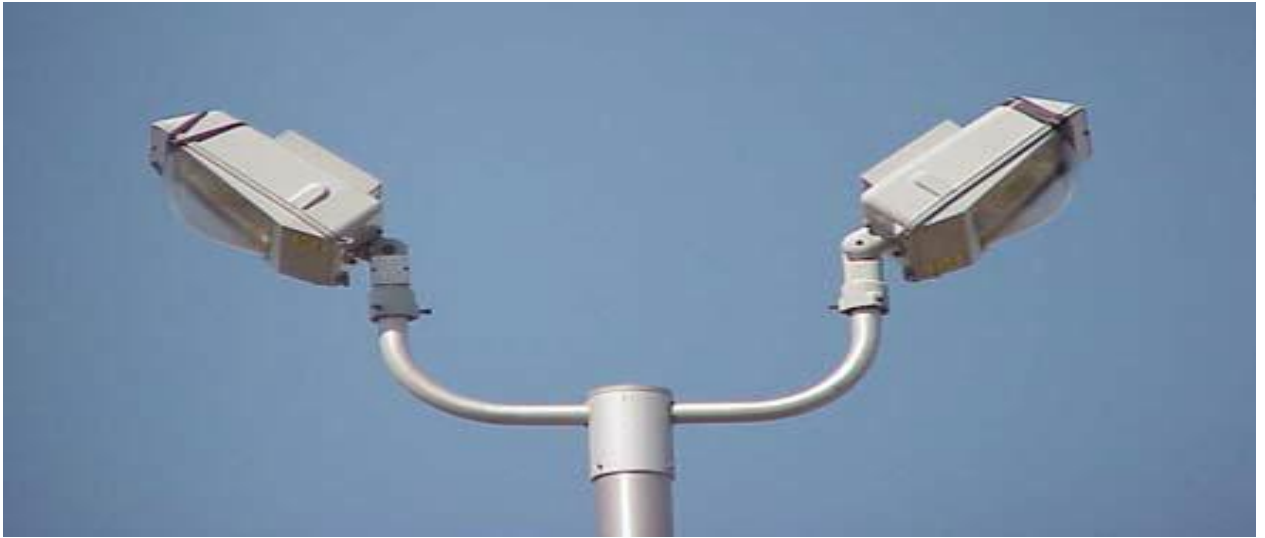
Picture 52: Vertical Mount Style Luminaires

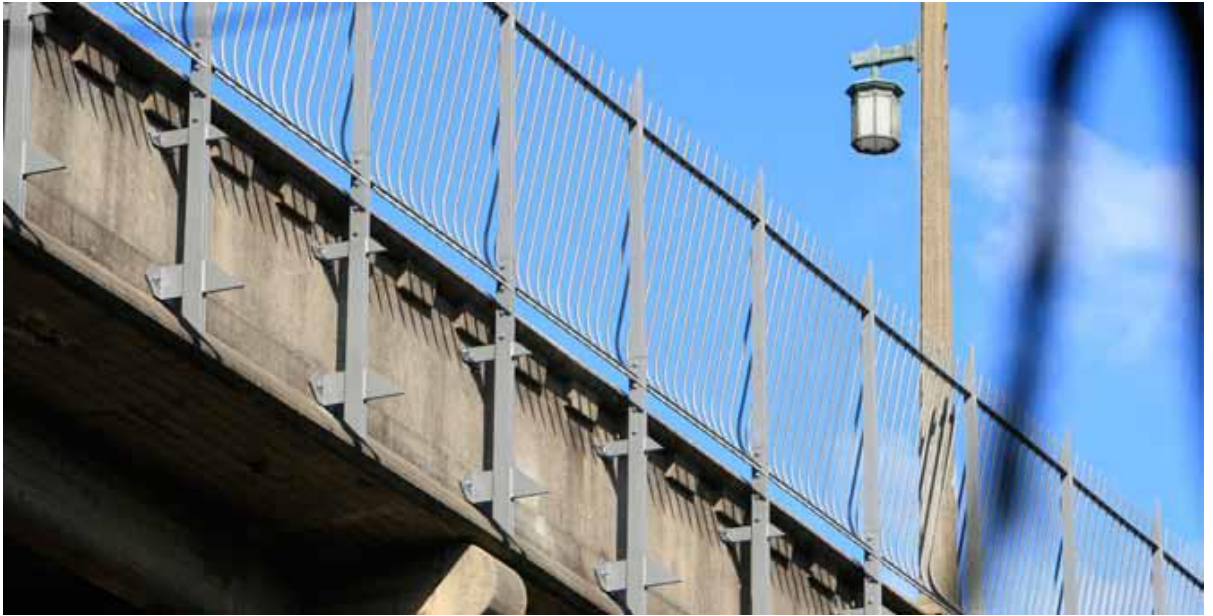
Picture 55: Bridge with sides protected by mesh
