**GEOLOGICAL AND GEOTECHNICAL CONDITIONS
OF NAIROBI SUBSURFACE**

*A thesis submitted in fulfilment of the requirements for the degree of Doctor of
philosophy in Engineering Geology of the University of Nairobi*

July, 2012

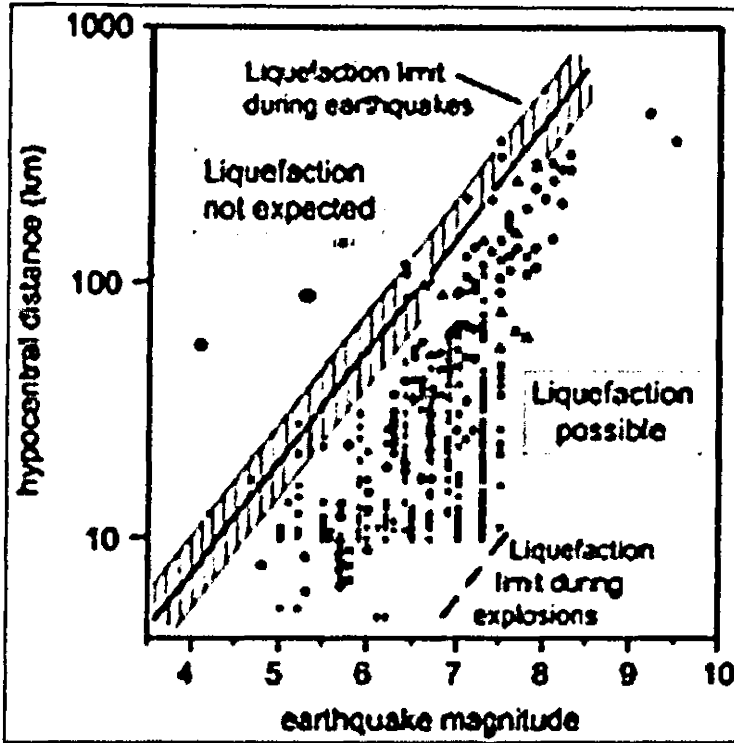
Figure 3.4: Chart for determining potential of liquefaction (Wang et al., 2006)

subsoil characteristics and the distance of the site from Lake Magadi in Kenya that is known to be the most seismically active part of the Rift Valley. This was to investigate whether the loose deposits that underlie Nairobi are liable to liquefaction and determine any relation between earthquakes and defects in structures.

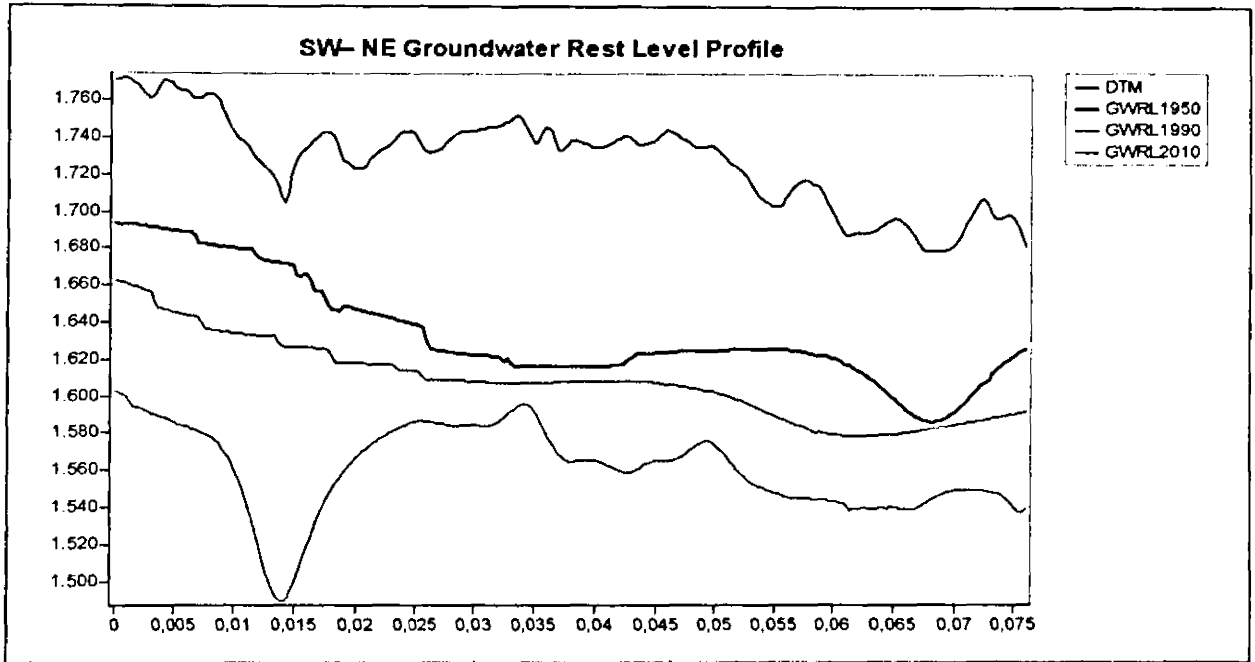
Figure 4.11: Profile of rest level surfaces at 1950, 1990 and 2010 compared with local terrain (X axis in Decimal degrees; Y axis altitude in 10^{-3} meters)

Some anomalies that have no relationship with the structural geology or proximity to rivers were noted on the 3-D surfaces. For example, the two peaks from the 2010 surface that are visible in the middle of Figure 4.10 had to be explained. Rainfall hydrographs were used to relate the static levels with seasons. It was noted that high precipitation preceded drilling of the two boreholes. Figure 4.10 together with the analysis depicted in Figure 4.9, demonstrate that the rest levels have been descending over the past 70 years: from 1950 through 1990 and 2010. Figure 4.11 presents profiles representing rest level surfaces of 1950, 1990 and 2010 in comparison with the local terrain. The planimetric extent of this profile is depicted in purple in Figure 4.6.
