**EFFECTS OF LAND USE CHANGE ON STREAM FLOW, CHANNEL
EROSION AND RIVER GEOMORPHOLOGY: A CASE STUDY OF
MOTOINE/NGONG RIVER SUB-CATCHMENT, NAIROBI RIVER BASIN,
KENYA.**

**A Thesis Submitted for the Award of Master of Arts Degree in Geography
(Geomorphology)**

2014

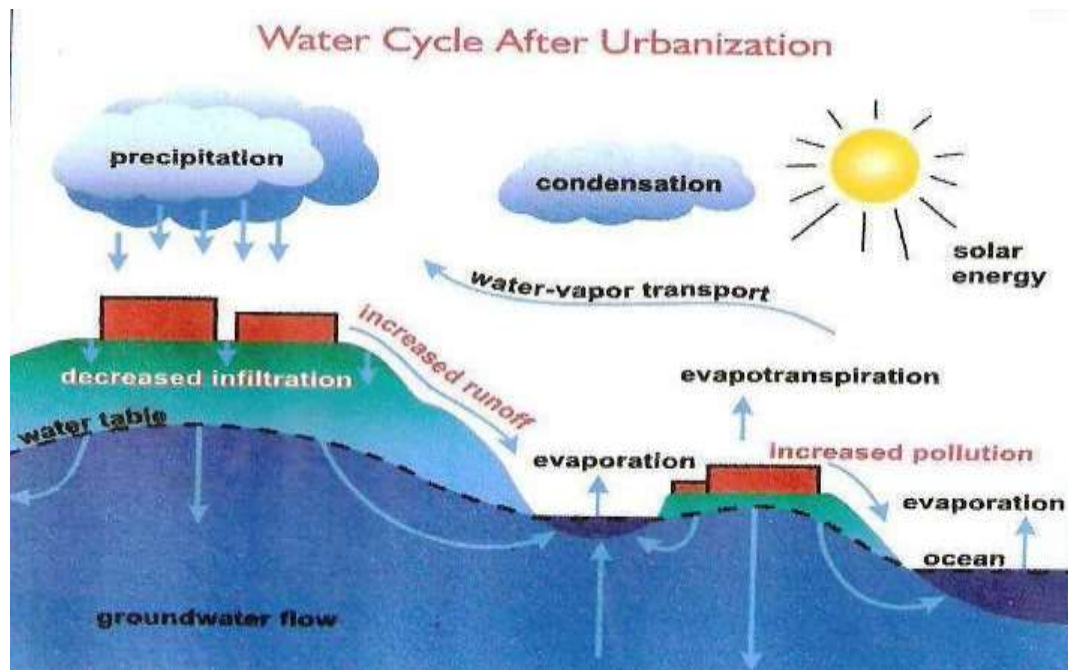
Figure 2.1: Hydrological Cycle of an Urban Watershed

Urbanization affects the hydrological characteristics of a catchment by reducing infiltration of rainwater into the ground and increasing the volume and speed of surface runoff (Fig. 2.1). The replacement of forest cover with paved surfaces or other land use types increases water yield due to reduction in water losses as a result of compaction of soil (Mansell, 2003). This increases stream discharge, an important element in fluvial processes of erosion and sediment transportation (Christopherson, 2010). The processes of erosion and sediment transport result from an interrelated set of natural, human and hydrologic factors within a river basin. The natural factors responsible for erosion are topography, geology and soils. The hydrologic factors are climate and the amount and distribution of surface water runoff and ground water discharge; while land use is the main human factor (Olaka, 2005). The effect of land use on river flow, and the consequent land degradation, is one of the most important environmental problems of our time.

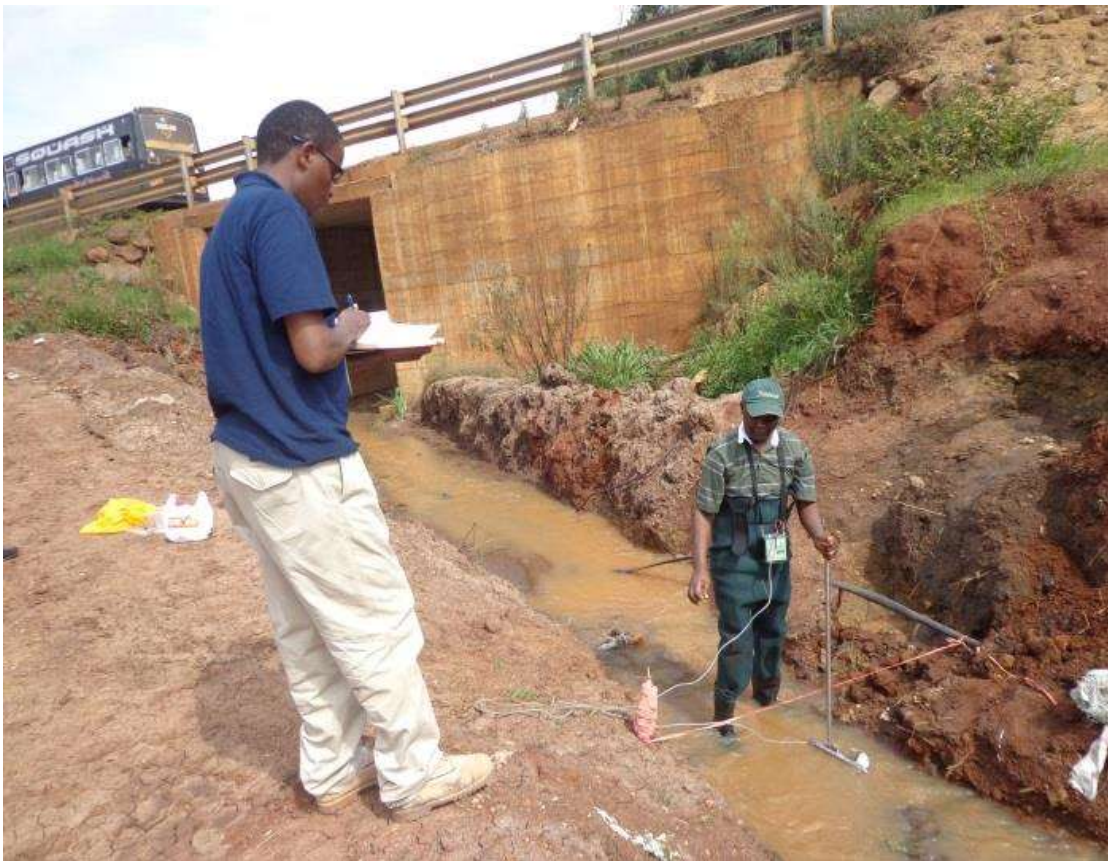
Plate 3.1: Taking discharge measurements using current Meter by wading at Motoine River, Ngong Road Bridge on 17/12/2013.

Q = discharge (m³/s), A = Cross-section Area (m²), V = Mean velocity (m/s).

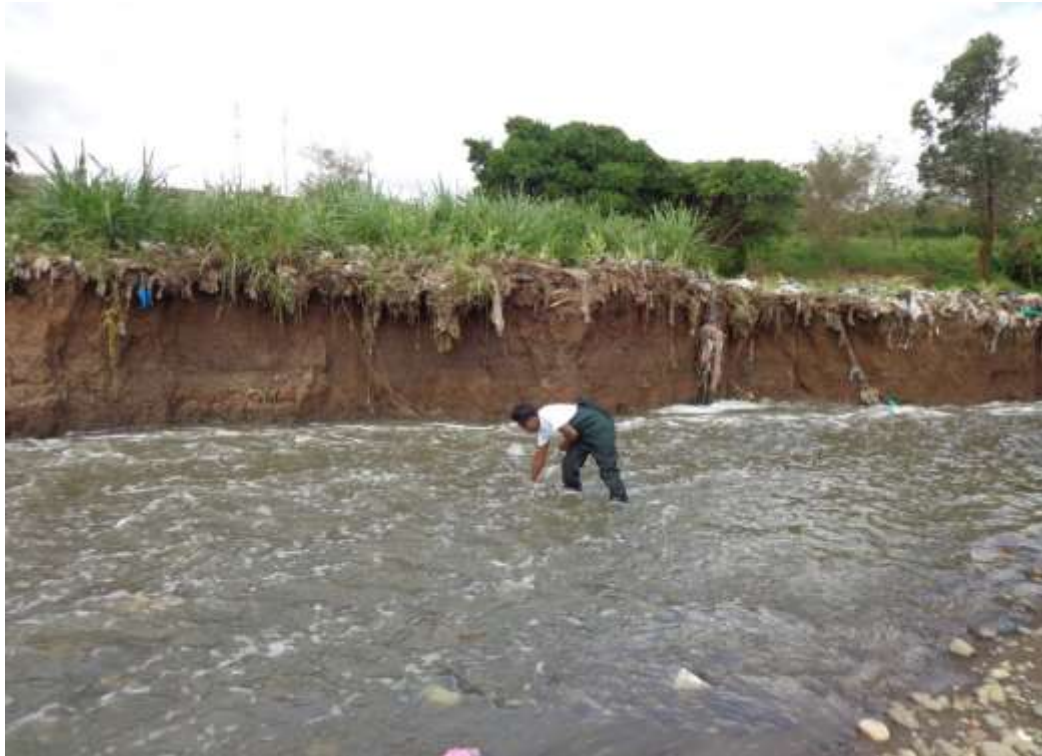
Plate 3.2: Depth integrated sampling of water of Ngong River 100 m upstream of the Kangundo Road Bridge. Photograph was taken on 17/12/2013.

Direction of flow of the river is from the left towards the right.

Suspended sediment samples were collected, while ensuring that depth was integrated, at the same point where stream flow measurements were taken so as to relate stream discharge and sediment concentration (Plate 3.2). This was done at river stretches that were straight with threads of velocity parallel to each other and with flat streambeds free from large rocks, weeds or protruding obstructions which create turbulence (Herschy, 1995). There were four representative sampling points along the river course: at the Motoine swamp outlet (37M 0242157 UTM 9857007), Ngong Road Bridge (37M 0271397 UTM 9861770), Nairobi dam inlet (37M 025450 UTM 9854120) and at Kangundo Road Bridge (37M 0271396 UTM 9861765) (Fig 1.1). This method was previously used by Kithiia, (2006) in studying temporal changes of sediment dynamics within Nairobi River sub-basins.

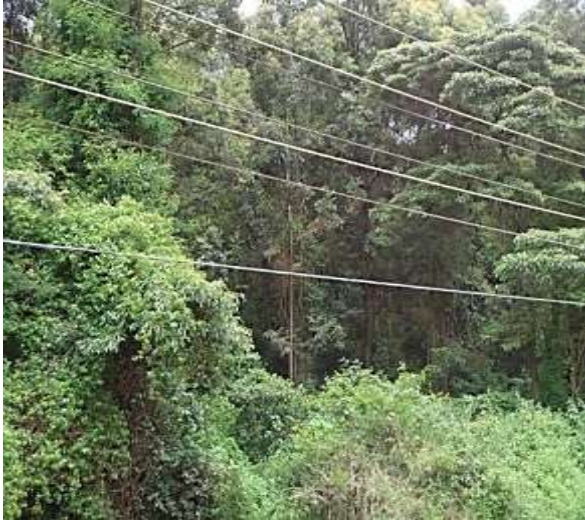
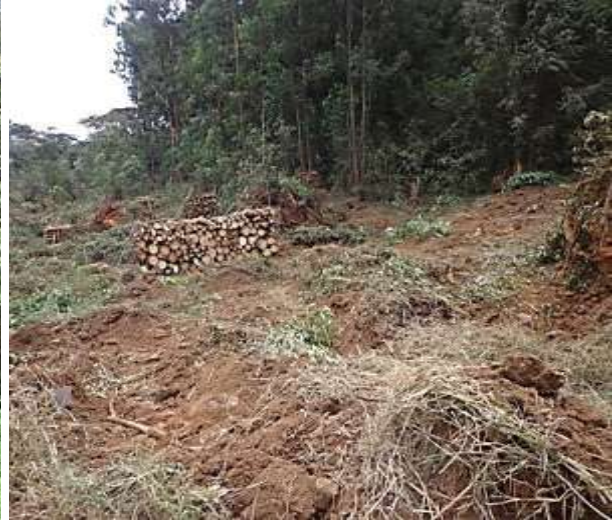
Plate 4.1 a: Part of Ngong Road Forest **Plate 4.1 b: Site cleared for road construction**

Plate 4.1 a was taken on 4/6/2013 and 4.1 b on 25/7/2013

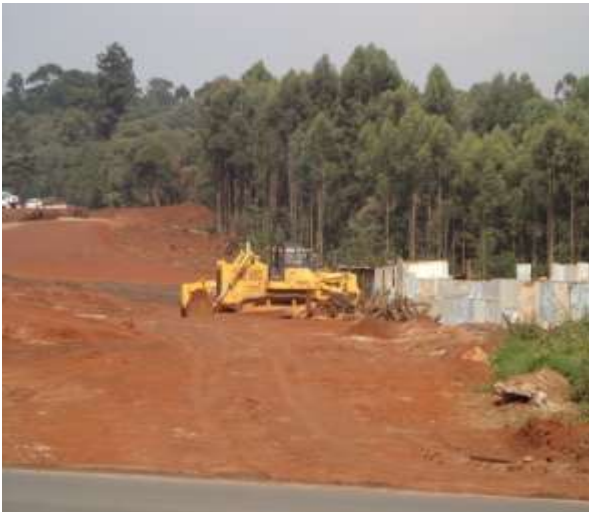
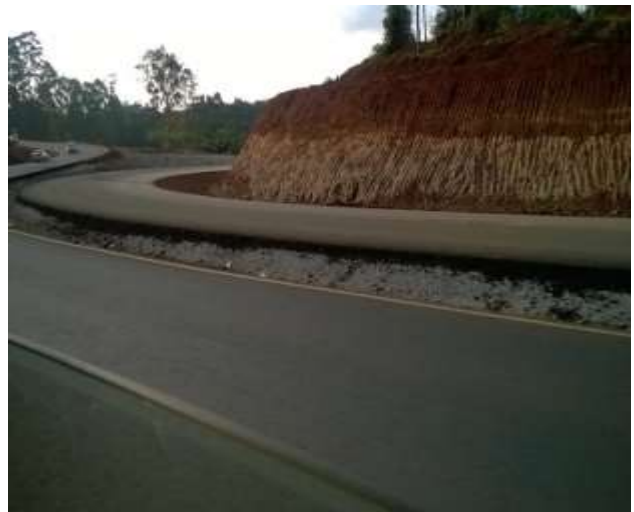
Plate 4.1 c: Road construction underway and site is completed source of sediments to the river surface cover

Plate 4.1d: Road construction and forms an impermeable

Motoine/Ngong river has data limited to only that on which measurements have been made because it does not have gauge stations. For this reason data on discharge for Mbagathi and Nairobi rivers, which are within the same catchment, was interpolated. Discharge for 1970 compared to discharge for 2012, showed that the mean monthly and annual discharge has generally increased over time. Discharge for Nairobi river in the month of April 1970 (Appendix XIV) was $1.720 \text{ m}^3/\text{s}$ and $8.180 \text{ m}^3/\text{s}$ for the same month in 2012 (Appendix XVI, Fig 2). This indicates that rain season flow was quite high in 2012 compared to 1970. Total annual rainfall for 1970 was 1,110 mm and 1,475 mm for 2012, an increase of 32.88%. In the months of April recorded rainfall was 469.1 mm for 2012 and 347.3 mm for 1970, an increase of 35%. Discharge for Nairobi River for this same month was $8.18 \text{ m}^3/\text{s}$ for 2012 and $1.72 \text{ m}^3/\text{s}$ for 1970, an increase of 375.58%. In spite of higher rainfall recorded in the months of April 2012 than 1970, stream flow was several times higher in 2012 compared to 1970. This is attributed to increase in impermeable surface cover in the catchment due to increase in built up area and road pattern of land use (plate 4.1 d, Appendix VII).

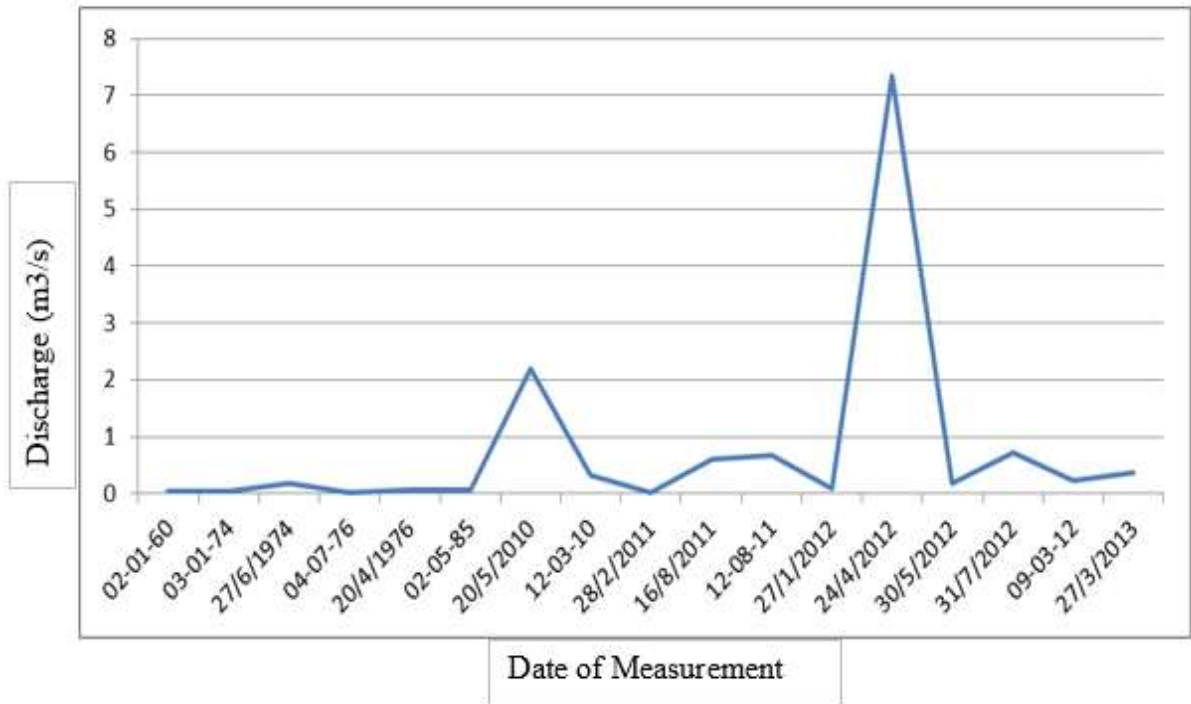
Figure 4.1: Trend of Flow for Mbagathi River (RGS 3AA04) from 1974 to 2012

The same trend was evident for Mbagathi River in the month of September 1970 (Appendix XV) and 2012 (Appendix XVI); an increase in rainfall by 156% and an even higher increase in discharge by 243% (Fig 4.3). Information from the questionnaire indicated that flow filled the channel during the wet season and the water level was very low during the dry season. The trend of flow for Mbagathi river indicates a steady increase in stream flow. This is attributed to land use change and not rainfall because increase in rainfall was not significant as earlier discussed to cause such significant increase in discharge (Fig 4.1, Appendix XVI).

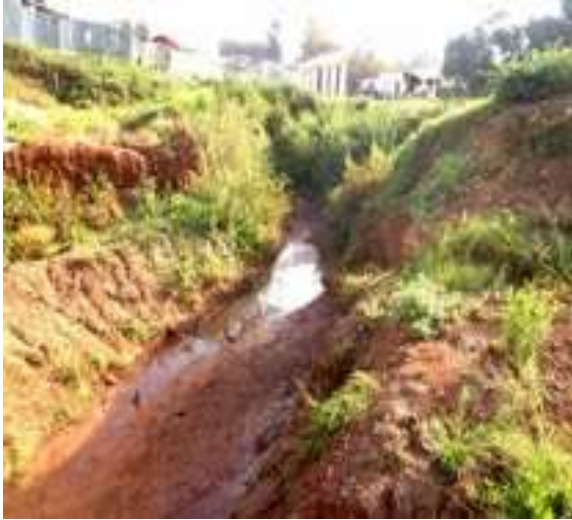
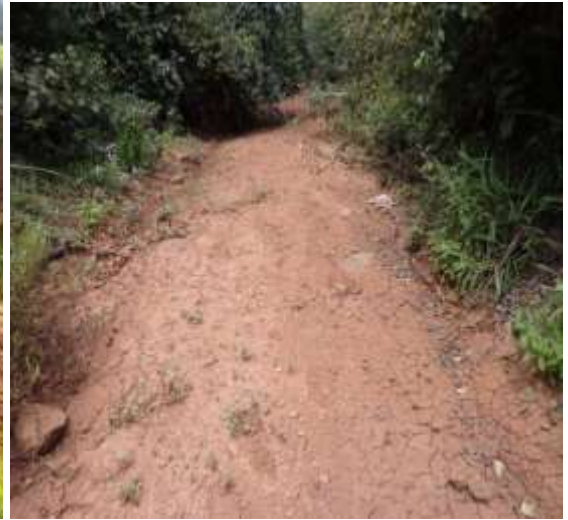
Plate 4.2 a: River bed drying up

Plate 4.2 b: Dry river bed

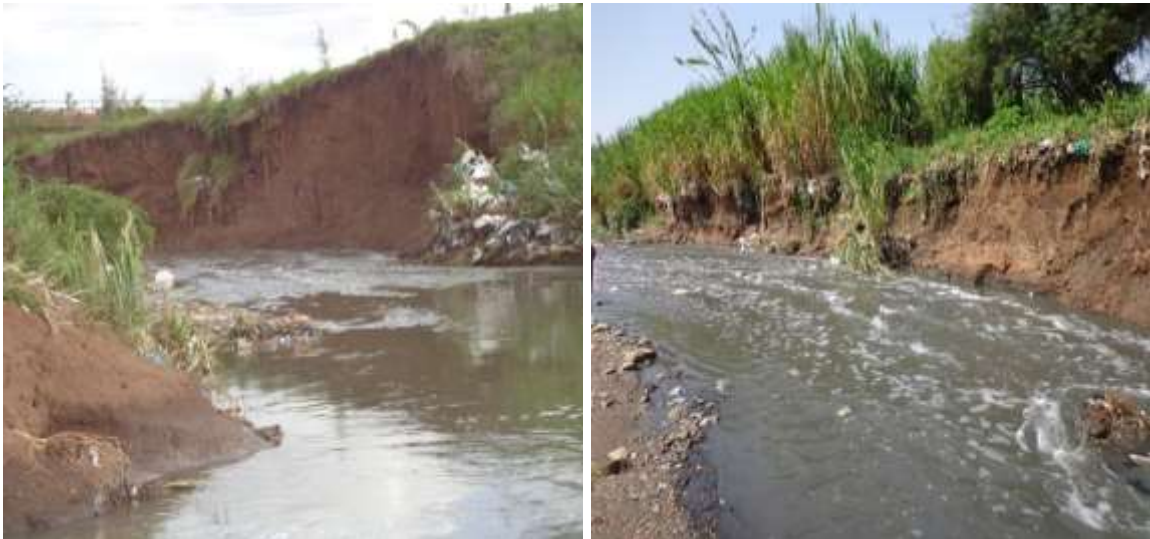
Plate 4.2 c: Land slide of high river cliffs **Plate 4.2 d: Collapsing of banks**

It was noted that mass wasting occurred along sections where the bank material was composed of erodible soil as well as having high cliffs and therefore had low resistance. Prolonged rainfall events cause strength reduction and increase in unit weight of the materials causing them to collapse. Gray and Sotir (1996) say that failure occurs when

the erosion of the bank and the bed adjacent to the bank have increased the bank height and steepness (slope), to a point where it reaches a condition of limiting stability.

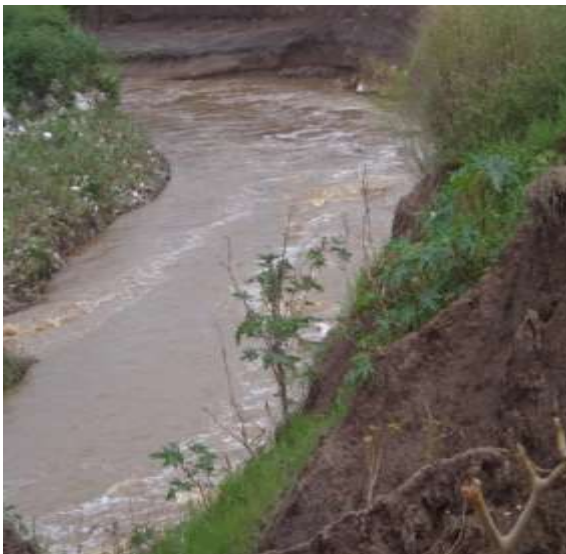
Plate 4.2 e: Undercutting of outer bank

Undercutting was noted both on the concave (outer) banks of the river and the convex (inner) banks of the river as evidenced by occurrence of cavities at both river banks (Plate 4.2 e & f). The cavities occurred at the middle and lower parts of the banks which imply that removal of toe material occurred during medium and low stage periods due to excessive pore pressure and overburden. As earlier discussed flow of Motoine/Ngong river varies between seasons and flash floods rise and fall rapidly after a rainfall event. Thorne (1998) found that pore pressure along the river banks caused small to medium sized blocks of fine grained cohesive material to fall out leaving a cavity. The fine cohesive materials allow the buildup of positive pore water pressure and strong seepage within its structure. The roof of the cavity may collapse resulting to river bank retreat.

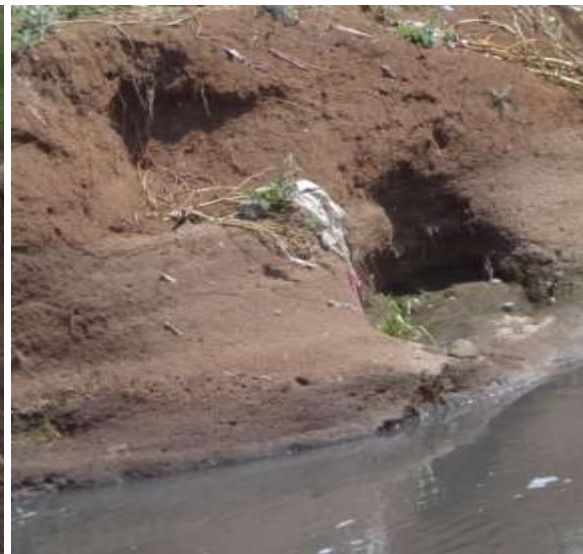
Plate 4.2 f: Undercutting of inner bank/pop out failure results to cavities

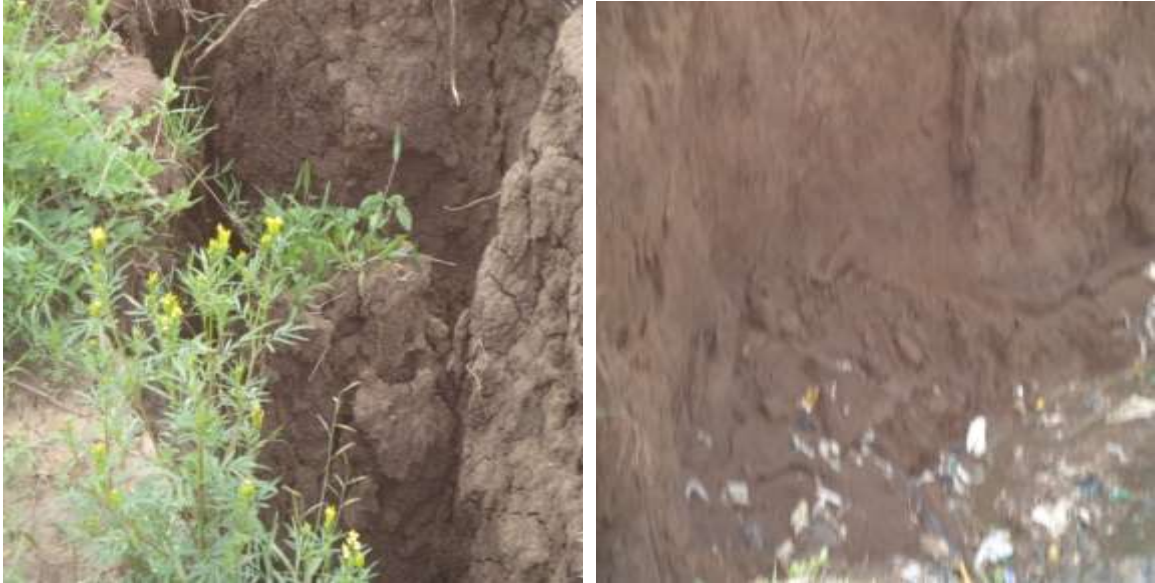
Plate 4.2 g: unstable outer bank showing cracks Plate 4.2 h: collapsed outer bank

Some sections of the river banks had deep and gaping tension cracks (Plate 4.2 g). Other sections where the cracks had progressed lost resistance and had collapsed into the channel (Plate 4.2 h). This results from weathering through desiccation which occurs in rocks with high clay content. During the wet season the clay soils absorb moisture and expand. During dry weather the soil loses moisture and contracts. It is during contraction that cracks develop in the soil and subsequently collapse into the river. This steepens and erodes river banks.

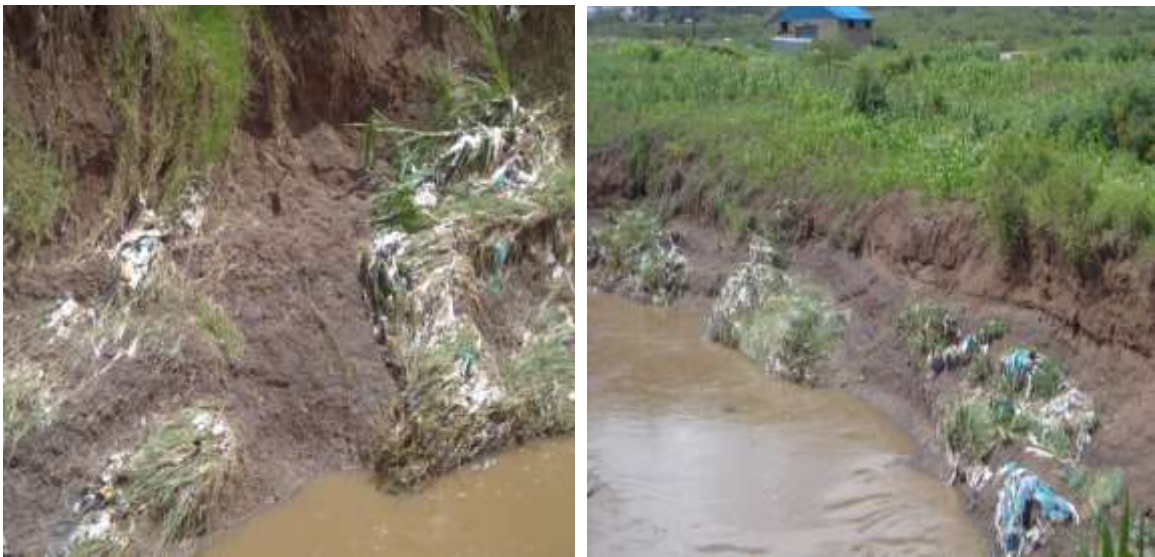
Plate 4.2 i: Basal Cleanout of the inner bank. Plate 4.2 j: Basal Cleanout of the outer bank
Source: Researcher, (2013)

Photographs were taken near Kangundo Road Bridge on 28/12/2012.

Some points of the river banks portrayed basal cleanout as they had been freshly swept clear of loose soil particles (Plate 4.2 i and j). Direct observation and photography in the field revealed that flash floods had removed loose soil particles and uprooted vegetation that had colonised the river banks. This removal of supportive and protective material, either vegetation or sediments, at the base resulted to bank instability. It was noted that the removal of collapsed bank material left the lower river bank material exposed to a continuous cycle of undercutting, collapse and removal, and the subsequent process of river bank retreat. This removal of sediments and vegetation resulted to apparent widening of the river channel during the rainy season mainly at the outer banks. Sedimentation at the inner banks was observed forming point bars.

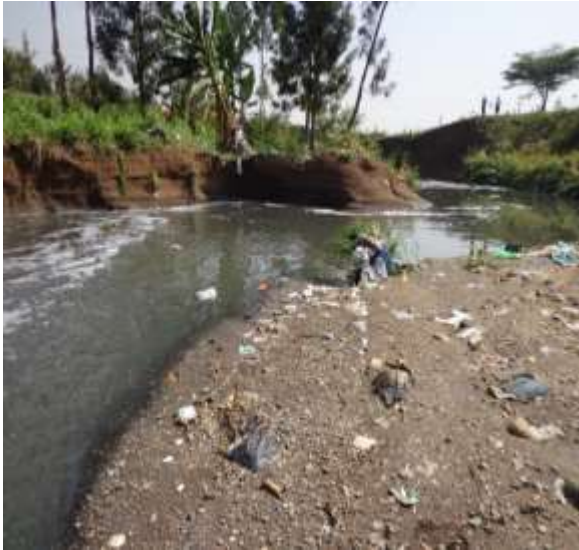
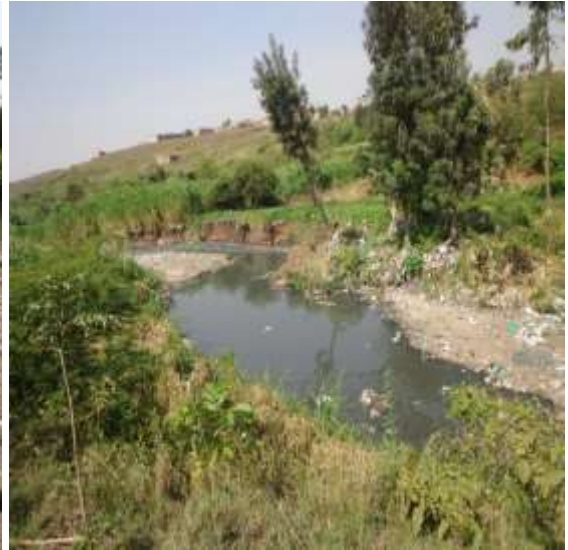
Plate 4.3 a

Plate 4.3: a & b: Channel meanders, slip-off slopes and river cliffs at Njiru 100 m upstream kangundo Road Bridge. Photographs taken on 5/9/2013

portion of the meander curve was subjected to erosion by hydraulic action and abrasion. This formed a deep and steep bank, an undercut bank. This resulted to development of a river cliff. The inner portion of a meander receives sediment fill and had formed a point-bar deposit, which had developed into a slip-off slope (Plate 4.3 a and b).

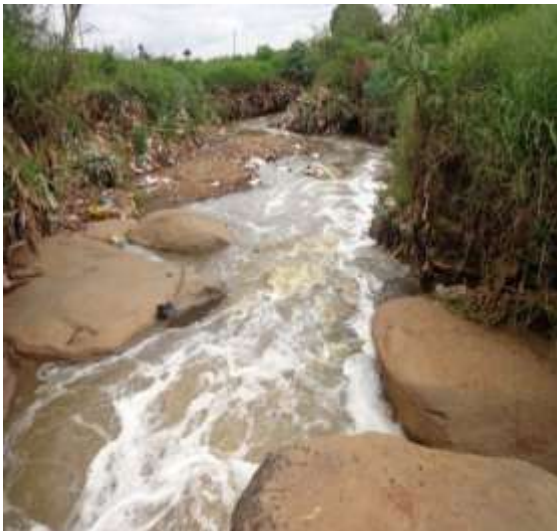
Plate 4.3 c

Plate 4.3 c: Channel meanders, slip-off slopes, river cliffs and outcrop rocks near dam inlet.

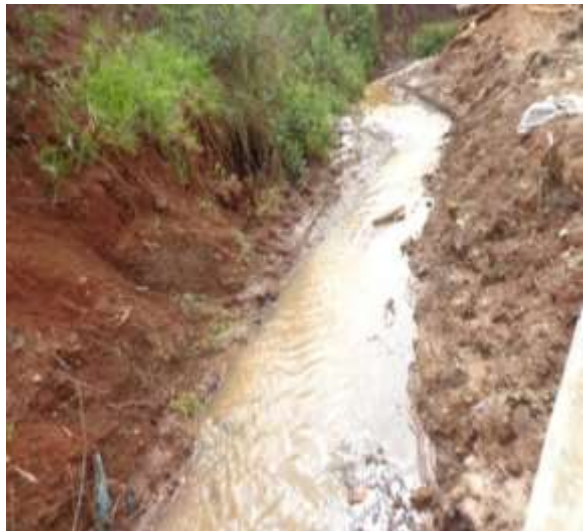
Plate 4.3 d

Plate 4.3 d: Channel meanders, slip-off slopes and river cliffs at Ngong Road Bridge.

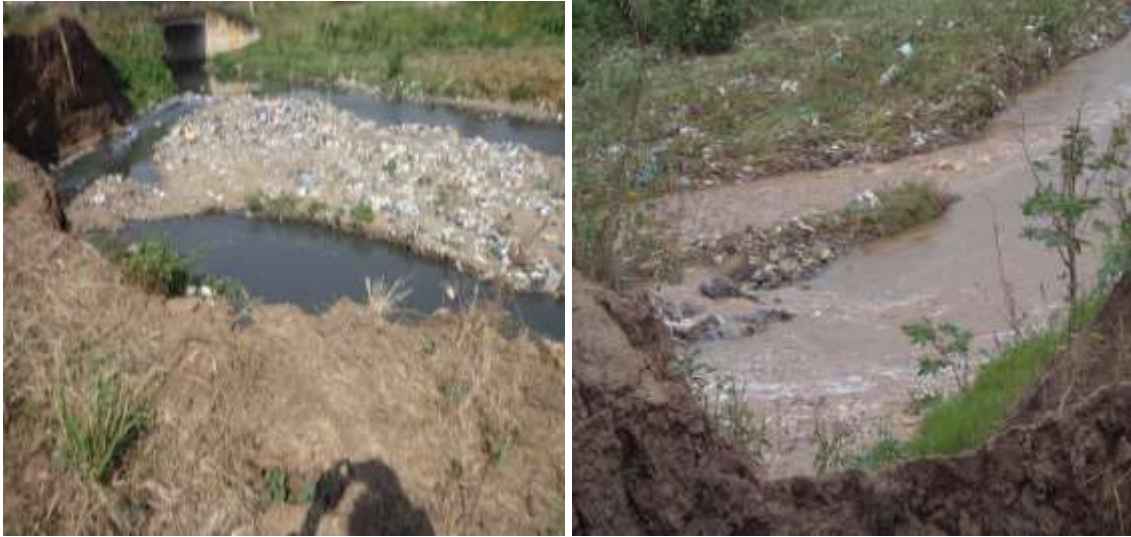
Plate 4.3 e: Dry season Channel Braids

Plate 4.3 f: Wet Season Channel Braids

Direct observation and photography in the field revealed that the bars that form the braided channel at the Motoine/Ngong river have no vegetation. This implies that there is frequent refreshing of bar surfaces, bar destruction and re-formation. This means there is increased erosion and flood frequency and magnitude. Presence of vegetation indicates a degree of stability. The bar size and material composition also vary between the rainy and dry season. During the dry season the bar was larger and composed of finer materials (Plate 4.3 e). During the rainy season the fine materials that formed the bar had been eroded by flash waters, leaving behind boulders. Some of the boulders may have been deposited by flash floods because of their high competence. At the same time of high flow no sedimentation of fine sediments occurs because the river's competence is high (Plate 4.3 f).
