**AN ASSESSMENT OF THE EFFECTS OF CANALIZATION ON THE WATER
QUALITY AND BIRDLIFE IN LAKE NAIVASHA**

A PROJECT REPORT SUBMITTED IN PARTIAL FULFILMENT OF THE REQUIREMENTS FOR THE AWARD OF
THE DEGREE OF MASTER OF ARTS IN ENVIRONMENTAL PLANNING AND MANAGEMENT (EPM) OF THE
DEPARTMENT OF GEOGRAPHY & ENVIRONMENTAL STUDIES, UNIVERSITY OF NAIROBI, KENYA

2016

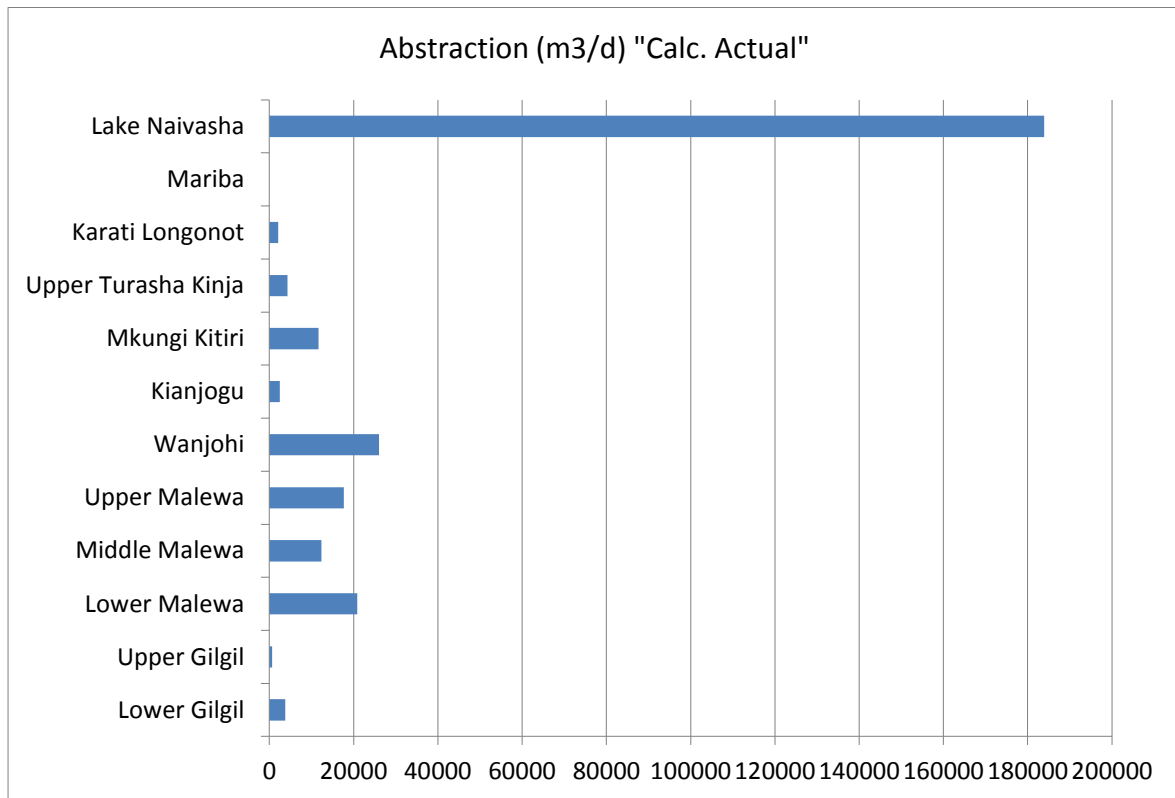
Figure 2-1: Water Abstraction from the Lake Naivasha Basin
(WRMA, 2011)

that water abstracted from the Lake Naivasha shoreline is twice as much as all other sources combined.

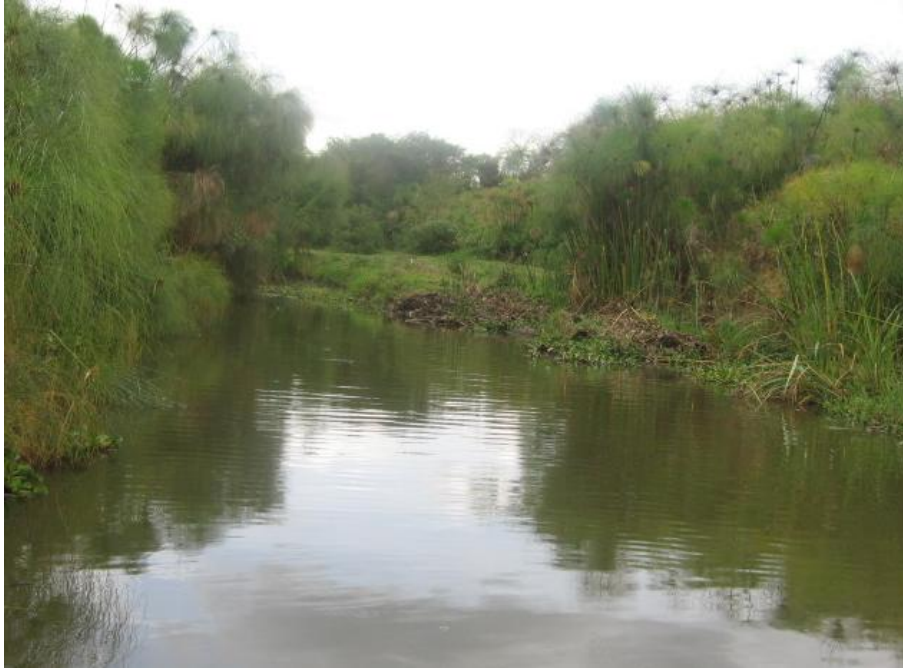
Plate 2-1: Typical canal point in Lake Naivasha

The core issues relating to water resource management within the basin are focused around catchment degradation, the rampant encroachment of riparian lands and non-compliance to natural resources management laws which have led to the recorded decline in water quantity and quality. Plate 2-1 is a photo of a typical shoreline canal, most of which were between 10-30 meters wide. The greenish water reveals high levels of eutrophication of the water. Back flow of water is more notable when the lake levels are lower. Canals inevitably increase the surface area for evaporation, contact with soil and seepage, which affects the water quality.

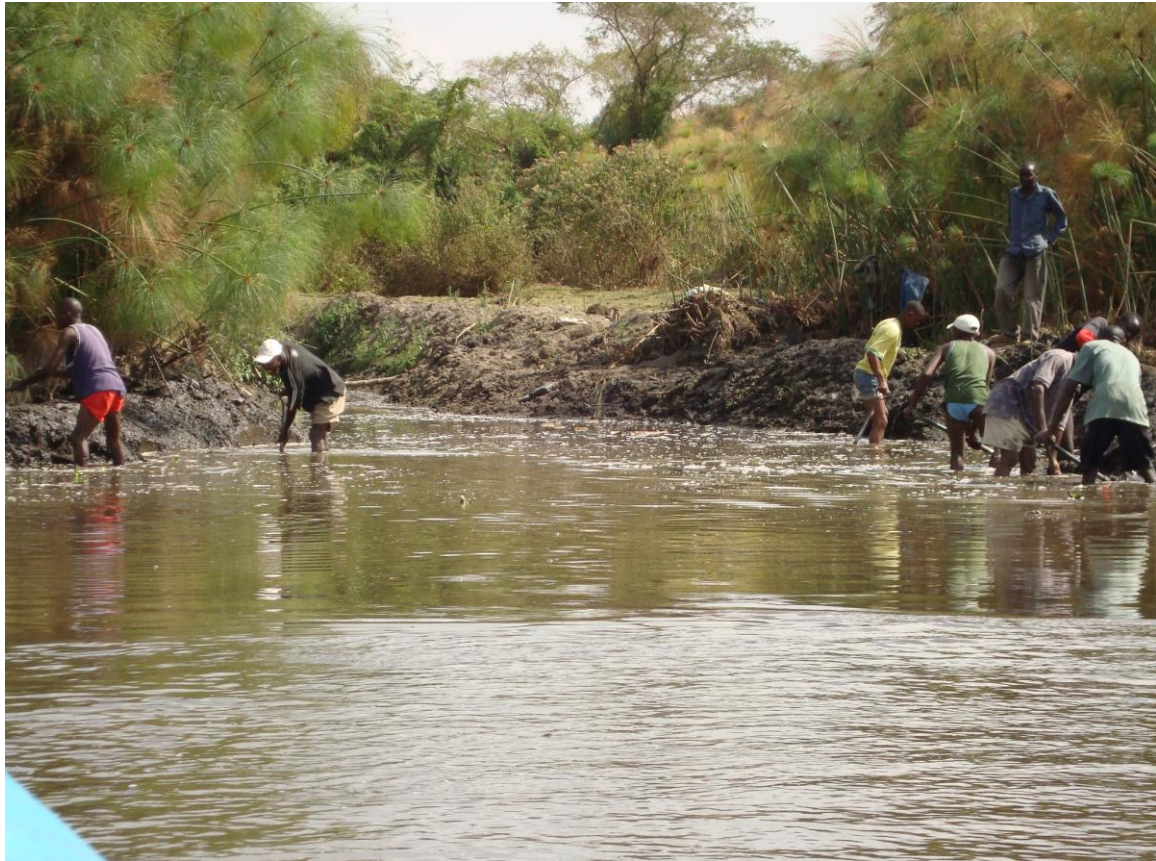
Plate 2-2: Canal dredging and repair works in the southern zone of Lake Naivasha
(Researcher 2009)

Plate 2-2 shows dredging works in progress to deepen a canal and enable water to flow by gravity. This disrupts bird life, especially in some cases where heavier machinery and dredging tractors were used.

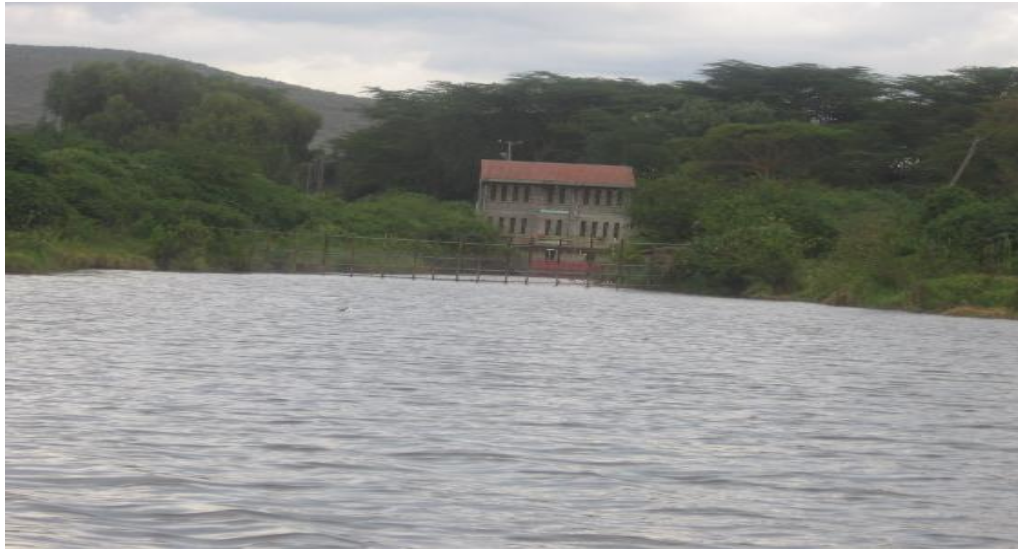
**Plate 2-3: Oserian Pump House Lake Naivasha
(Researcher 2009)**

Plate 2-3 is of a pump house on the lake shoreline, and 2-4 excavations aided by tractor, the noise and suction power interfere with serene ecosystem needed by birds.

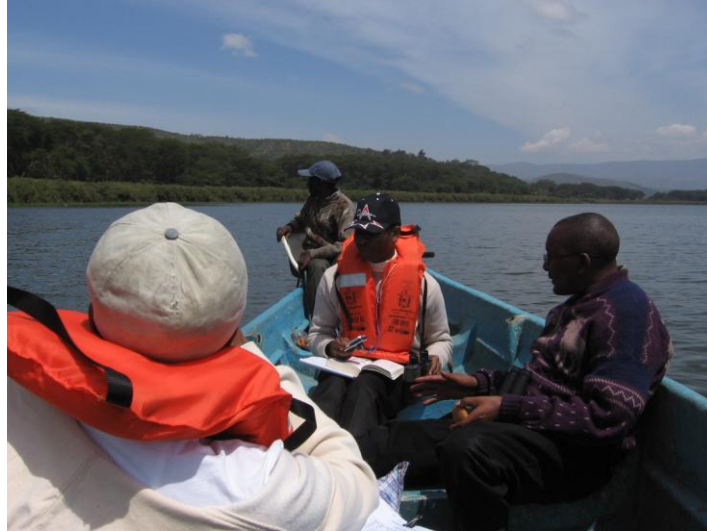
Plate 3-1 – Canalization survey
Researcher (2009)

The points chosen for collection of data were the canal points of Lake Naivasha. The entire perimeter area of the shoreline of the lake was targeted. All the points were accessed from the boat within the water and all visible canals were sampled. Identification of the canals and naming by was done with assistance of two resident Fisheries assistants who were very conversant with the lake as they were involved in routine patrols of the lake for about 20 years on the routine discharge of their duties. Marking of the canal points was done by a hand held Garmin 64 GPS (Global Positioning System) portable device. GPS units are used to determine the geographic coordinates of landscape features. The coordinates were recorded as Eastings and Northings to be later plotted on a satellite map of the area in order to ascertain the actual positions on a map. At every canal, the width of the canal was recorded and the water quality and bird counts taken. The use of binoculars was most useful in noting the birds present within the shoreline while still a long way off thus avoiding disturbing the counting process (Plate 3-1).

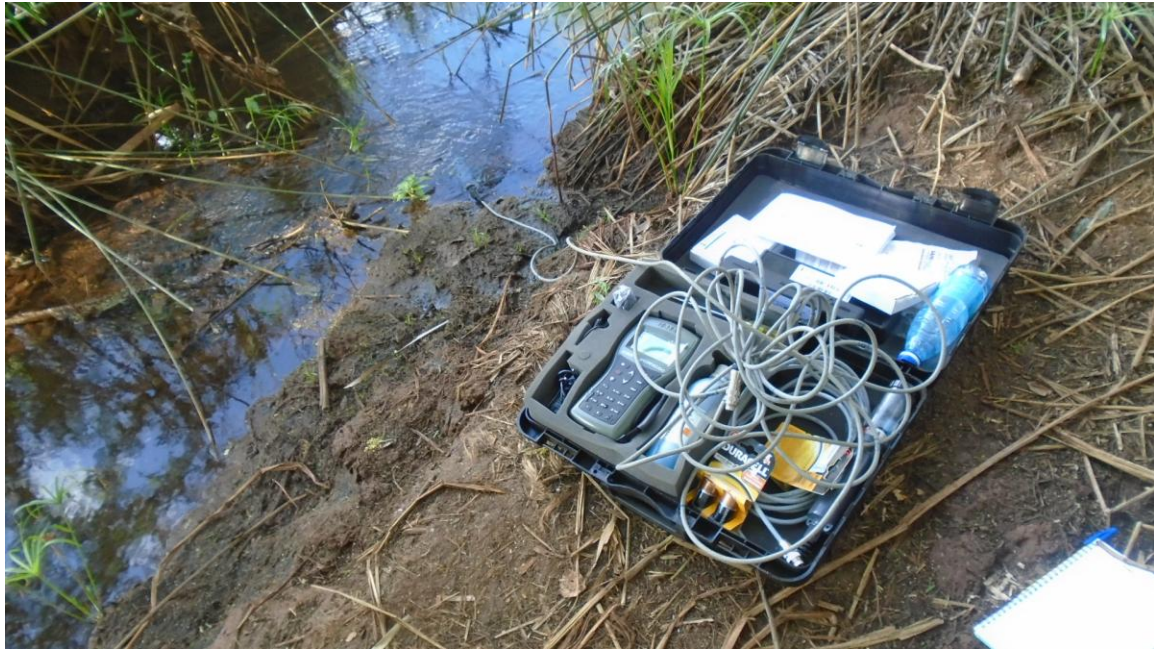
Plate 3-2: On site water quality measurement
Researcher (2009)

The parameters were measured on site using a portable multi-parameter water analyzer model Hanna HI 9828 (Plate 3-2).

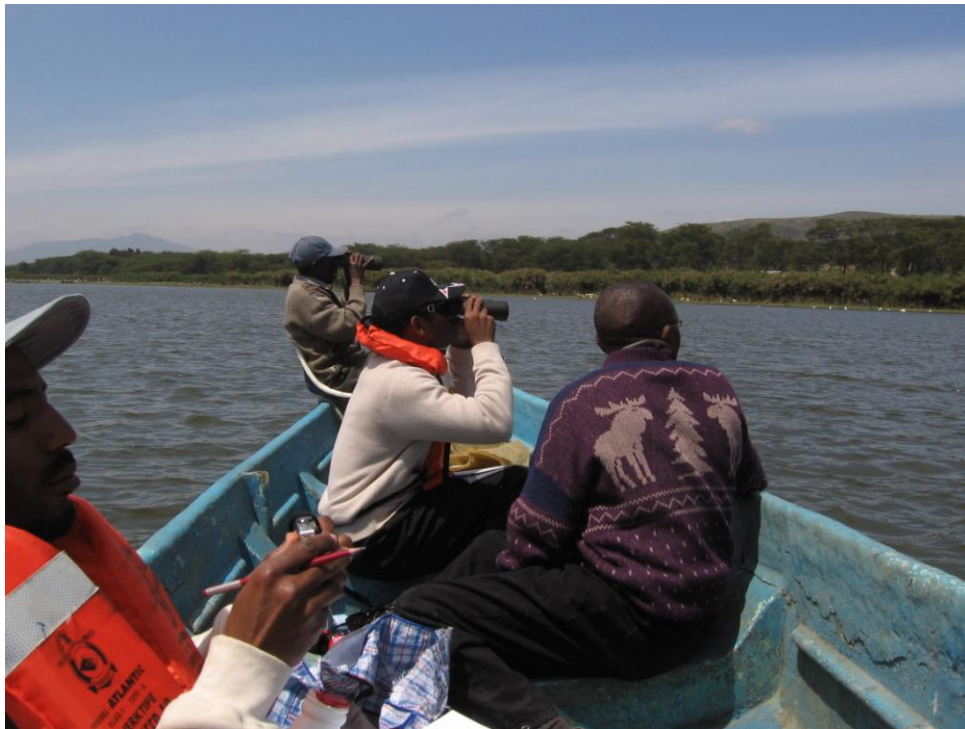
Plate 3-3: Birdlife assessment

During the surveys, bird counts and quantification of bird species was done by physically counting the birds available on the shoreline within the canal area, while still a long way by use of binoculars. The engine of the boat was switched off to avoid disruptions and bird numbers counted by three persons on board. The numbers of bird species were also identified and counted. Both swimming and foraging birds on the shoreline were counted. However, birds overflying the area were not included, unless they landed and remained within the area in focus.

A physical count of the bird species around the canal and the actual number of birds sited, whether swimming or foraging within the canal area was noted and reconfirmed (Plate 3-3). The number of birds and species was recorded and averaged in cases where the three persons noted disparities. Identification of the various species was done by identifying the common name and later adding the scientific name.

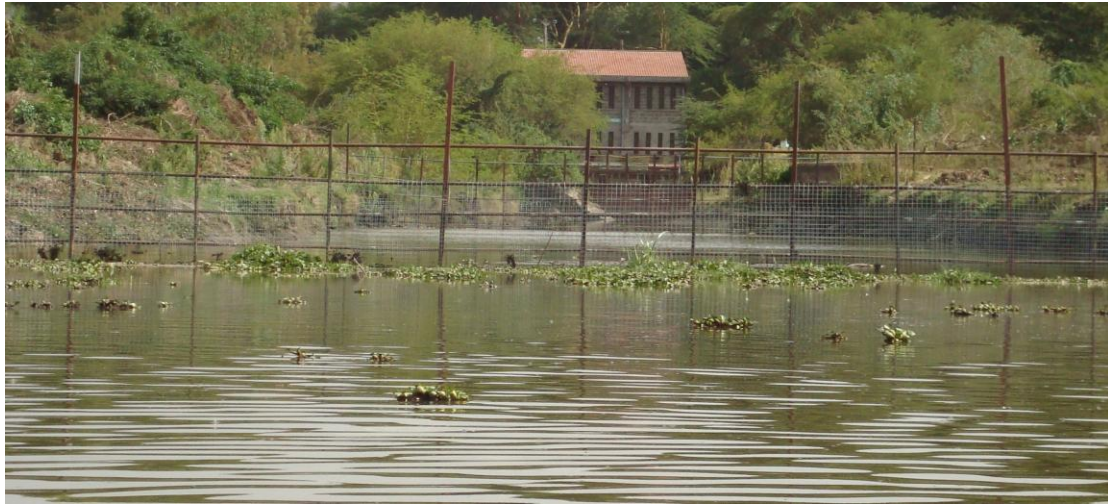
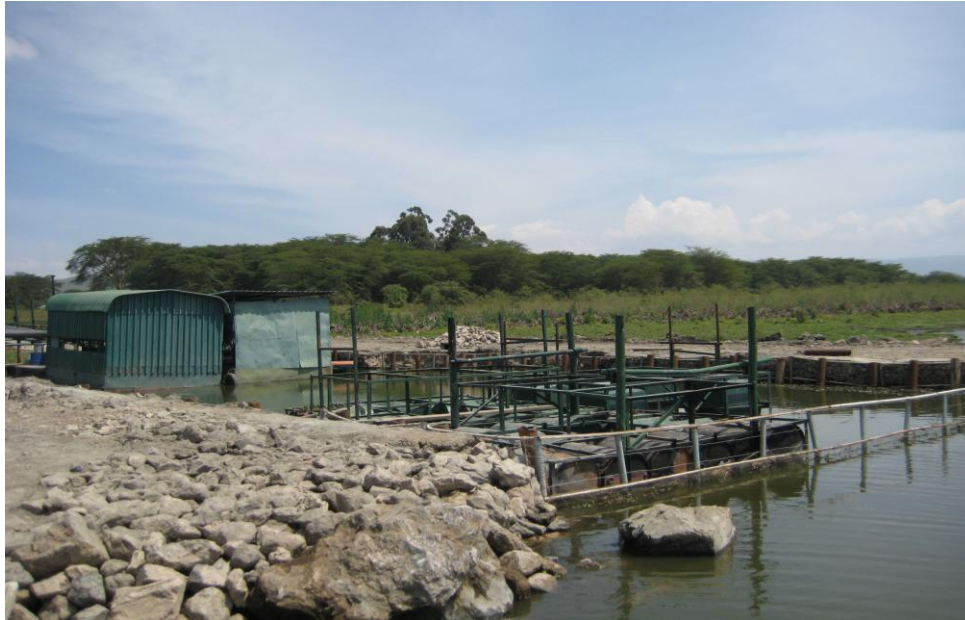
During the field sampling exercise, all the widths of the canals were taken. In terms of individual widths the widest canals found within the zones were as follows: The eastern zone had three 20 meters canals which were the widest on that zone; on the northern zone the widest canal was 10 meters, whereas, the southern zone had two canals of 30 meters each. The water levels were fairly low by late 2009 and the water within the canal areas had a deep green appearance as can be seen on the foreground of Plate 4-1 and 4-2.

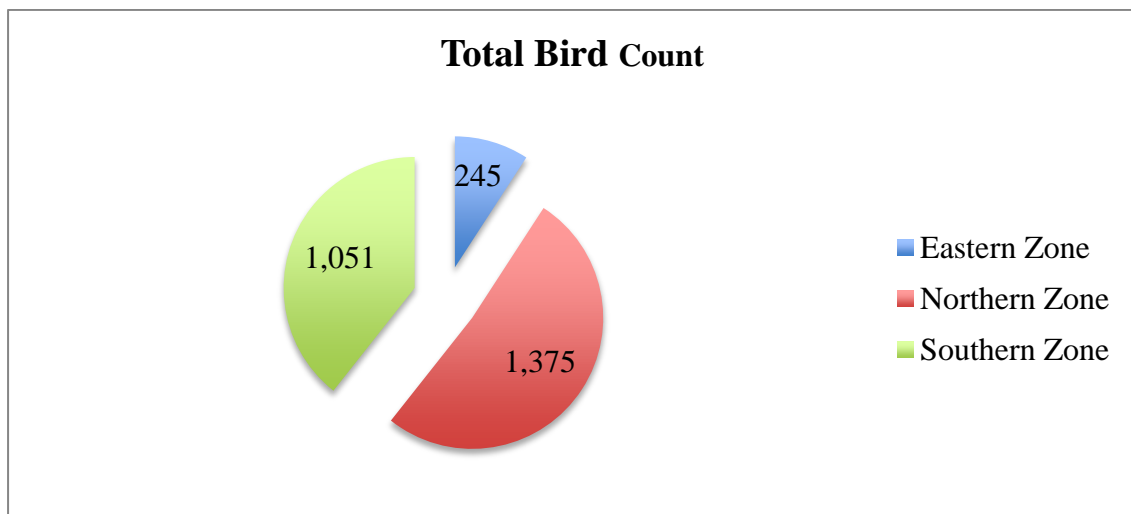
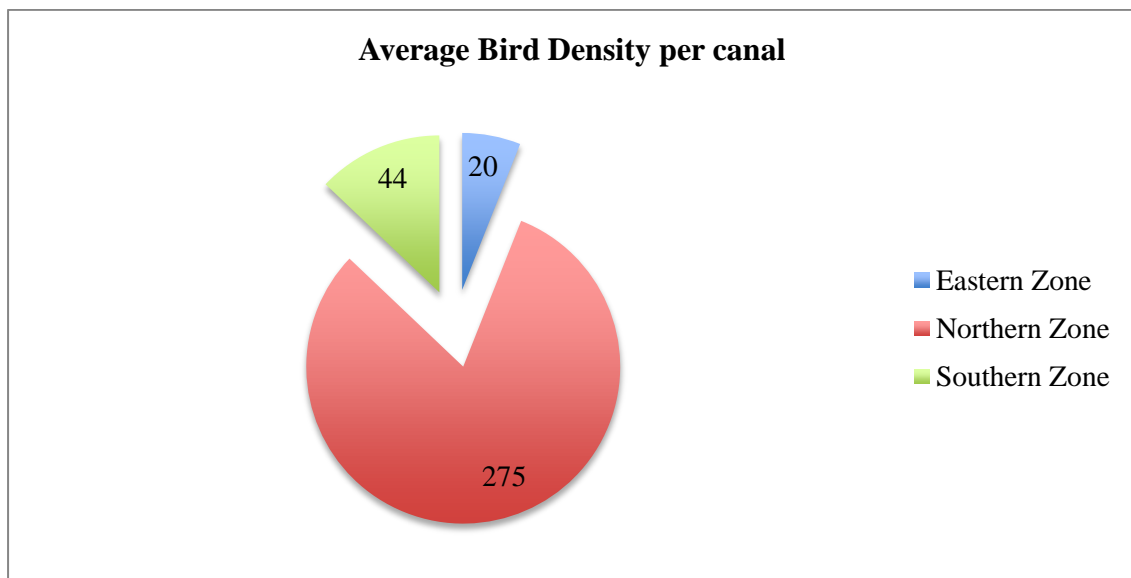
The Northern Zone elicited the highest bird count. Chart 4-4 shows the actual number of birds counted for every canal zone. Chart 4-5 and chart 4-6 further gives the total number of birds for each of the zones and the average number of birds per canal in the zones. The Eastern zone had the least number of birds counted at the canals and also the lowest number of birds per canal. The bird numbers are inversely related to the canalization density.
