**The Effect of Road Design and Land Use on Gully Erosion: A  
Case Study of the Rural Access Roads in Embu District, Kenya**

A thesis submitted in partial fulfillment of MASTERS OF SCIENCE IN  
AGRICULTURAL RESOURCE MANAGEMENT Department of Plant  
Science and Crop Protection Faculty of Agriculture and Veterinary Sciences,  
University of Nairobi

August, 2010

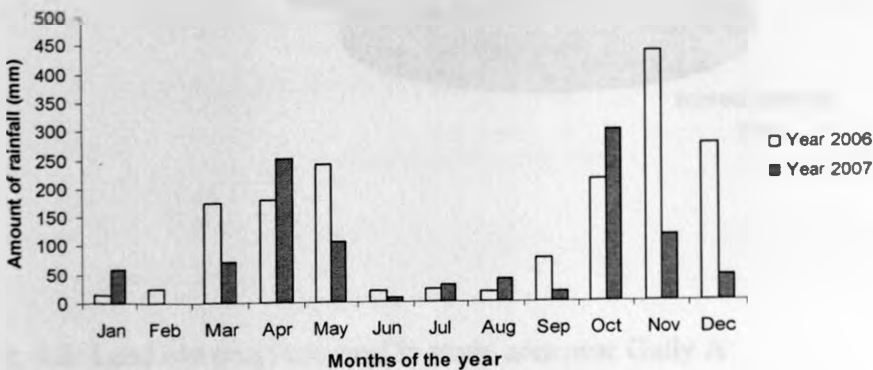
**Rainfall analysis:** The rainfall was highest during the short rains with the month of November 2006 recording the highest rainfall of 438 mm (Fig. 4.1). The highest rainfall (105 mm) for the long rains was recorded in May 2006 (Meteorological Department, 2006). In both cases the road runoff culminated into extensive gully erosion.

In 2007, the highest rainfall (300.3 mm) was recorded October during the short rains while the highest amount (250.5 mm) was recorded during long rains in April 2007 (Fig. 4.1). On the average the year 2006 had more rainfall than 2007 (Meteorological Department, 2007).

Fig.4.1: Annual rainfall for Gully A in the year 2006 and 2007

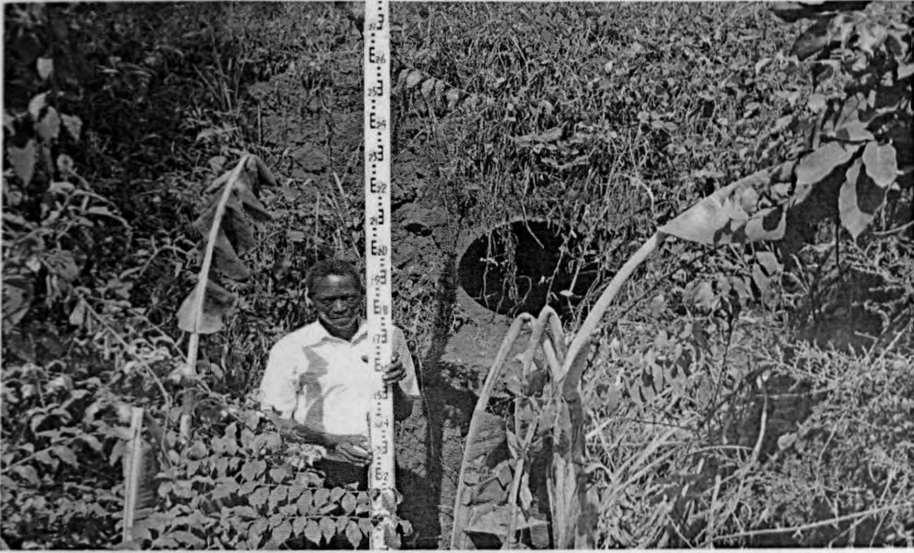
**Causes of gully erosion in Gully A:** Eighty percent of the farmers were of the agreement that concentrated road drainage into the farm coupled with poorly protected natural waterway caused the initiation of gullying. From the interviews, 60 % of the farmers said that most gullies started immediately the culverts were placed. In this case the water was directed through a culvert into the cropped land (Plate 4.1). In a study by Nyssen *et al.*, (2002), it was found that a gully is caused by a rapid expansion of the surface drainage system in an unstable landscape. Some farmers (10 %) attributed the causes of gully formation to dwindling land sizes. Thirty percent attributed it to population pressure causing the land to be subdivided into uneconomical sizes. This was in agreement with the findings of Kaboro, (2002) that stated that land sizes were becoming smaller and smaller due to population pressure. This has led to cultivation of land above 55% slope. Farmers also cultivate along the road reserves and some encroach into the road.

Plate 4.1: Culvert draining road runoff into Gully A

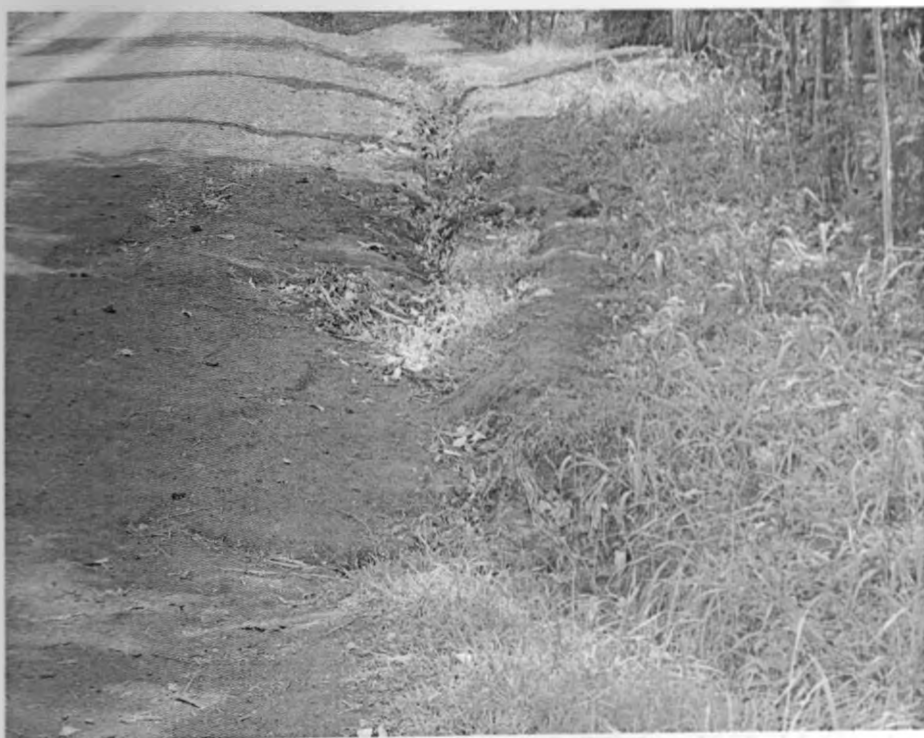
Plate 4.2: A badly maintained side and mitre drain that was draining into gully A

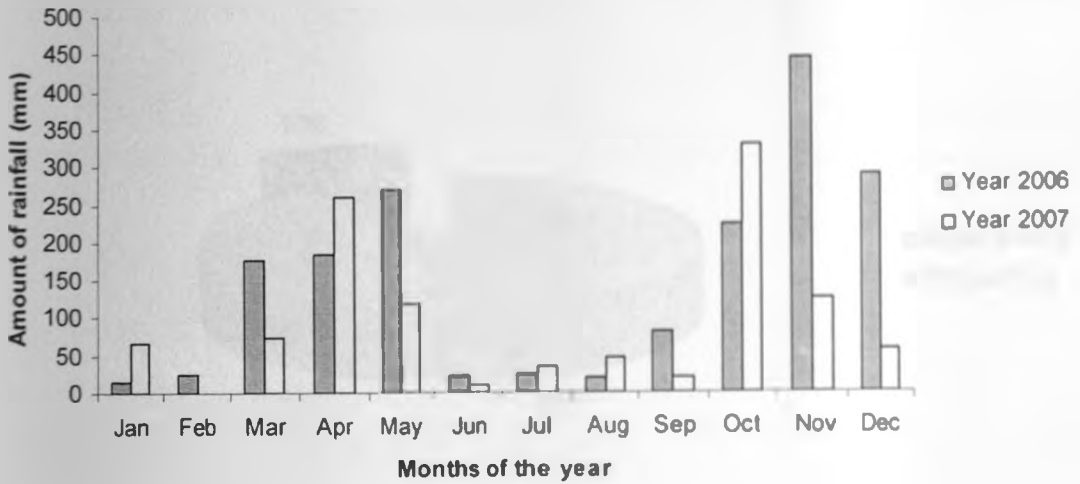
**Rainfall analysis:** The rainfall was recorded for the general area in four seasons which translated to two years (Fig. 4.6). As expected, the rainfall was highest during the short rains period. The month of November 2006 recorded the highest rainfall of 446 mm. During the long rains period, highest rainfall recorded was 269.8 mm in the month of May 2006 (Meteorological Department, 2006). High runoff rate experienced at that time.

Fig. 4.6: Annual rainfall amount for Gully B in the year 2006 and 2007

In 2007 the highest rainfall amount of 329.3 mm was recorded in the month of October for the short rain period (Fig. 4.6). The long rains had the highest in April at 260.5 mm. On the average the year 2006 had more rainfall than 2007 (Meteorological Department, 2007).

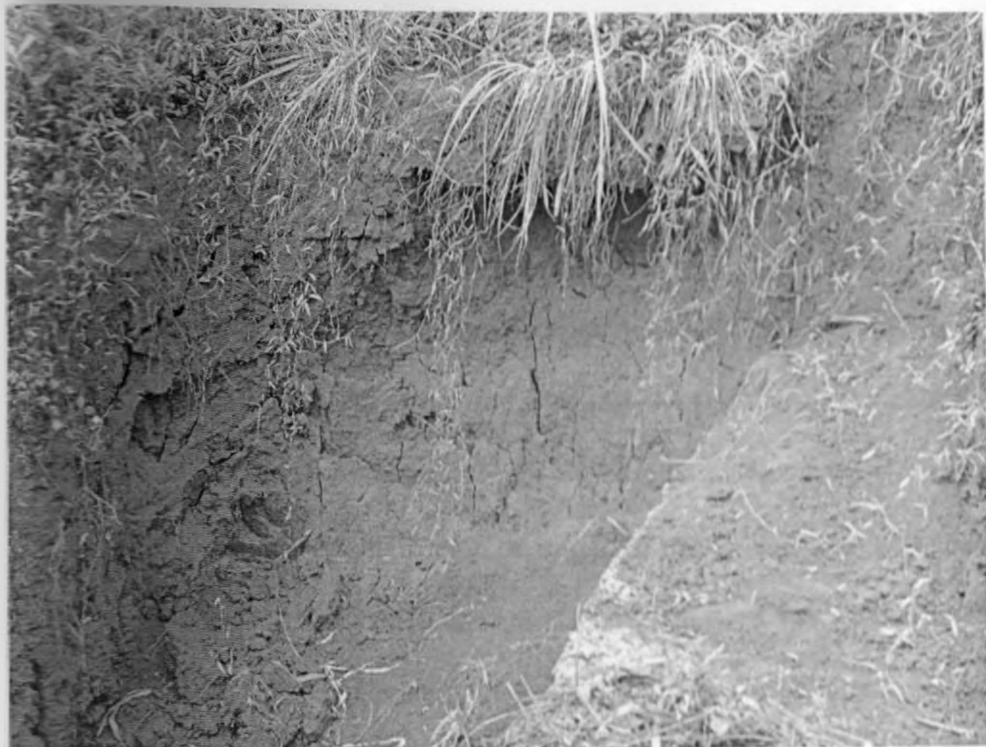
**Gully headscarp, floor and sidewall characteristics:-**The depth of the headscarp was 2.1 m and the width was 3.2 m. The average slope was 30%. The headscarp was extending as erosion continued. This implied an active gully. Most of the gully floor had little or no vegetation. The only vegetation was the one overhanging from the sides which was mainly the blacken fern. Due to the great force of runoff during the rains, most of the fertile top soil was probably washed away and so was the vegetation. It was a harsh condition in which to establish vegetation (Thomas, 1997). The gully had also hanging sidewalls with negative side slopes which indicated that collapse could occur on wetting or on slight disturbance (Plate 4.3). This implied that the gully had not attained a stable slope and shape in most of its length which were in agreement with the findings of Sidochuk, (2006).

Plate 4.3: An overhanging sidewall of gully B

The major processes of erosion were bed scouring, undercutting (Plate 4.3) and sidewall collapse (slumping). The minor processes identified included rilling on gully sides, splash erosion on gentle sidewalls and gully floor, wash erosion and caving due to undercutting. Similar erosion processes had been identified at Olkaria in a study done by Gitonga, (1993).

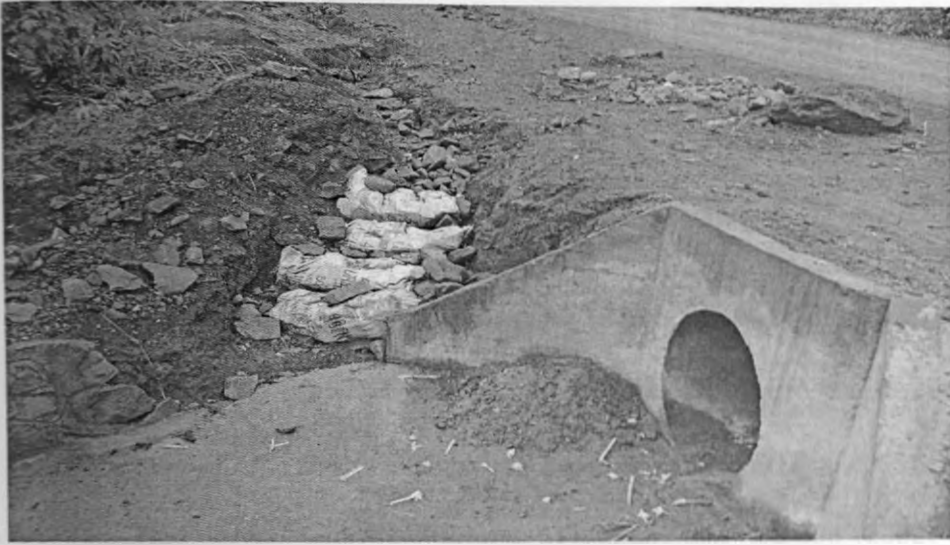
The width was less than 0.5 m in most cases. The slope of the drains was well within the recommended gradient. It ranged from 1 - 4%. The minimum recommended width of the mitre drains is 0.60 m and they should have a gradient of 2 - 5%. Where a side drain has very steep gradient, additional measures in the form of checks or gabions may be necessary. These checks will silt and form steps, thus decreasing the gradient and slowing the flow. Gradients should be carefully checked to ensure that they drain within these limits (Ministry of Public Works, 1992). The runoff from the road surface is supposed to be collected into side drains which discharge through mitre drains to grassland or through culverts to a stable waterway (Thomas *et al.*, 2003). The mitre drains in this case were discharging into the cropped land.

Plate 4.4: Badly maintained side drain along Mutunduri road next to Gully B discharging into cropped land.

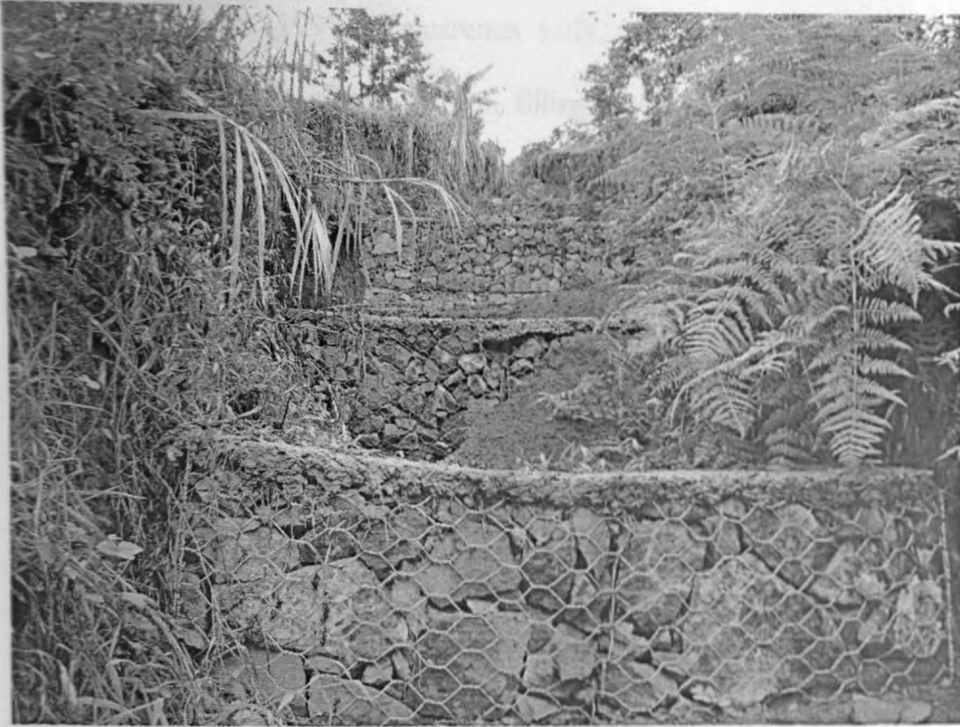
In this study it was impossible to divert the runoff as this was the lowest point on the slope of the road. Options for controlling gully head erosion include diversion of runoff (Kennedy *et al.*, 2001). Unfortunately, such outlets are difficult to find and often the instability may be transferred from one area to another (Natural Resources and Water, 2006). In Ethiopia, gully control has been carried out mainly using stone check dams, with U-shaped and parabolic spillways. These check dams have been quite effective in smaller and average size gullies, but bigger ones needed more sophisticated control structures (Wolde-Aregay, 1996). Controlling gully erosion can be difficult and costly (Mati, 2005). It may be justified on better quality soils where there is a reasonable chance of success or where the road or building is threatened by an advancing gully (Hudson, 1995). In this study, a farm and a road were threatened. After the control the long profile changed as shown in Fig 4.9.

Plate 4.5: Gabions put in Gully B to control erosion

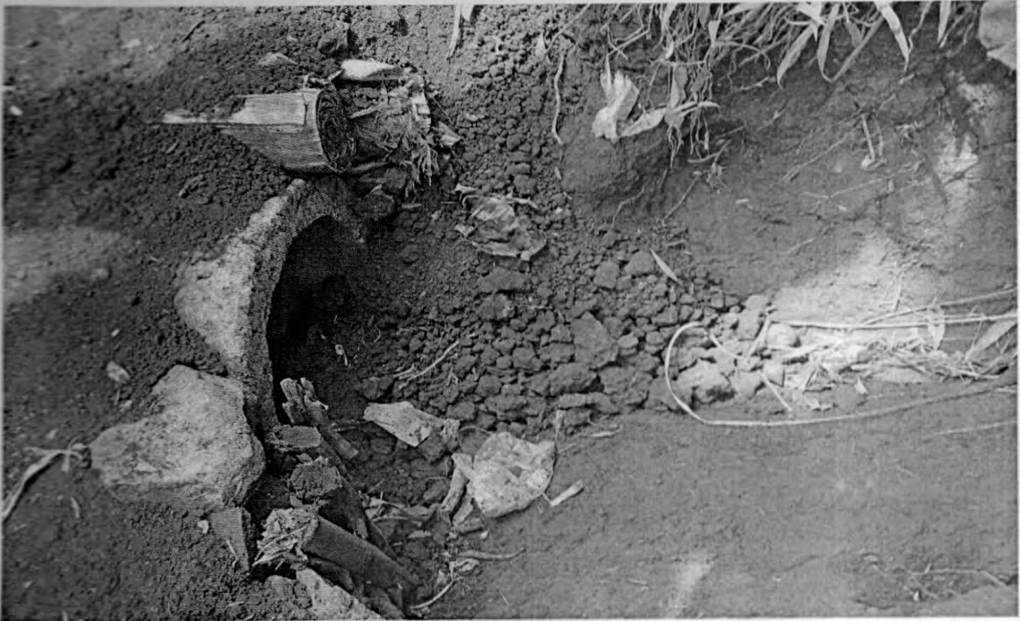
**Plate A1: Blocked culvert near Gully A**

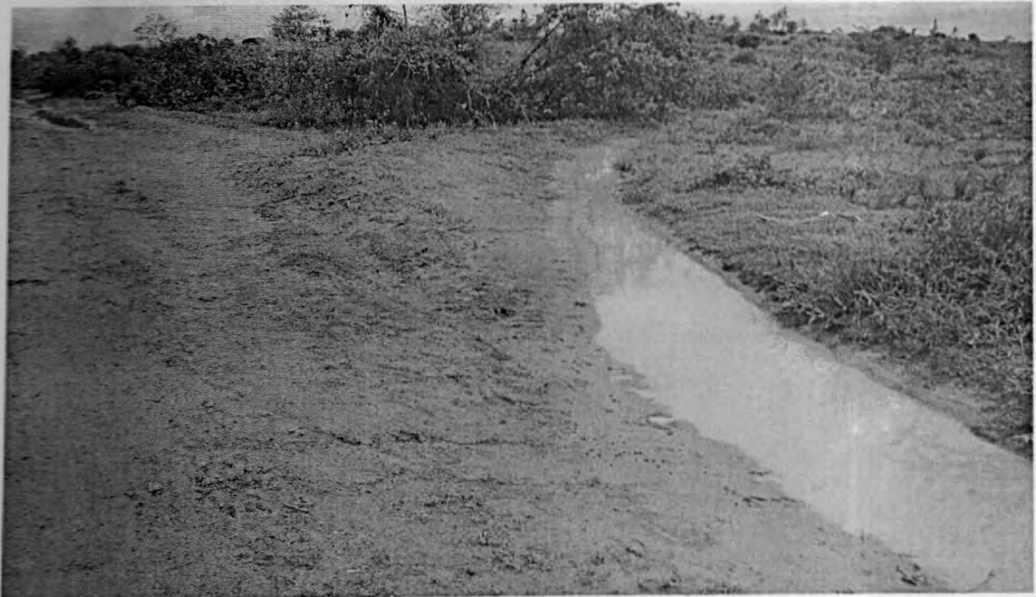
**Plate A2: Water directed into the farms through mitre drains**

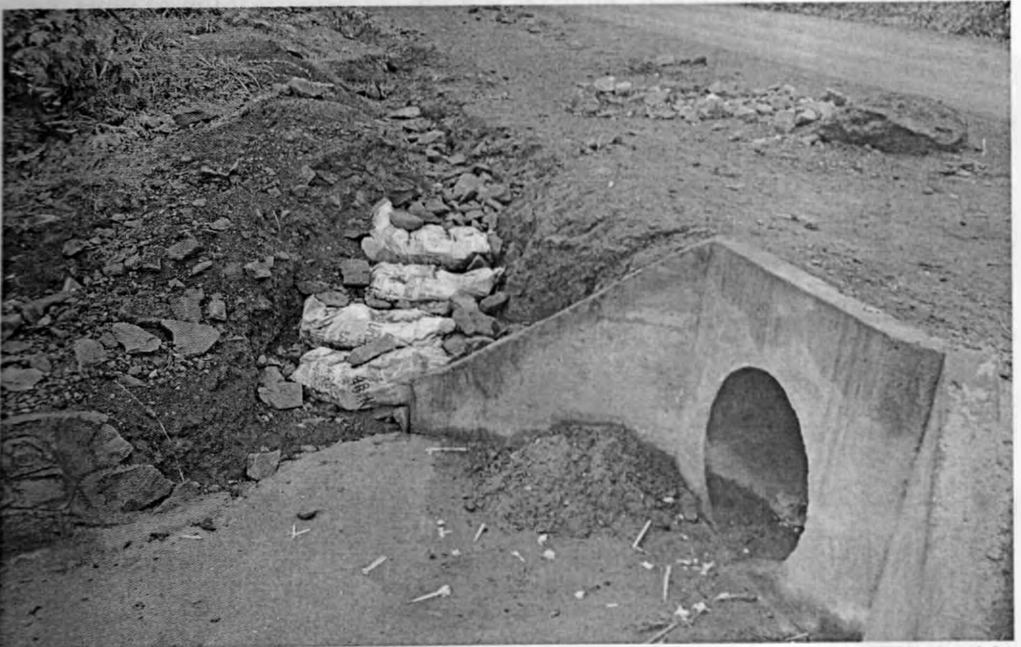
Plate A4: Controlling soil from entering the culvert using stones and bags filled with soil.

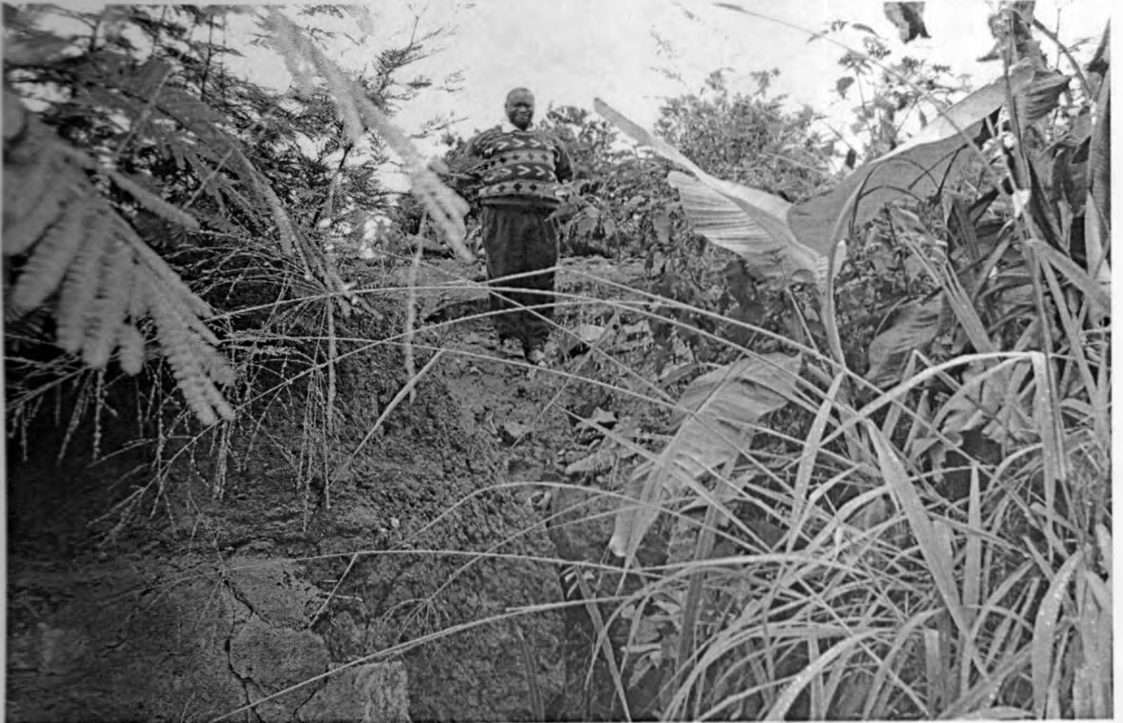
Plate A5: Head of gully showing the gully B extending headward

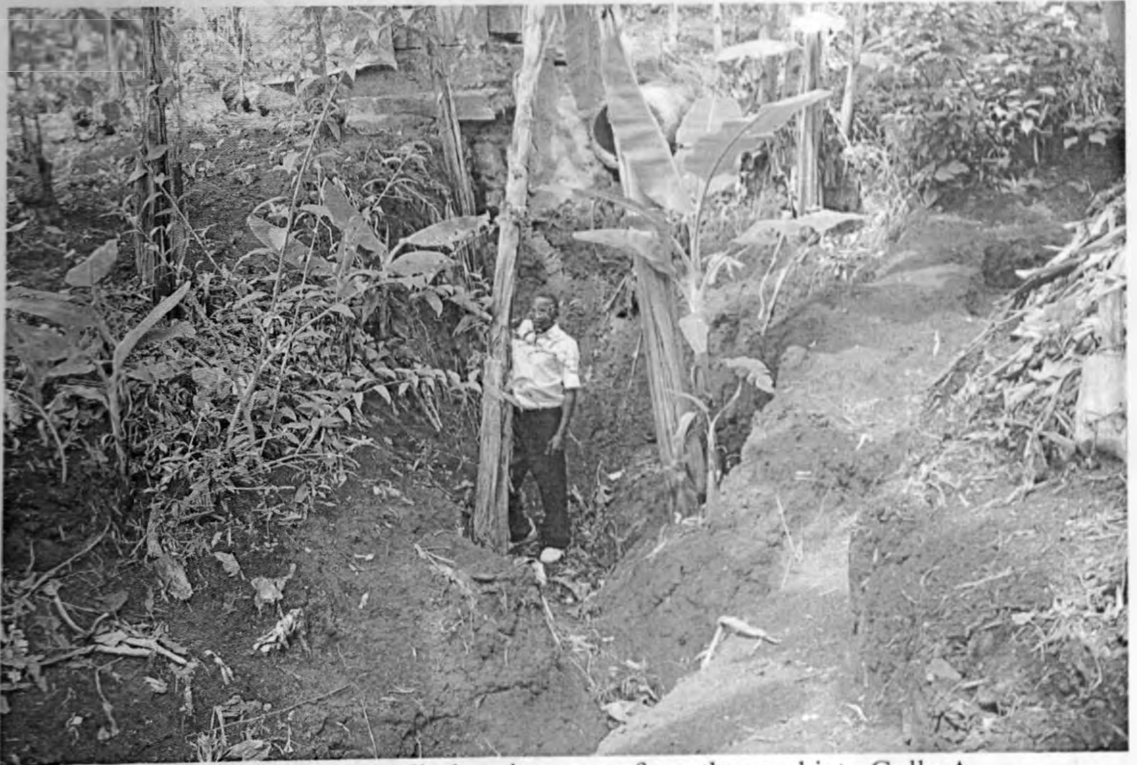
Plate A6: Culvert discharging water from the road into Gully A
