**GULLY DEVELOPMENT AND CONTROL ON
A VOLCANIC ASH SOIL AT OLKARIA,
KENYA**

**A thesis submitted in partial fulfilment of
MASTER OF SCIENCE in LAND AND WATER MANAGEMENT
Department of Agricultural Engineering
Faculty of Agriculture
College of Agriculture and Veterinary Sciences
University of Nairobi**

September, 1993.

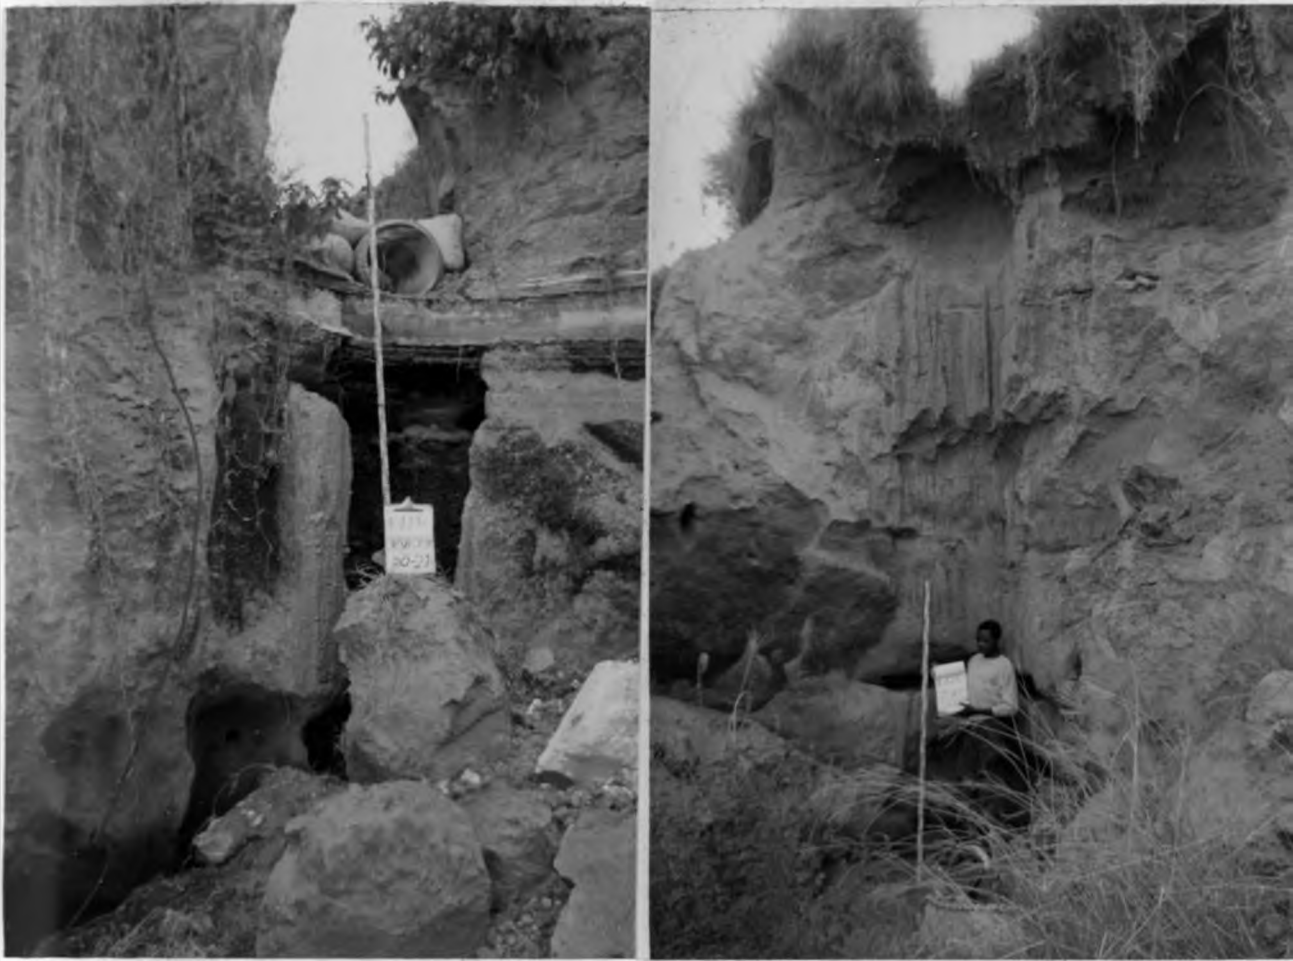
(1) Lower

(2) Upper

However this runoff event did not have significant change on the upper headscarp (plate 2) which retreated appreciably later after 4 days of inflow emanating from the overflowing water tanks in the catchment. The upper headscarp retreated 3 m upstream mainly by headwall collapse after it was soaked with water. Immediately below the headscarp a lot of sidewall collapse occurred, an observation similarly got by Daniels and Jordan (1966) on a loess soil.

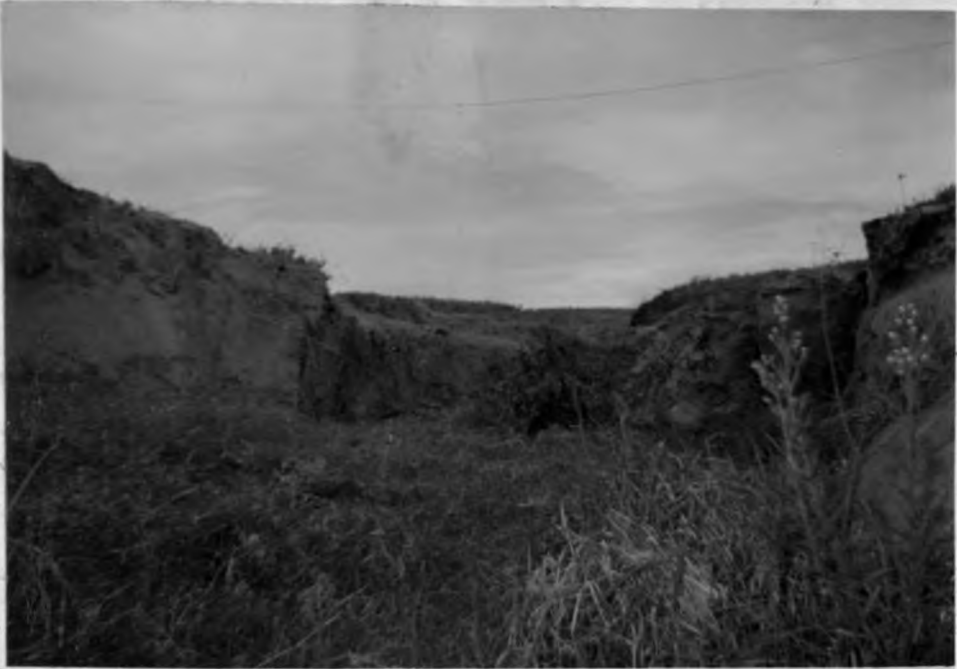
Plate 3. A section immediately upstream of the lower headscarp of gully A that was heavily vegetated by star grass.

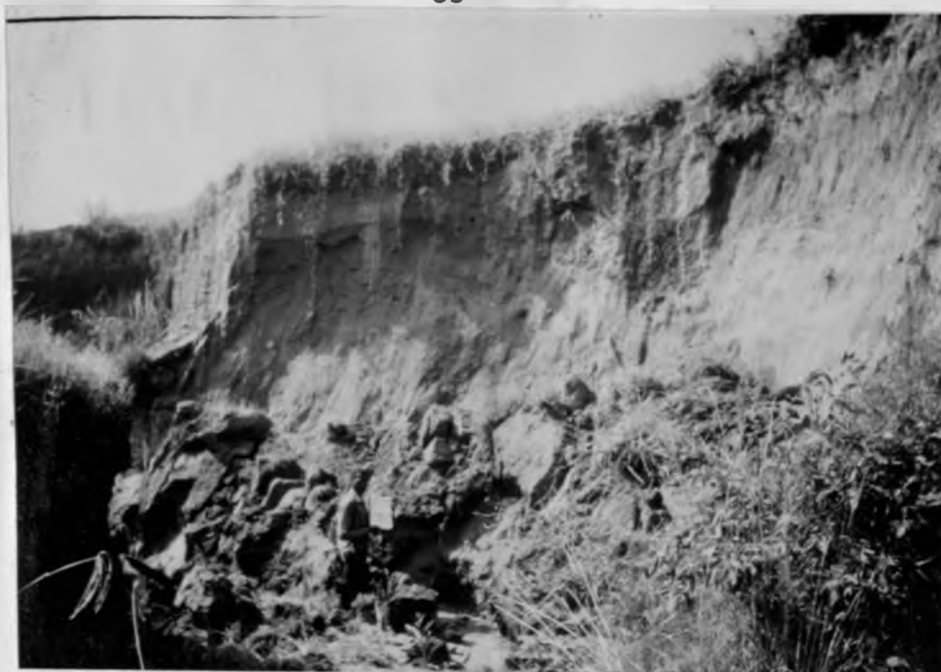
Plate 4. A major sidewall collapse at a deep section (19-20) of gully A.

Undercutting was evident in the steeper and meandering gully sections where the impact of runoff on the toe of the gully wall was substantial. It was observed that these sections were also prone to slumping. At the deeper sections of the gully, slumping occurred due to gravity even after slight wetting (either by overland flow or directly by rainfall) of the vertical gully sidewalls (see plate 4). On the contrary Roloff et al (1980) observed that gully wall stability seemed unrelated to overland flow in a deep loess.

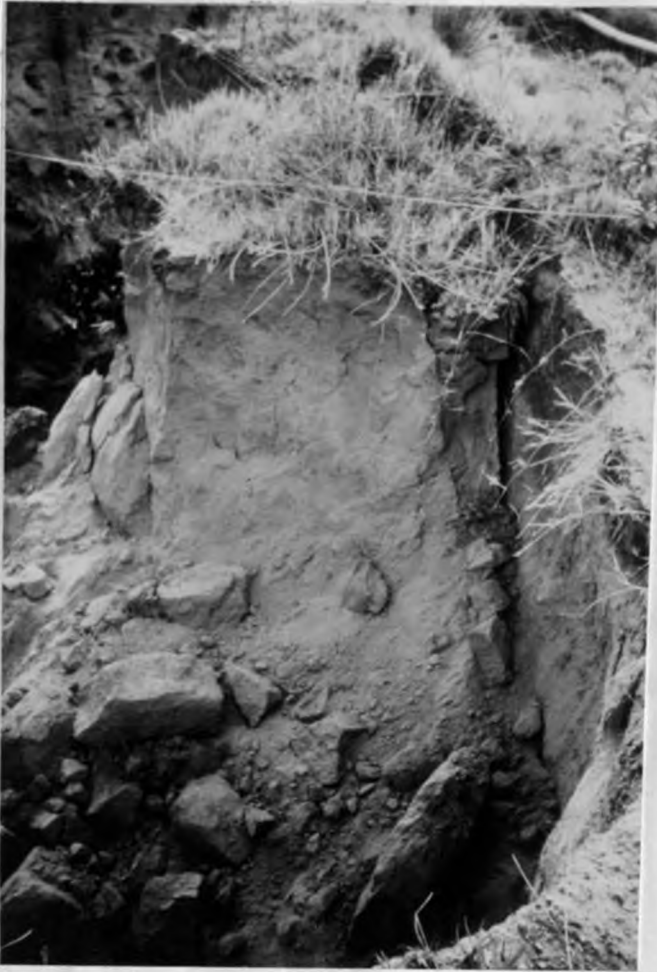
Plate 5. Block of soil cracked from the gully wall in section 15-16 of gully A.

In some cases slumping was preceded by both undercutting and wetting or undercutting alone. Even without wetting or undercutting overhanging, dry loose material could slough into the gully due to their non-cohesive nature. Failure of this kind occurs where shear stress becomes equal to the shear strength of the soil at a particular point (Bolton, 1984). Large blocks of soil, cracked from the main soil body, could be seen which later collapsed into the gully upon wetting and through gravity under their own weight (see plate 5).

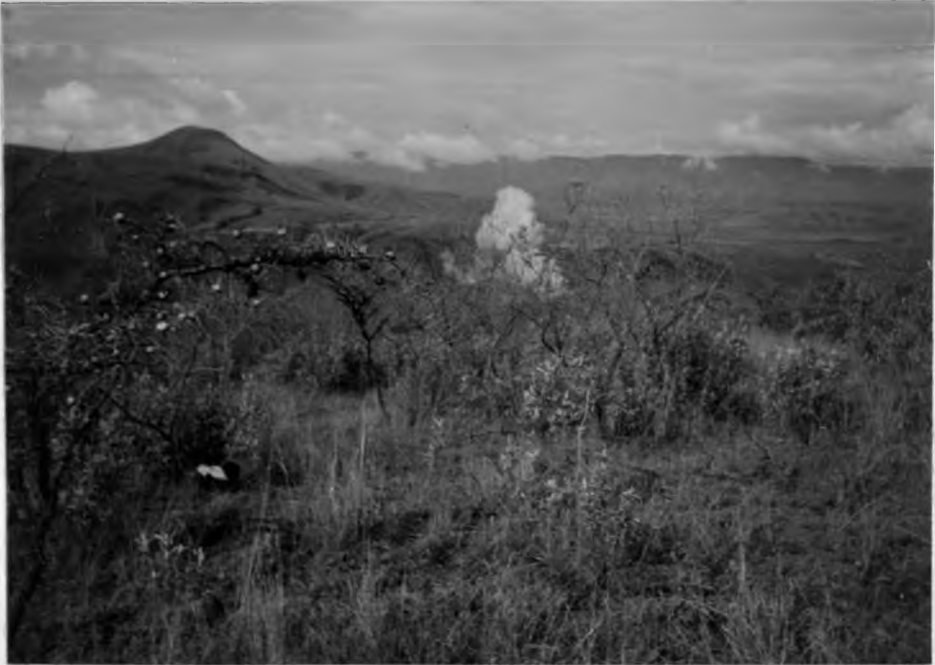
Plate 6. Part of gully A catchment showing vegetation cover.

stones and rock outcrops which had presumably insignificant effect on infiltration and therefore runoff. Small bare parts of the catchment had soil crusts on the surface. Otherwise most of the catchment had a good vegetation cover of wooded grassland with leleshwa having a burnt canopy which was recovering after the fire in 1991. The good vegetation cover encouraged infiltration of rainfall and therefore the catchment yielded little runoff especially in the beginning of the rainy season when the rainfall intensities were low.

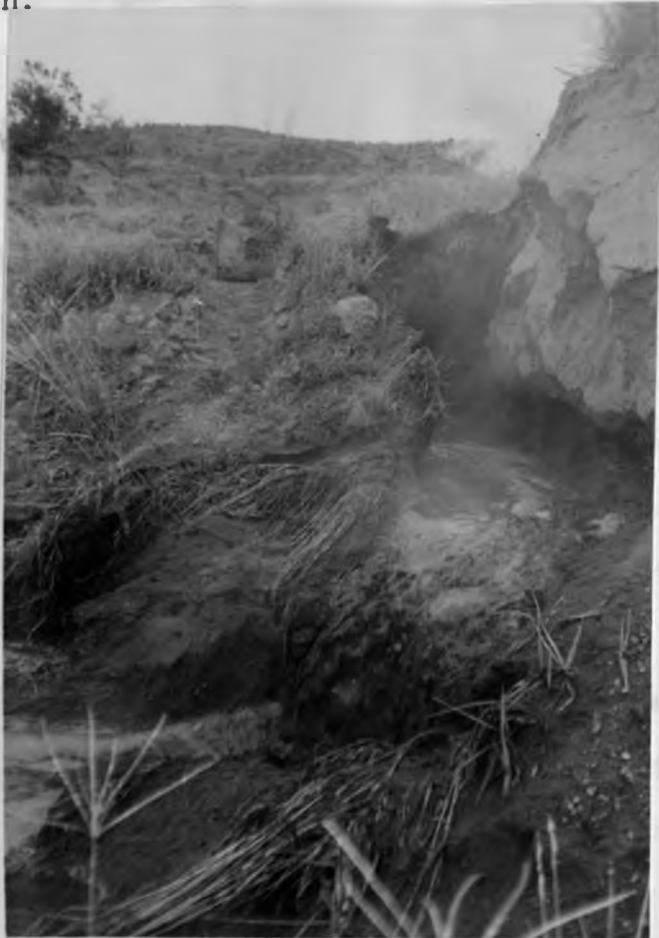
Plate 7. Hot water discharged into gully A from a collapsed sump pond of well 707.

The correlation of rainfall characteristics with gully erosion in this gully therefore becomes difficult due to the effects of the other sources of runoff which, when they produced inflow into the gully, they left it in a raw/soaked and unstable condition.

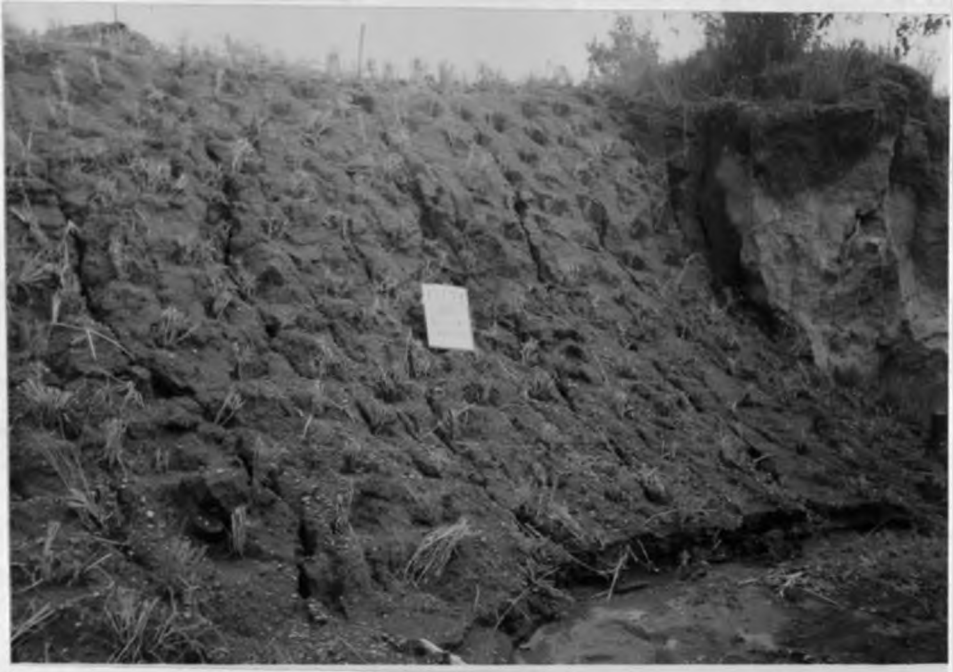
Plate 8. Part of the reshaped gully A wall showing rilling and soil washing at its toe region.

Other grass performance trials carried out near the gully (which was grassed to reduce inflow into the gully and therefore minimize rilling) showed that star grass had the highest survival rate of about 99 %. Also tried were oil grass (98 %), woolly finger grass (90 %) and Rhodes grass (36 %) (table 10). However Rhodes grass had the best spreading characteristics such that its ground cover was more or less the same as that of star grass at the end of the first rainy season.

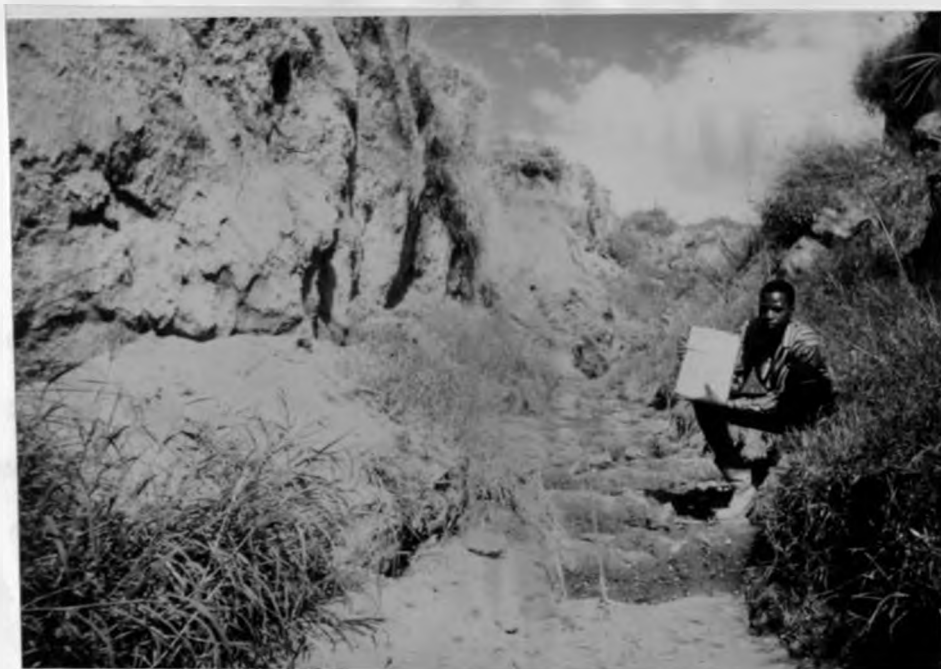
Plate 9. Scoured bed of the grassed parabolic waterway of gully A after the first rainy season.

and replanting was done in mid-December 1992. Rainfall during the month of November 1992 was very little (total monthly rainfall was 39 mm) with most of the days being dry. During the month of December 1992 it became wetter whereby the total rainfall was 92 mm providing a better soil moisture condition for grass establishment. However the grass did not establish well before the January and February 1993 rains which scoured the parabolic waterway (plate 9).

Runoff concentrated at the middle of the channel enhancing bed scour due to increased shear forces. Shortly before the scour, performance of grass splits of star and Rhodes grasses were monitored for survival rate and the results are given on

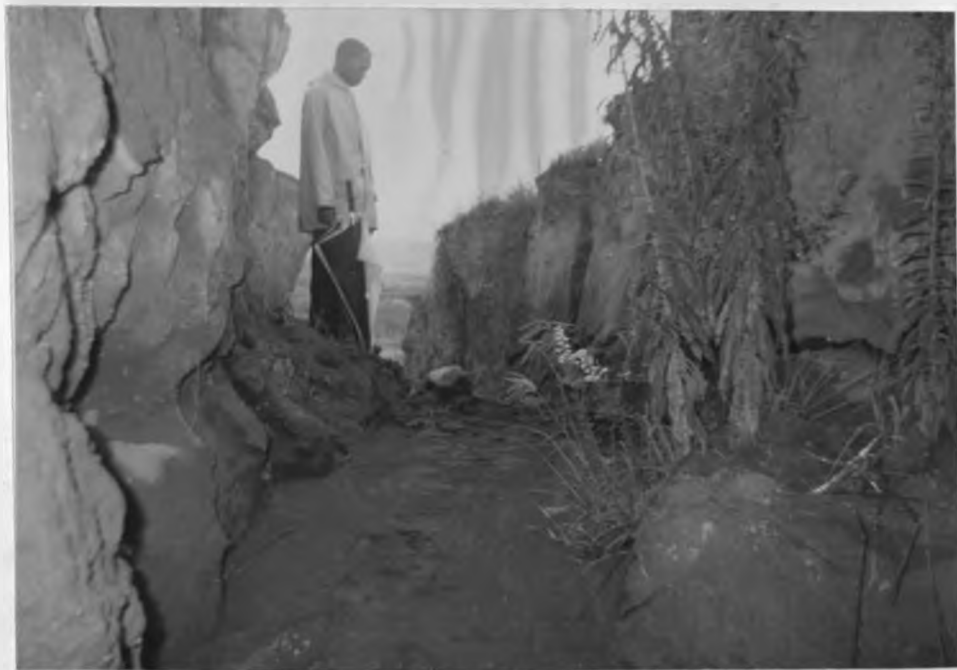
Plate 10. Deposition upstream of loose stone check dam no. 2 at the end of the first rainy season.

check dams got breached when they lost some of their stones to the runoff. Loose stone check dam no. 4 (the most upstream of the loose stone check dams) did not prevent bed scouring since water went round and undercut the gully at its southern shoulder causing gully wall collapse and most of the earlier deposition was washed downstream. The poorer performance of this check dam than the others might be attributed to its position upstream of the other loose stone check dams whereby it received most of the runoff impact and probably, due to reduced velocity of the water, the others received less impact and therefore were less vulnerable to breaching and undercutting at their shoulders and keys.

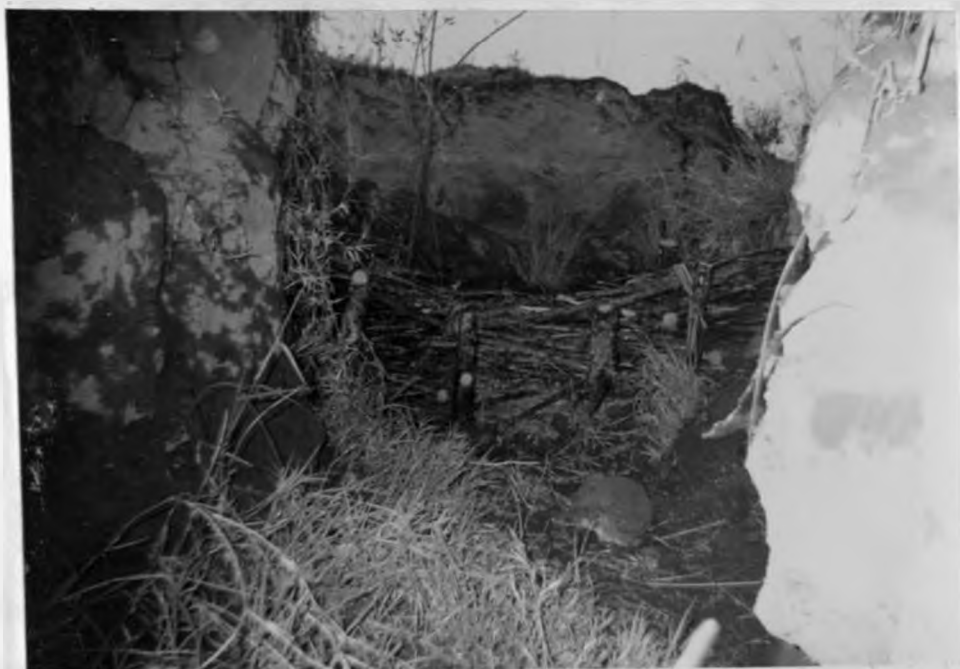
Plate 11. Brushwood check dam no. 1 shortly after the first runoff event during the study.

A brushwood check dam (plate 11) can resist larger flows than loose stone check dam if built of strong posts of about 10 cm diameter and inserted about 30 cm into the gully floor. Even with the most intensive rainstorm brushwood check dams neither collapsed nor had their parts moved by water except for water going round their sides.

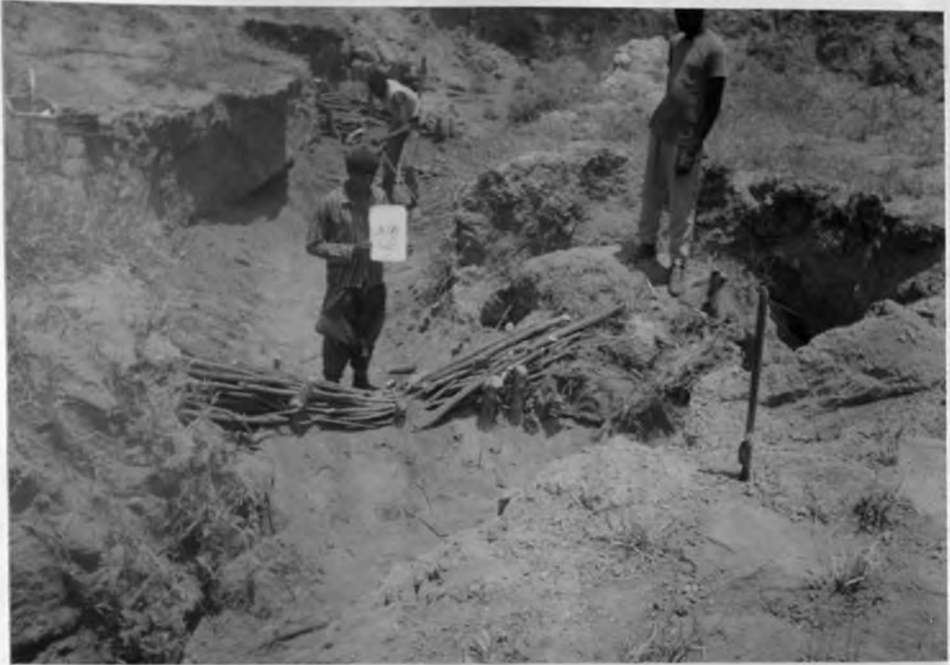
Plate 12. Brushwood check dam no. 2 after the first rainy season. Notice key failure on the right.

However brushwood check dam no. 2 had its northern side shoulder undercut and the gully wall collapsed at its key region causing water to go round it (see plate 12). On repair runoff later found its way through the disturbed key region on the southern shoulder of the check dam.

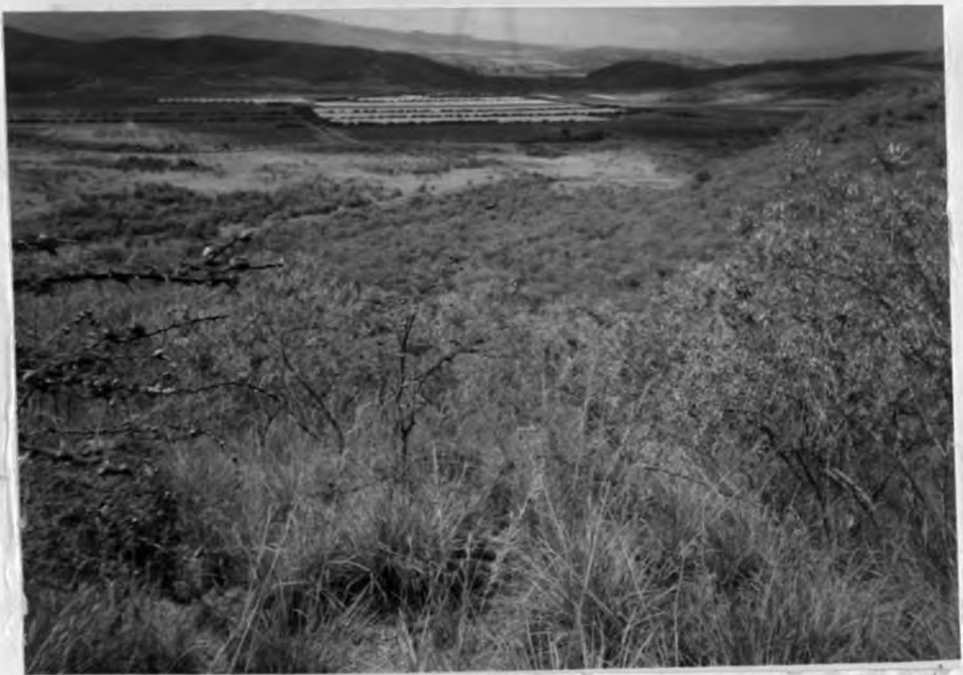
Plate 13. Part of gully B catchment showing vegetation cover and horticultural development in the background.

The total area of the catchment was estimated at 12.6 ha with approximately 3.1 ha of bare ground which was mainly occupied by a quarry, a murram road and a tarmac road. The catchment had a vegetation cover of wooded grassland mainly composed of oil grass (*Cymbopogon afronadus*), red oat grass (*Themeda triandra*), Leleshwa (*Tarconanthus camphoratus*), whistling thorn (*Acacia drepanolobium*) and a few traces of star (*Cynodon dactylon*) and Rhodes (*Chloris gayana*) grasses which were seen only near the gully (see plates 13 and 14).

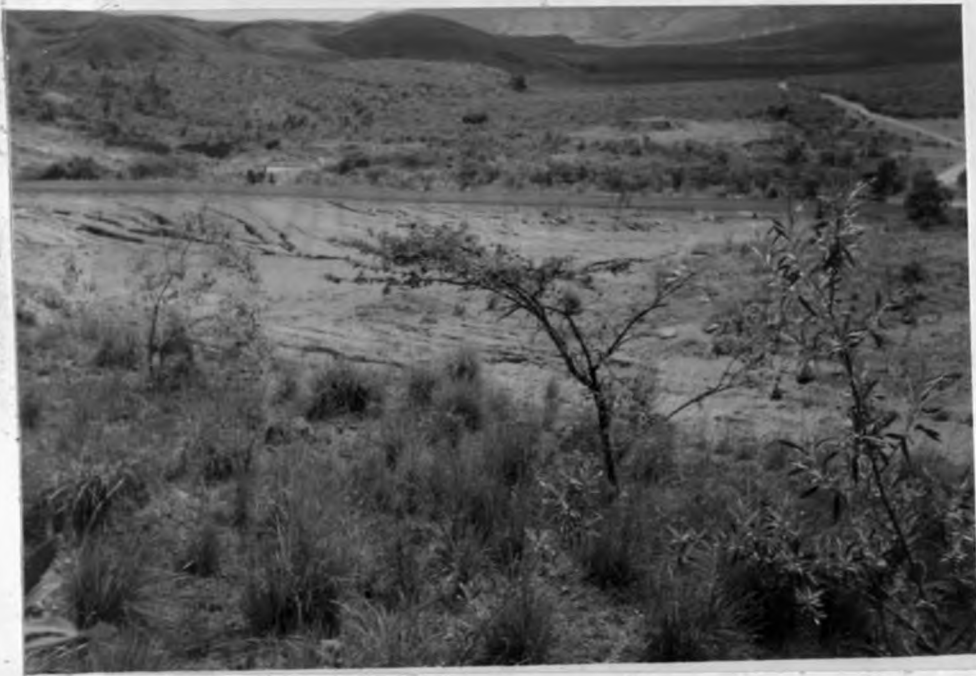
Plate 14. The eroding quarry in the study gully B catchment.

pumice and there were few rock outcrops in an adjacent valley that joined the gully. Many rills formed and developed into shallow and narrow gullies on the quarry with a risk of undermining the adjacent tarmac road (plate 14). A murrum road on the upper part of the catchment was eroding and draining runoff into the gully through a natural valley and the tarmac road drains. The runoff needed to be safely diverted away from the gully.

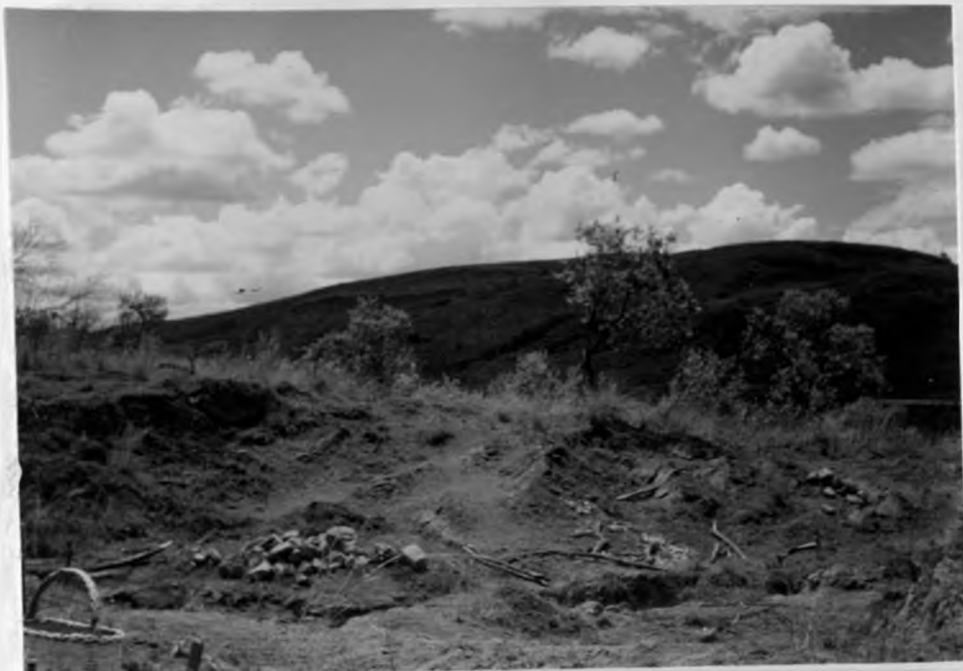
Plate 15. Bulldozed middle section of gully A, December 1992.

The 1986 and 1988 aerial photos showed similar features except for Maasai homesteads ("manyattas") that appeared only on the 1986 photos. Neither the study gully A nor well 707 were present. A well 714 was visible in the upper part of the gully catchment but absence of water tanks was noticed. The immediate catchment of the study gully A had its topsoil and vegetation scraped into the gully in an attempt to fill it (plate 15).

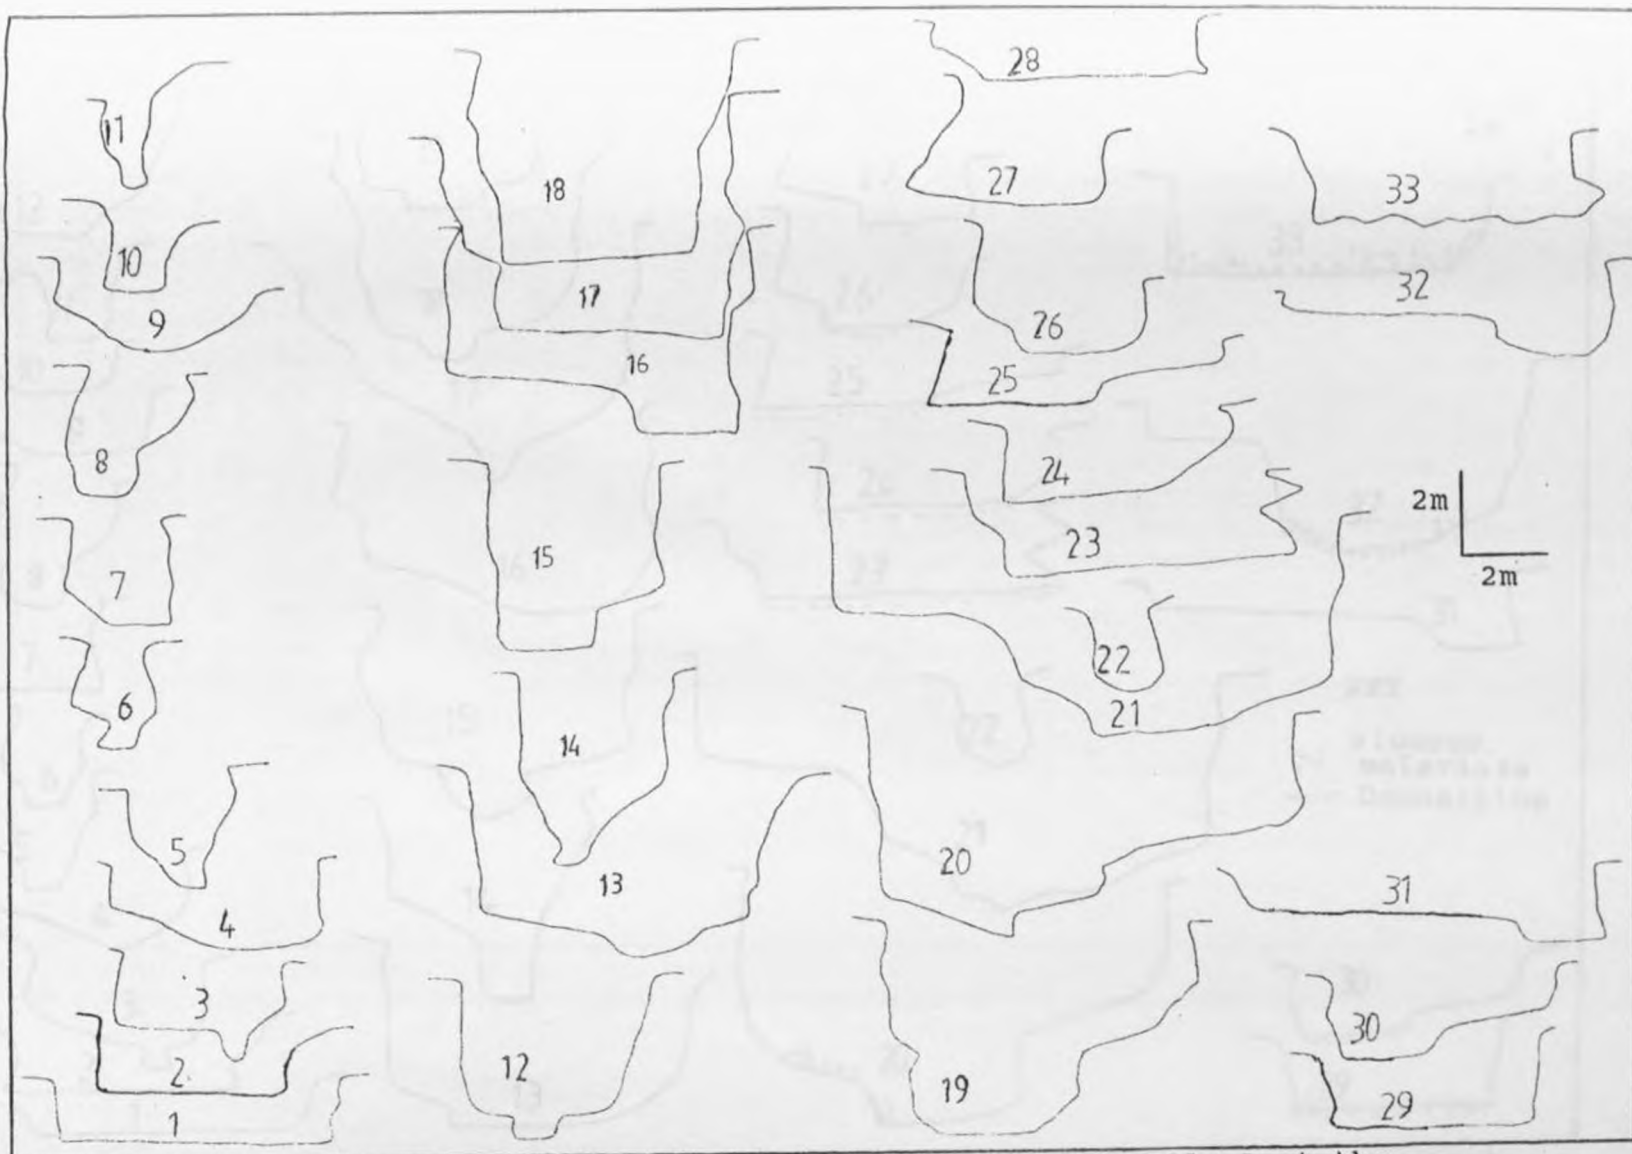
Fig. B.1 Cross profiles at every 10 m intervals of gully A at the beginning of the first rainy season, October 1992

In general the gully cross-section was U-shaped with many sections having beds that had scoured into the underlying hard soil layer to give a complex shape (figs. B.1 and B.2 in appendix B). The gully had also hanging sidewalls with negative side slopes which indicated that collapse could occur on wetting or on slight agitation. The hanging sidewalls were underlying a thin crusted topsoil layer formed on scraped land adjacent the gully wall which might have impeded infiltration of rainfall thus increasing sidewall stability.
