Gully erosion in Western Kenya

Arid and semi-arid lands in Kenya are suffering from extensive soil erosion. Especially in the Lake Victoria basin in Western Kenya, soil erosion is developing into big gullies while are seriously threatening the inhabitants. During the period of July and August in 2003, we carried out an environmental field study on the biggest gully in Ndori Village, Nyando District, Nyanza

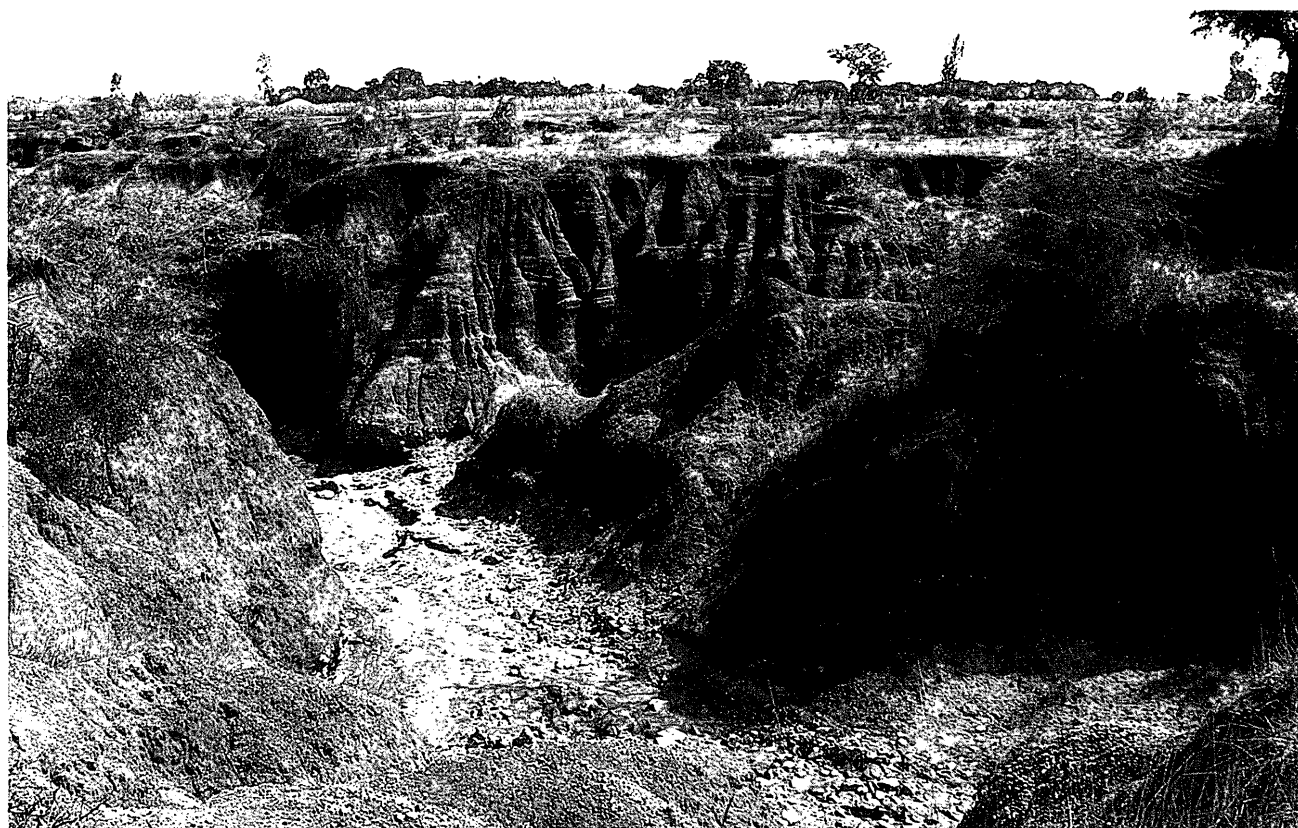
Fig.2 (bottom). Big gullies are cutting deeply into the inhabited and cultivated plain. Friable black-cotton-soil covers the plain widely and is underlain by the Quaternary deposits varying from gravel to silt. Sidewalls are about 14 m in height.

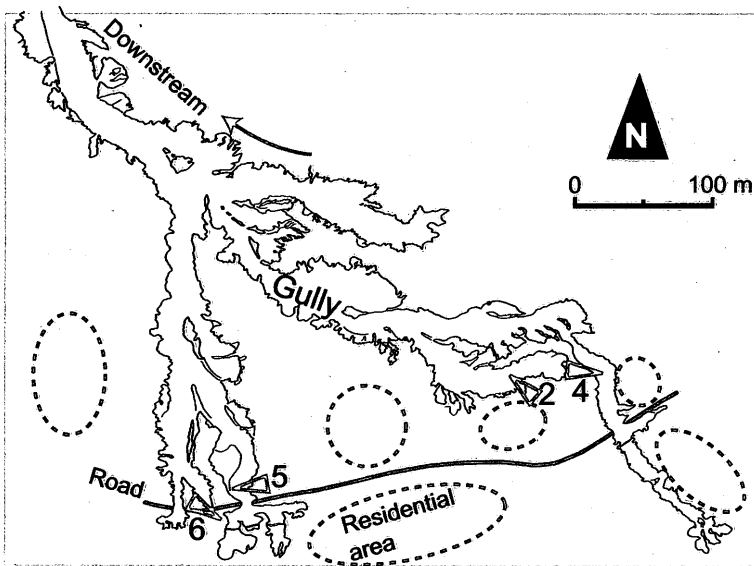
Fig.3 (upper). Detailed distribution of gully has been mapped in this field study. Camera angles and locations of the photographs inserted in this report are also indicated by red-coloured numbered arrows.

The Lake Victoria basin has been forming within Precambrian basement under the tensional tectonics of the Kavirondo Rift since the Miocene age. Thick piles of Quaternary fluvial and lake deposits infill the basin area and they are covered with black-cotton-soil. Detailed mapping of the gully distribution (Fig.3) revealed the serious condition of the erosion at this site (Figs.2, 4 and 6). The annual erosion rate reaches up to 20 m at the gully head (Fig.6) and the height of the gully sidewall reaches 14 m (Fig.5). If the gully erosion proceeds at the current rate, houses and cultivated land located upstream and around the gully will be lost in the near future.

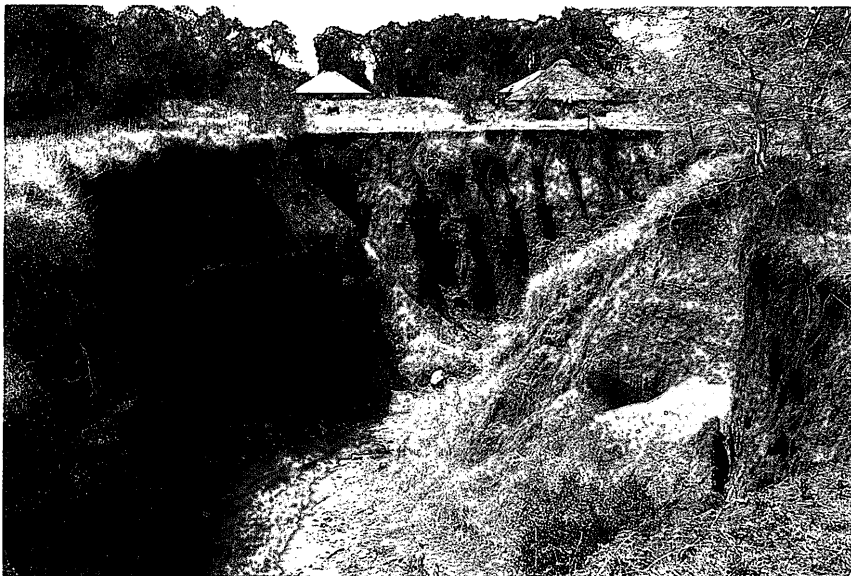
Fig.4 (centre left). Bank failure induced by lateral erosion. The gully edge is threateningly close to the residential area. Sidewalls are about 12 m in height.

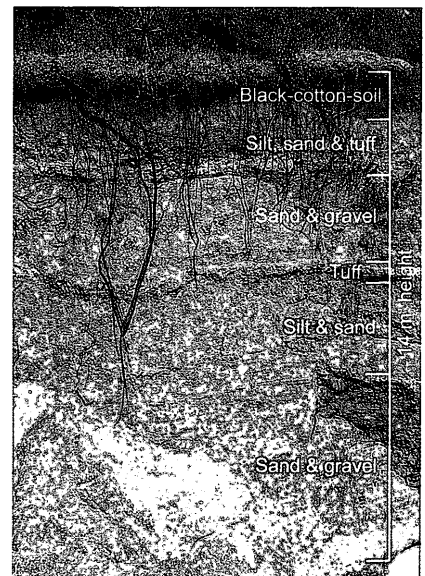
Fig.5 (centre right). A typical geologic section of the area. The Quaternary deposits underlie the top black-cotton-soil.

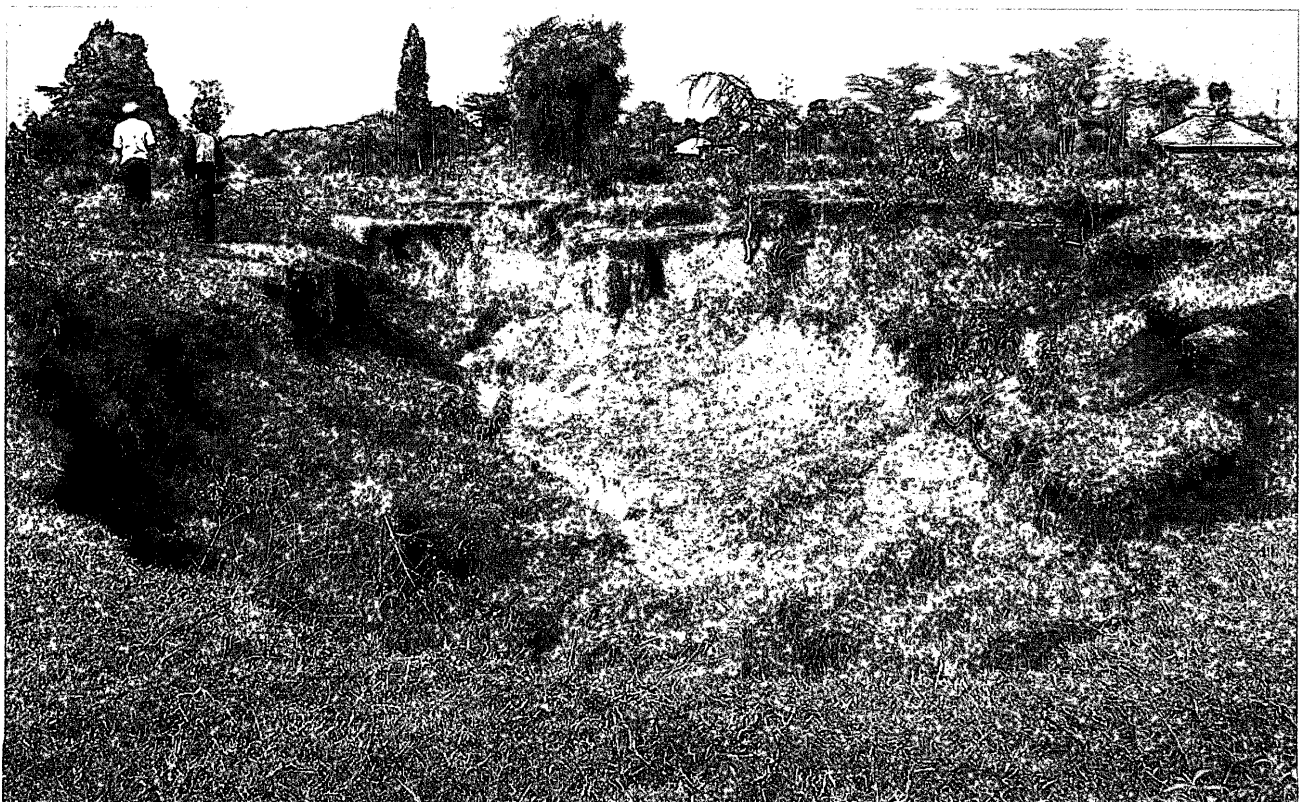
Fig.6 (bottom). Headword erosion also proceeds rapidly. The erosion rate reaches up to 20 m/y.
