**THE ROLE OF CLIMATIC FACTORS IN THE DETERIORATION
OF IMMOVABLE CULTURAL HERITAGE:
A CASE STUDY JANGA COASTAL REGION.**

**A PROJECT REPORT SUBMITTED TO INSTITUTE OF
AFRICAN STUDIES UNIVERSITY OF NAIROBI IN PARTIAL
FULLFILLMENT OF THE REQUIREMENTS FOR THE AWARD
OF POSTGRADUATE DIPLOMA IN CARE AND
MANAGEMENT OF HERITAGE AND MUSEUM COLLECTIONS.**

JUNE 2003

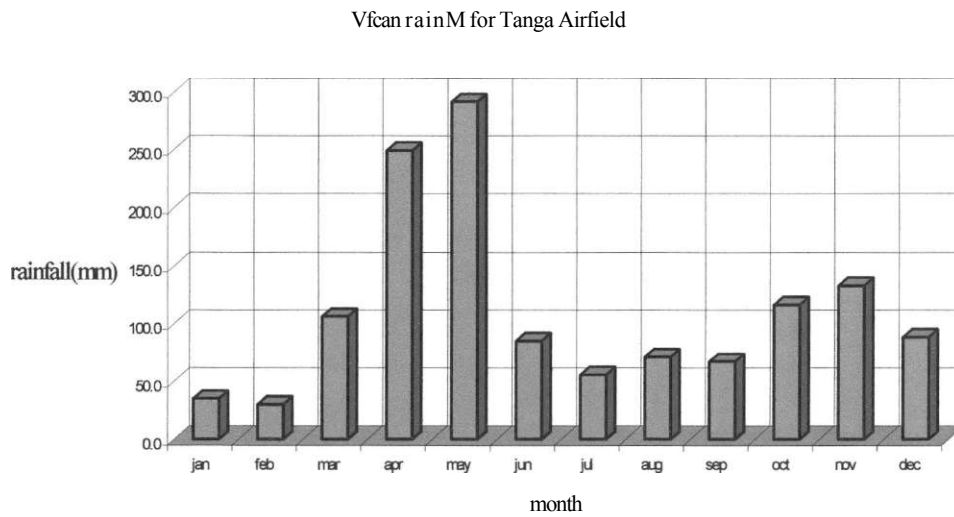
Figure 4.1: Mean monthly distribution of rainfall at Tanga airfield

This section presents meteorological data obtained by courtesy of Tanzania Meteorological Agency for Tanga Airfield representative of the coastal strip. The airfield is located at latitude 5.05°S and longitude 39.04°E and at an elevation of 48 metres above mean sea level. Tanga coastal areas experience tropical climate generalized as hot and humid with daily and seasonal variation in temperatures and humidity. The climate of the area is determined to a great extent by the movement of the rain belt, better known as the Inter Tropical Convergence Zone (ITCZ), which-responds to the apparent movement of the overhead sun north and south of the equator. This gives way to two rainy seasonal experienced between March - May (long rains) and October - December (short rains). The average annual rainfall ranges from less than 50 millimeters (mm) in February to about 300 mm in May as shown in Figure 4 3. Peak rainfall, as shown in Figure 4.3, is attained in May and November. Annual variation is remarkable as is shown in figure 4.4.

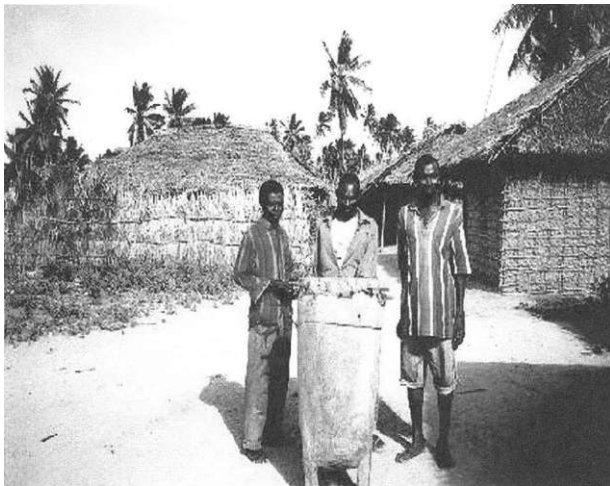
Plate 4. 1: Traditional house (Kichalikani)

Traditional houses in Tanga along the coast were mainly built using wooden poles, plastered by mud and thatched by grass (Plate 4.1). Traditional houses were built along the coast of Tanga by the local tribes including Digo, Bondei, Ngazija, Segeju, etc. These traditional buildings were not long lasting and durable due to the materials used in building them. In spite of this, they had an advantage of being environmentally friendly and cheap to build.

The traditional houses needed frequent maintenance and several of these buildings were very much affected by weather and climate. As such a routine for the owners to renovate the traditional houses after the end of every rainy season was necessary. The durability of traditional houses depended on location, technology and the

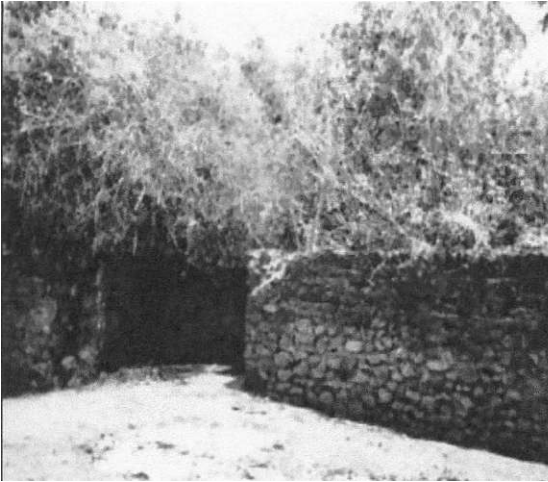
Plate 4. 2: Kwale defensive wall without Plaster

A survey conducted at Mwarongo, Kwale, Kizingani, Kichalikani, Chongoliani and Pangani shows that these walls still exist. Most of the defensive walls were built by using coral stones and limestone. It is unfortunate that a large part of the walls in most locations are now seriously deteriorating due to environmental conditions (Plate 4.4). Direct rainfall, high humidity as well as temperature contrasts caused by direct sunlight during the day caused expansion and contraction of construction materials as a result of which cracking, splitting, peeling off of plaster were observed (Plate 4.4). Moss, fungus, algae, lichen and higher plants which lead to collapse of some of the defensive walls through large roots were also noted to play role in the deterioration process during the visit.

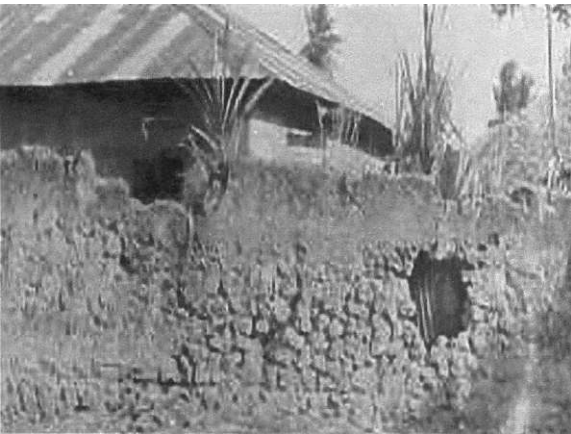
Plate 4.4: Deterioration due to climatic condition. Part of Chongolian defensive wall

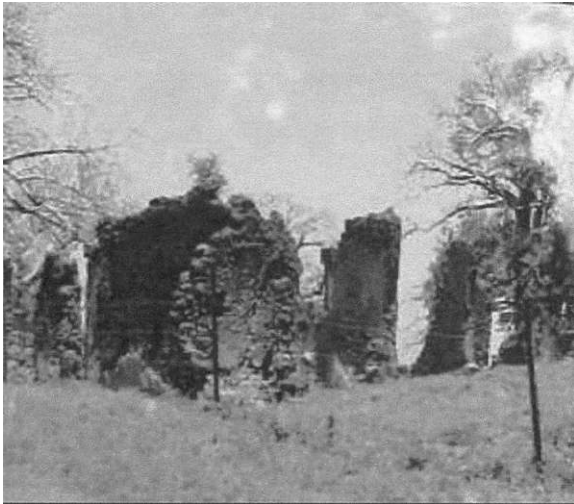
Plate 4.5: Tongoni ruins very fragile, some of the walls have a lot of cracks and peeling off of plaster.

fallen down of their pillars (Plate 4.5, & 4.6). Growth of small and higher plant mosses, fungus, grasses, and the like was also noted on some ruins (Plate 4.5 and 4.6).

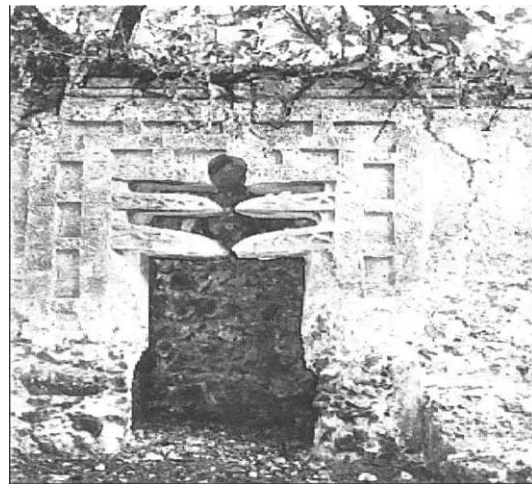
Plate 4.6: Cracks caused by plants at the Kwale

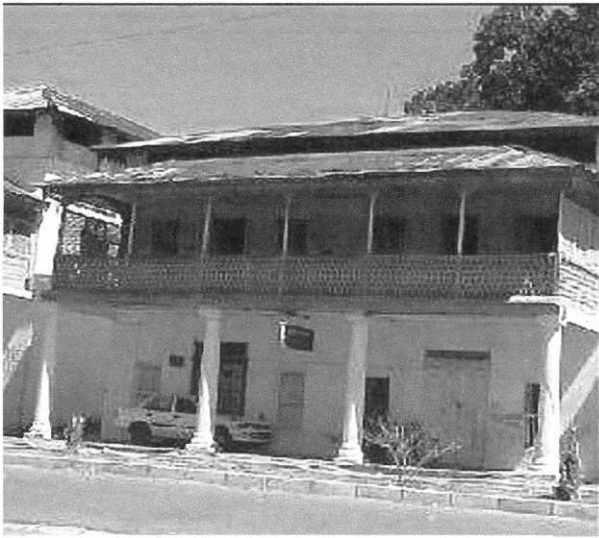
Plate 4.7: Persian Building with balcony and its roof was highly corroded due to high humidity and salt

The roofs were highly corroded due to salt and high humidity (Plate 4.7 & 4.8). The holes found on the iron sheet cause rainfall water to penetrate into wooden rafters. Rain water, which penetrate into iron sheet causes high dampness which as the result destroys the wood (Plate 4.8).

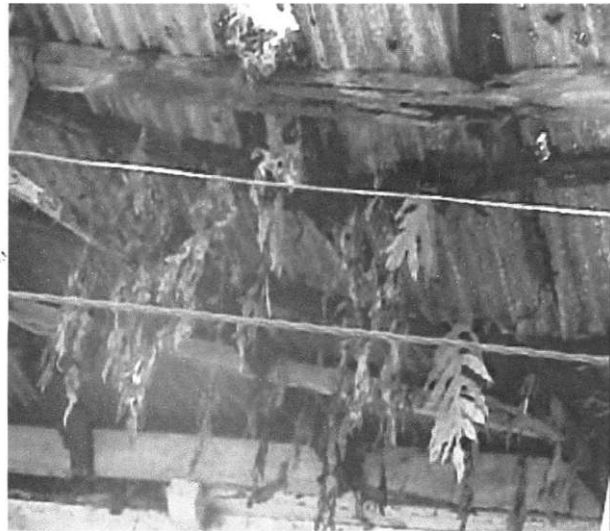
Plate 4. 8: highly corroded roof, Bohora building, Tanga

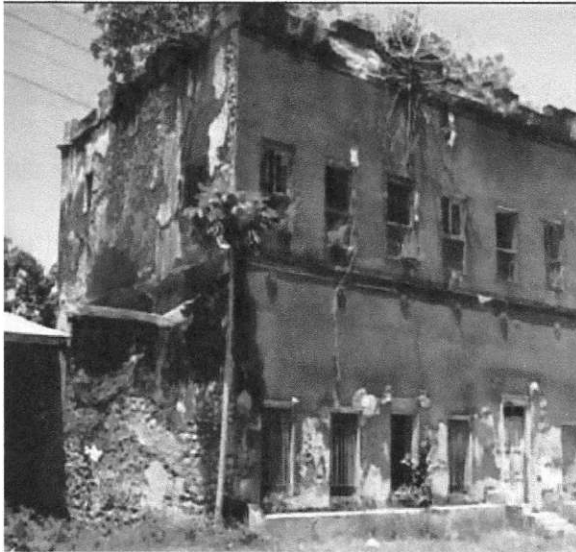
Some Swahili or Persian historical buildings were in good condition due to regular maintenance. These included the temples and mosques. Some of them were in a very bad condition especially in Pangani district where buildings have undergone deterioration due to climatic conditions (Plate 4.9).

Plate 4.9: Slave building, PanganUPeeling off of walls, cracks and growth of vegetation due to climatic condition effects.

The rafters, balconies, doors and window frames consisting of wooden construction material have decayed tremendously due to dampness, which provides a suitable environment for fungi growth (Plate no 4.9). Walls have severe cracks, splits and peeling off wall plaster while some of the building walls have disintegrated due to weathering (Plate 4.9).

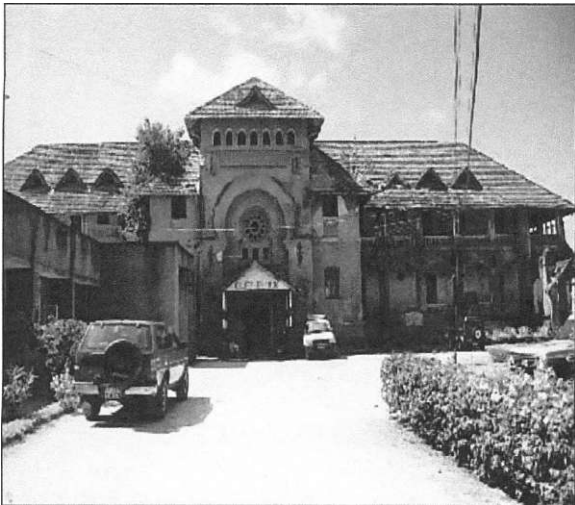
Plate 4.12: Front view of Cliff block,, deterioration caused by climatic condition (Growth of plant) On the left there was extension of new building.

Municipal Council. Corrosion, cracking, splitting and peeling off of wall plaster was desperately noted on most of these buildings. Growth of plants on the roof and walls was also observed (Plate 4.12).

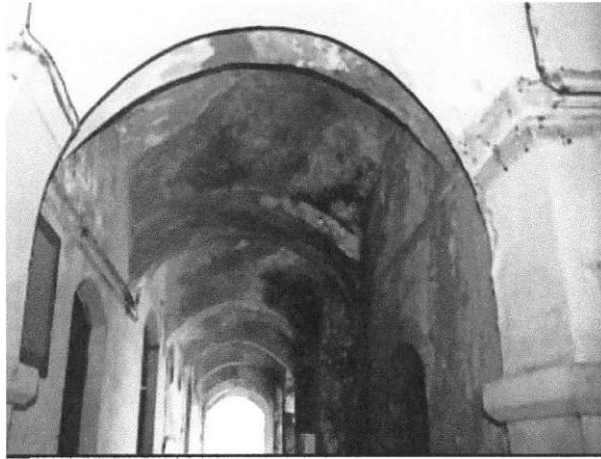
Plate 4.14; Peeling off of wall plaster inside the cliff block due to climatic conditions (Bombo hospital).

The plant growth on the roof causes leakage, which in turn lead to the deterioration of walls inside the cliff block (Plate 4.14). Additionally, infestation by subterranean termites was observed on German buildings. It is clear from the presence of brown mud-like materials or tubes, which line the walls.

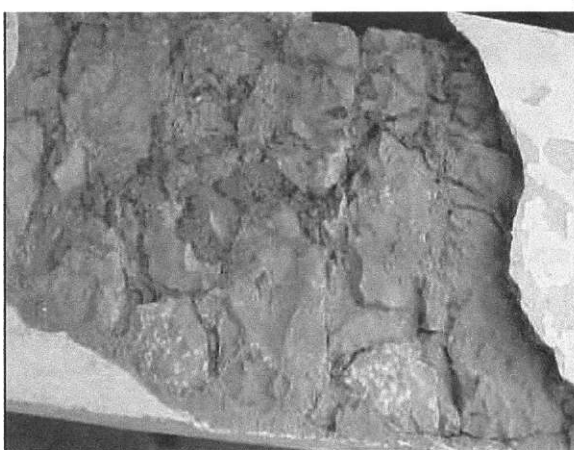
Plate 4.15;: Termites on the wall cause the peeling of wall plaster (Health building)

The presence of termites cause the peeling off of wall plaster as shown on (plate 4.15) In some buildings like the former Tanga sec. school which now serves as a health institute,

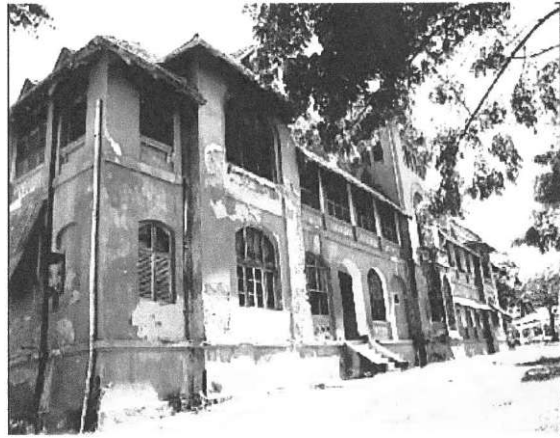
Plate 4.13: Peeling off of wall due to climatic condition [cliff block/

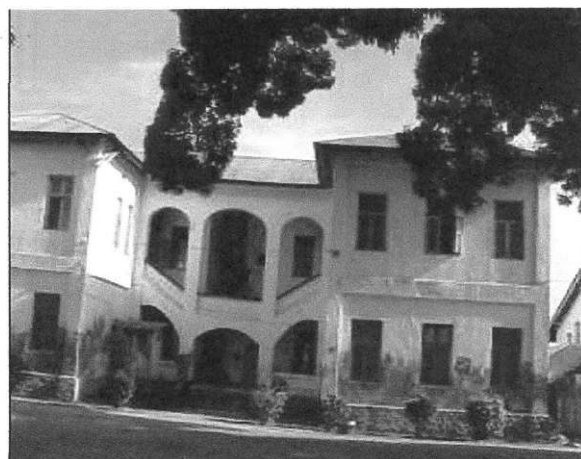
Plate 4.16: Peeling off of wall plaster and painting at lower part of building due to climatic condition effects, (health Building)

it was observed that the peeling off of wall plaster was caused by the hygroscopic water. Which means that the water moving upward to the building material through capillary action causes the peeling off of wall plaster (Plate 4.16).

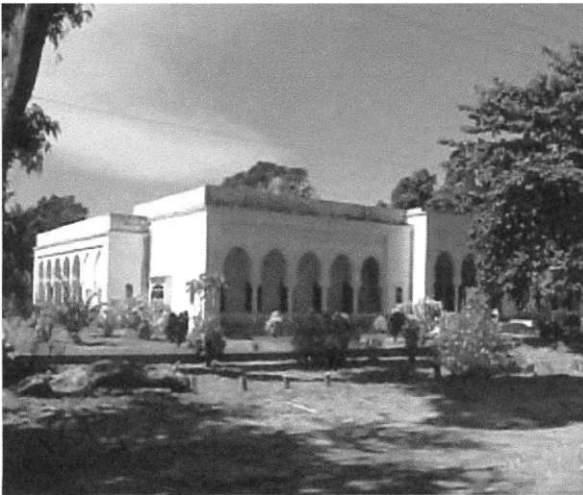
Plate 4.17: Tanga library built during the British period it was in good condition.

The British ruled Tanganyika after the first world war (Clarke 1960; 11). They took over most of the German buildings like the administrative buildings. New buildings dating to the British colonial era in Tanga include Mkonge hotel and the Tanga library.

mortar. These two buildings are still in good condition except for few cases. Weathering appears to be the main factor affecting these buildings and it will turn worse if deliberate measures are not taken to contain this.

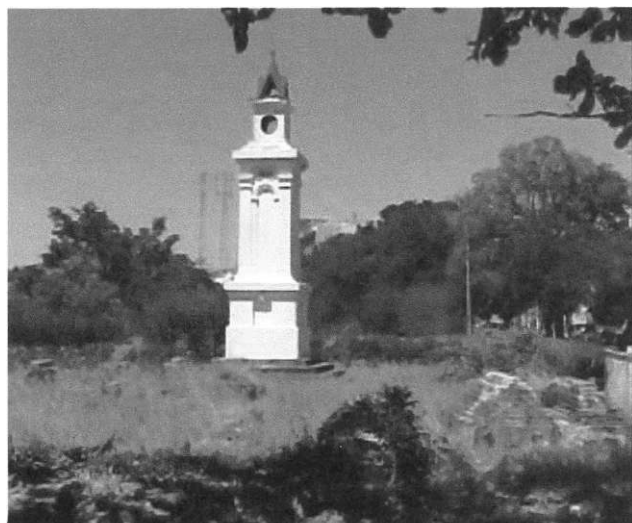
Research was carried out at landscape sites. It was observed that all were in good condition except on a few cases like the German tower which was covered by grass and cracks on the lower part (plate 4 18). The cracks may have been caused by the underground water or direct rainfall and sunlight.

Plate 4.18; on the right side, shown grass growth on German tower and graves-

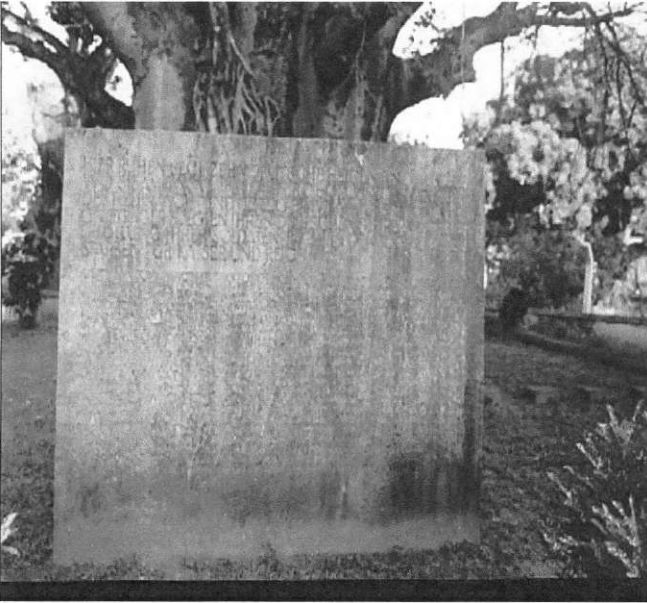
On the Second World War German landscape , the colour of the board with the names of people who were involved in war was fading out (plate 4.19). The fading of colour was caused by direct sunlight.

Plate 4.19: On left side shows fading of colour on a board with German second world war names/burials

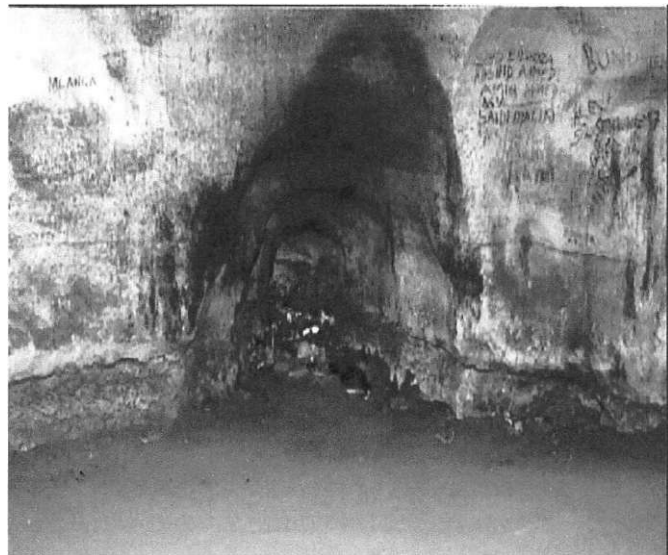
The caves have been developed in the Tanga Limestone series, which is of Jurassic age, and is estimated to extend over an area of 234 kilometers. Human beings through vandalism caused damage to Amboni caves by adding graffiti outside and inside the cave (Plate 4.20).

Plate 4.20: Graffiti on worship place inside the Amboni caves.
