**THE IMPACT OF DEVELOPMENT PROJECTS ON ARCHAEOLOGICAL  
HERITAGE: A CASE STUDY OF SELECTED COASTAL SITES AND  
MONUMENTS IN KENYA**

**A THESIS SUBMITTED IN PARTIAL FULFILMENT FOR THE DEGREE  
OF MASTER OF ARTS (ARCHAEOLOGY)**

**UNIVERSITY OF NAIROBI**

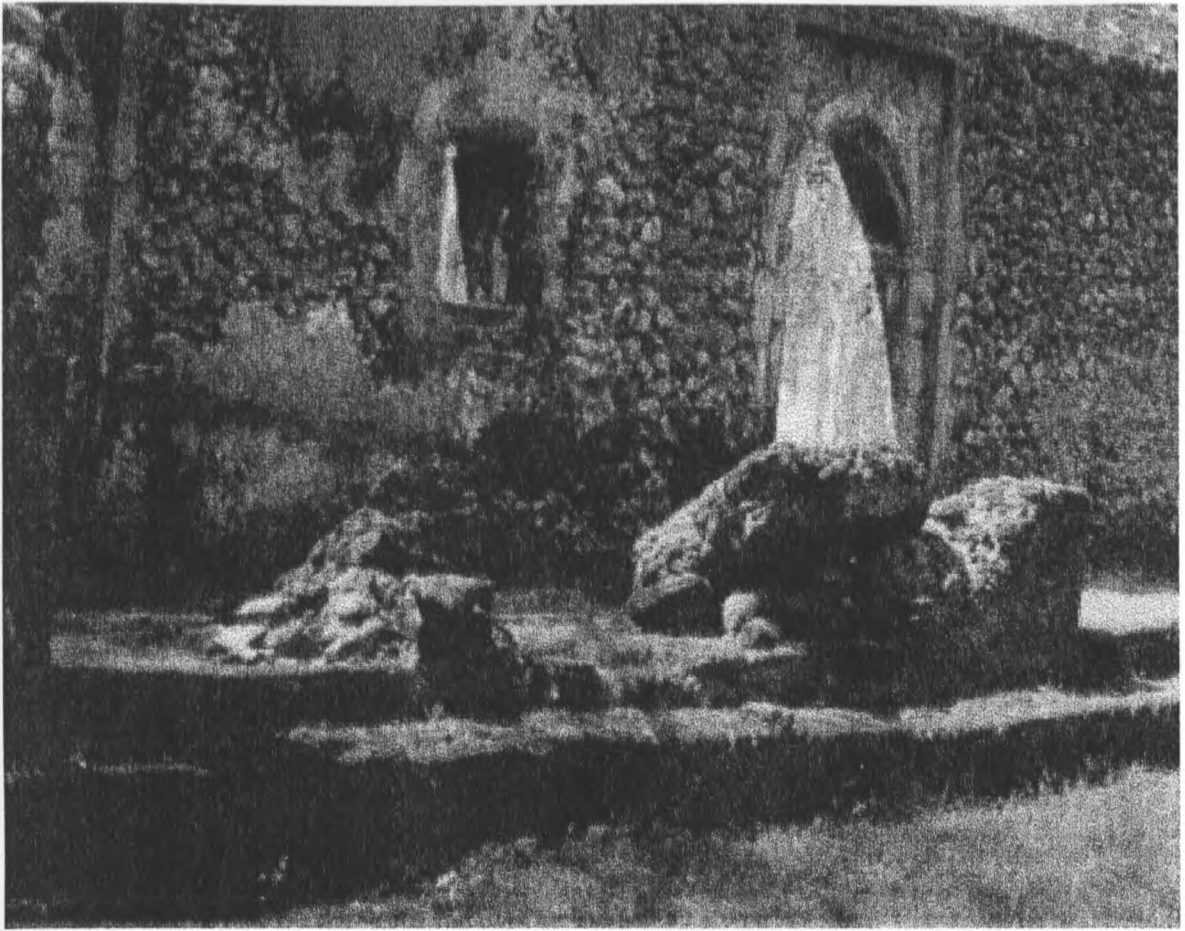
Plate 1: Rubbles of felled historic structure whose stones have been vandalized.

Since more than half of the ruins lie on the ground as rubble, it was not practical to know what caused the felling. However, by looking at the mounds of rubble at a private gate leading to one of the homes, it appears people have intentionally felled the walls. Most of the stones from the ruins have been used in the construction of new structures.

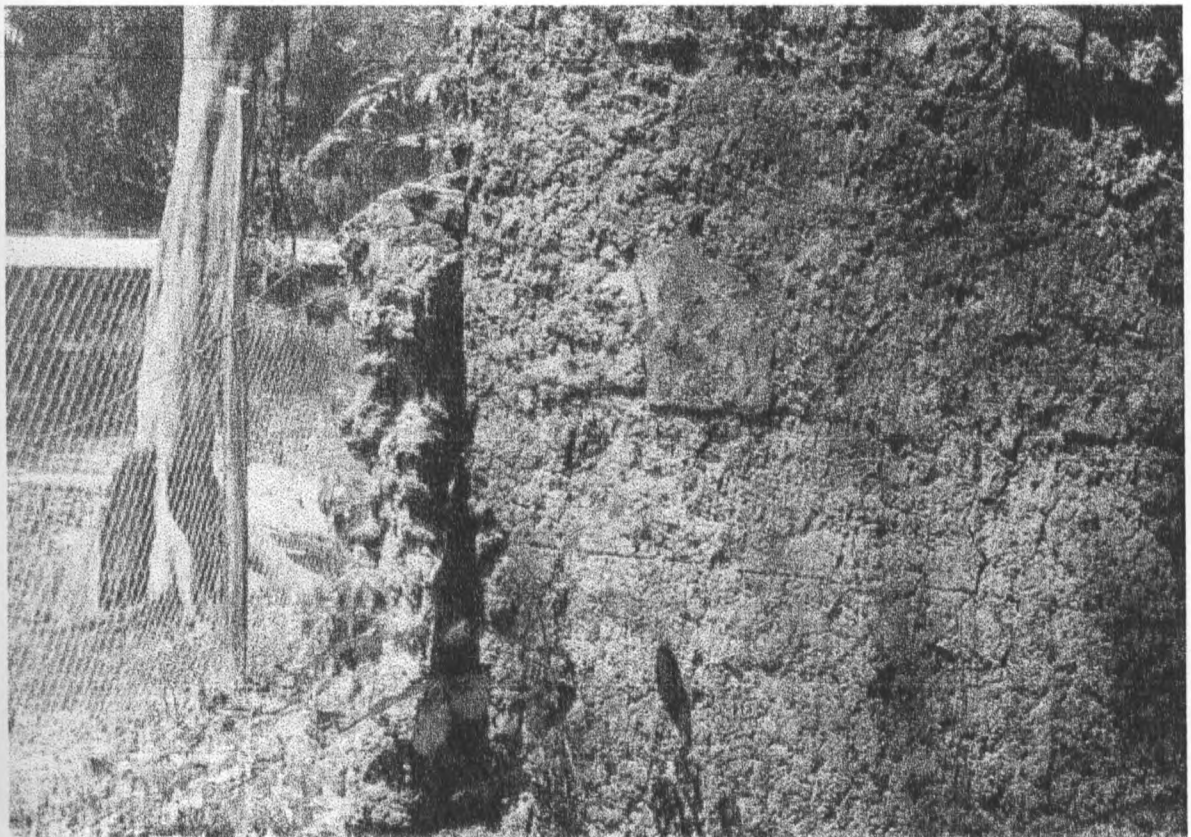
Plate 2: A Private fence skirting through historic walls at Mtwapa  
(See the left middle ground of the photograph).

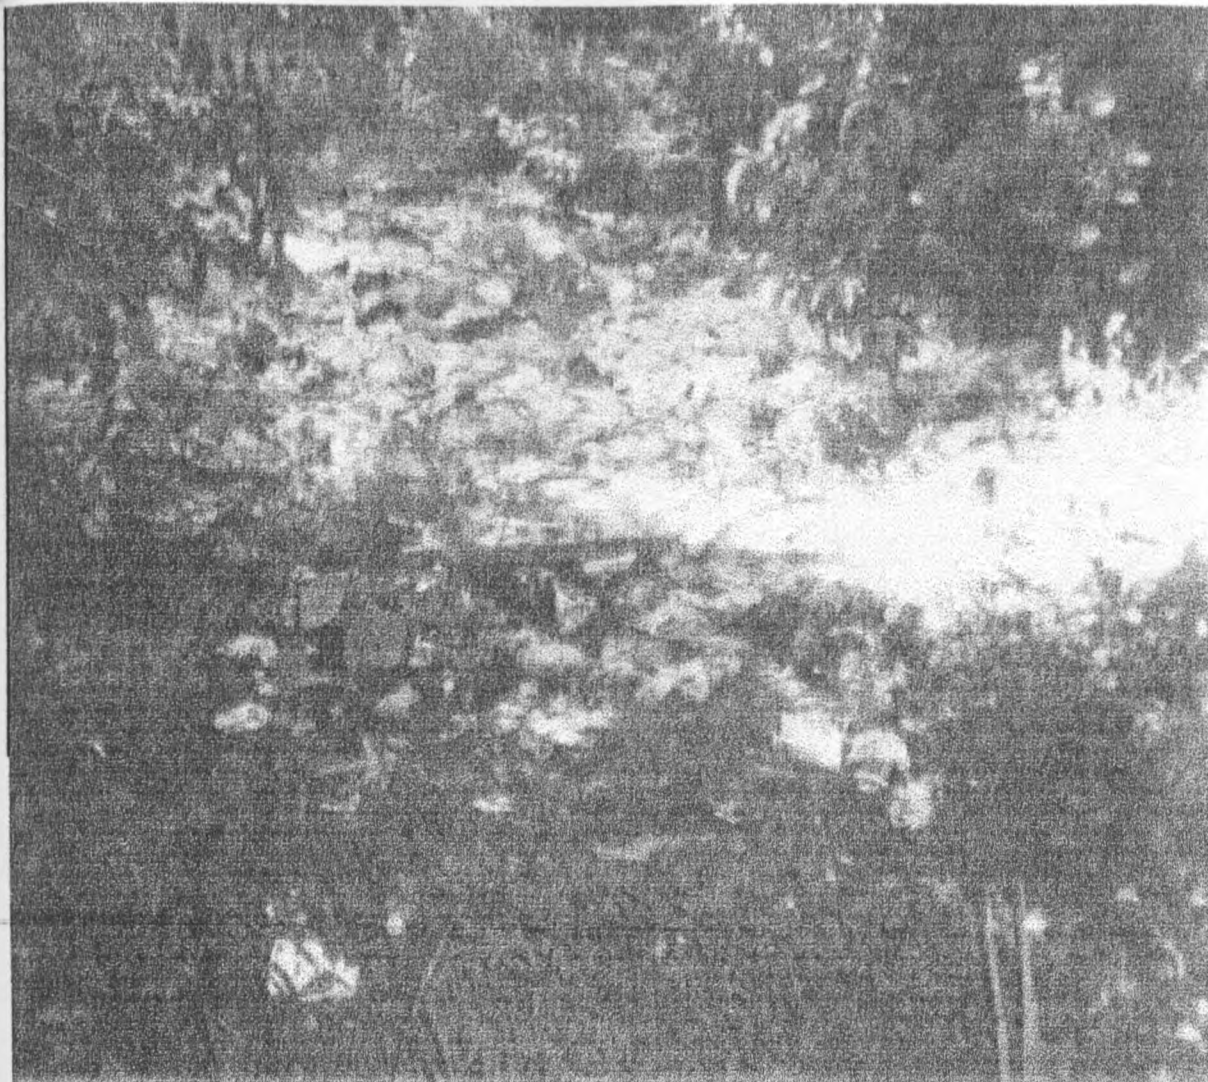
Plate 3: Dumping site within Mtwapa site.  
At the centre of the Photograph there are waste papers, tins and plastic materials.

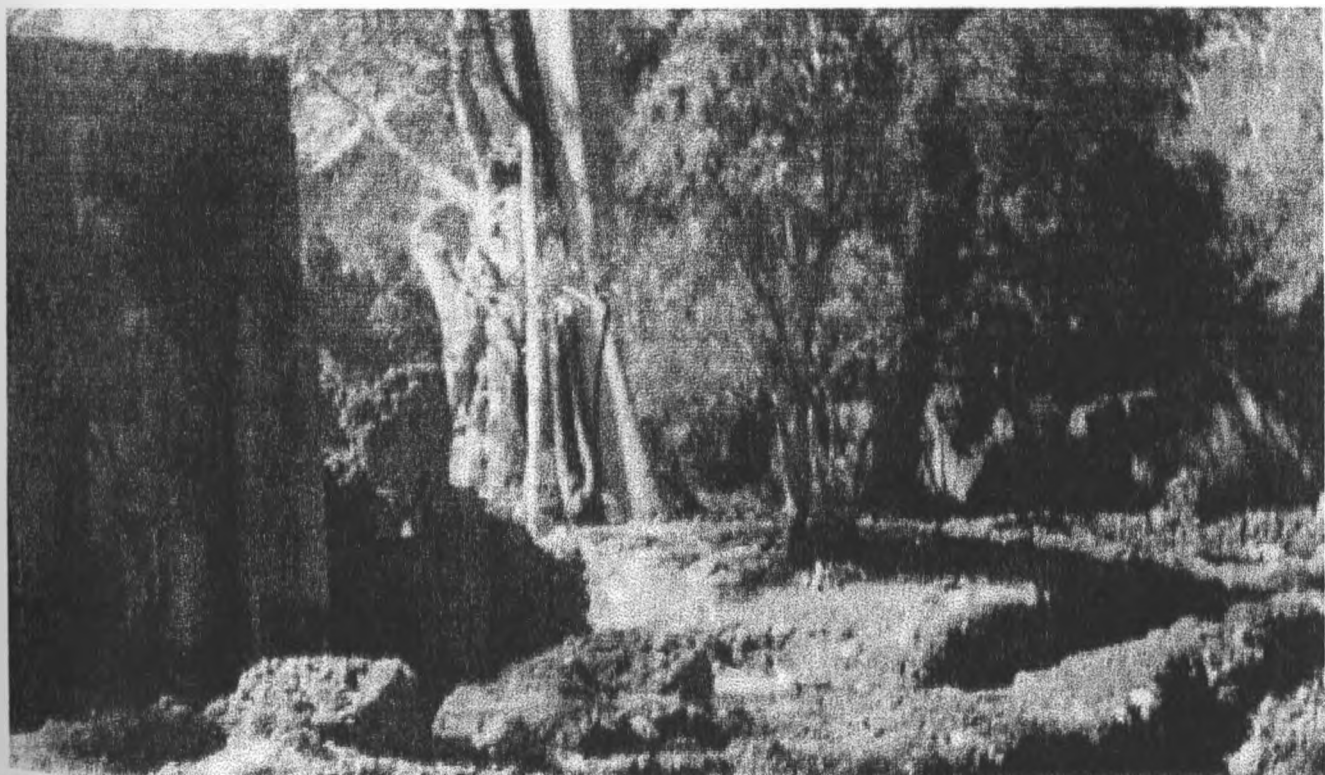
Plate 4: Buttress roots of trees.  
The right middle ground shows trees growing within Mtwapa site. The foundations of structures have crumbled.

Generally, the structures located in thick vegetation cover seem to disintegrate fast compared with those exposed to the sun and with little or light undergrowth. Thick vegetation cover enhances the decay process especially in this region of high temperature and moderate rainfall. Biological weathering has equally contributed to the collapse of historical structures as buttress roots of trees penetrate the walls and expand the cracks.

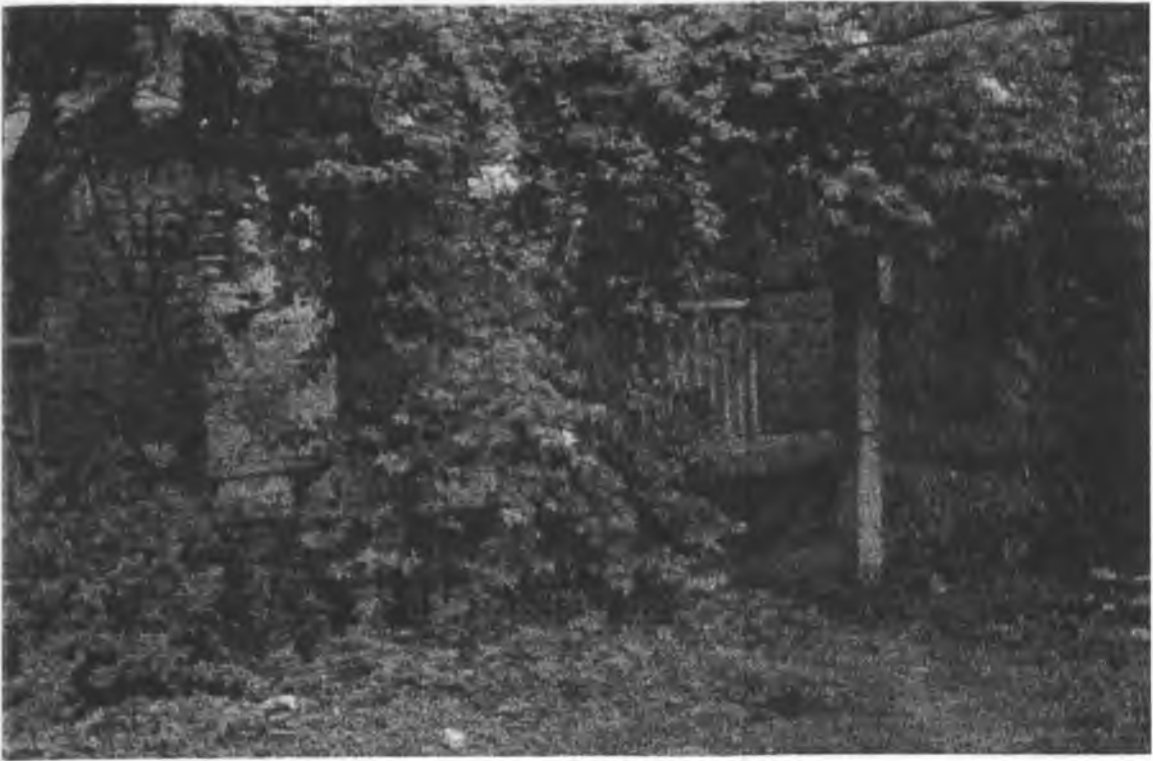
Jumba la Mtwana is generally rich in terms of wall structures that are still standing. The site was observed to have four modern settlements around it. All the four settlements were built on land containing historic ruins (Plate 5). The outline of the historic wall enclosure was traced across the compounds of the private homes.

Plate 5: A private housing scheme near Jumba La Mtwana.

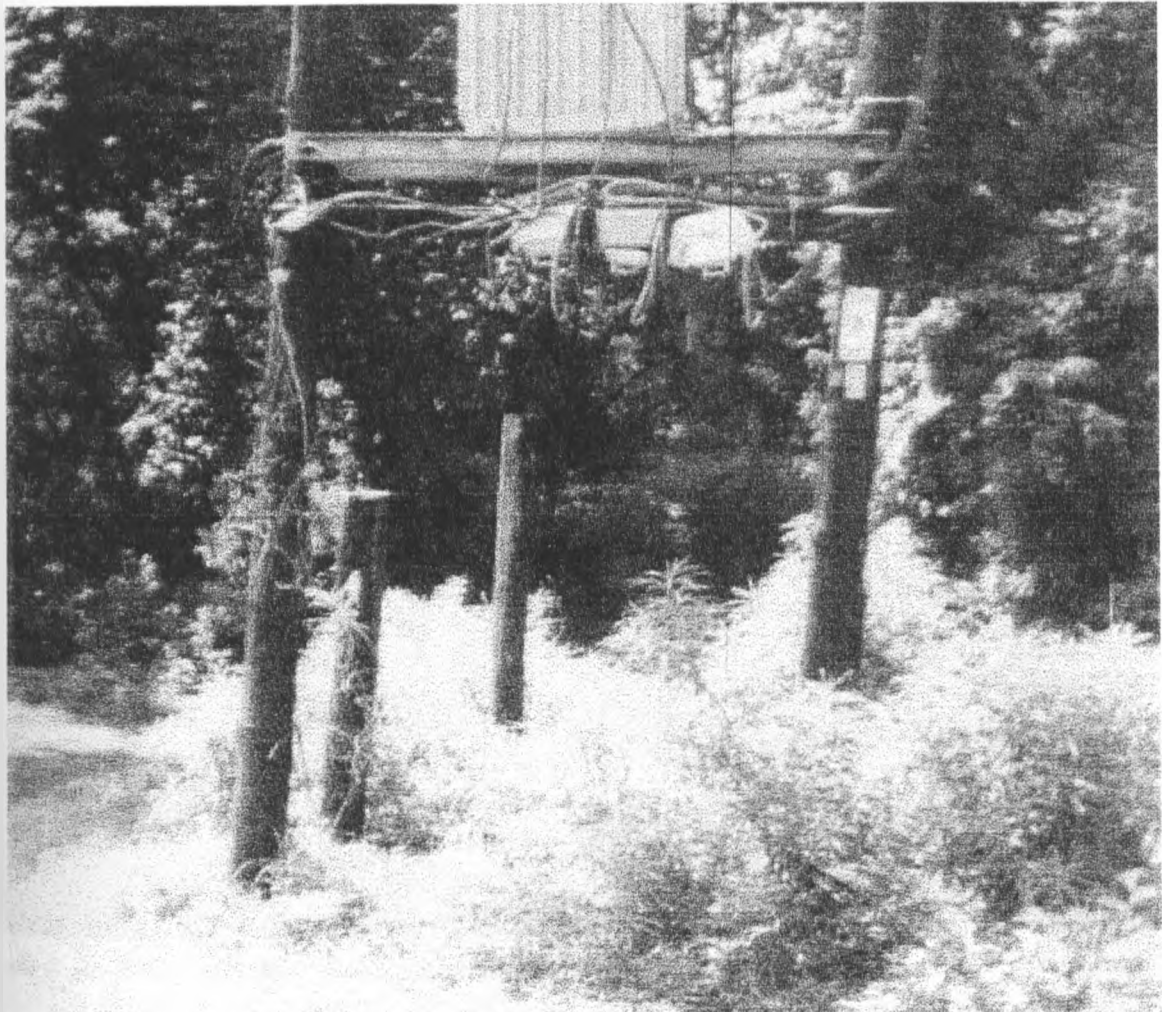
The walled enclosure on the northern side was observed to have hoof marks probably of domestic goats and cattle. Electric poles were observed as well as freshly fallen historic walls due to the 'planting' of the poles. Plate 6 shows electric installations put up by the Kenya Power

and Lighting Company within Mtwapa site. Several trees on the site were being cut down to give space for the power lines. And when asked whether permission had been granted by the museums to work on the site, the person in charge did not even know there were any structures which needed protection. Also observed to cause damage to the structures were buttress roots of trees that are characteristic of the bushes within the ruined structures (Plate 4). As these roots grow and enlarge in size, they penetrate and expand the cracks on the walls, which eventually crumble.

Plate 6: Electric installation within Mtwapa historic site. A path on the left foreground traverses the site.

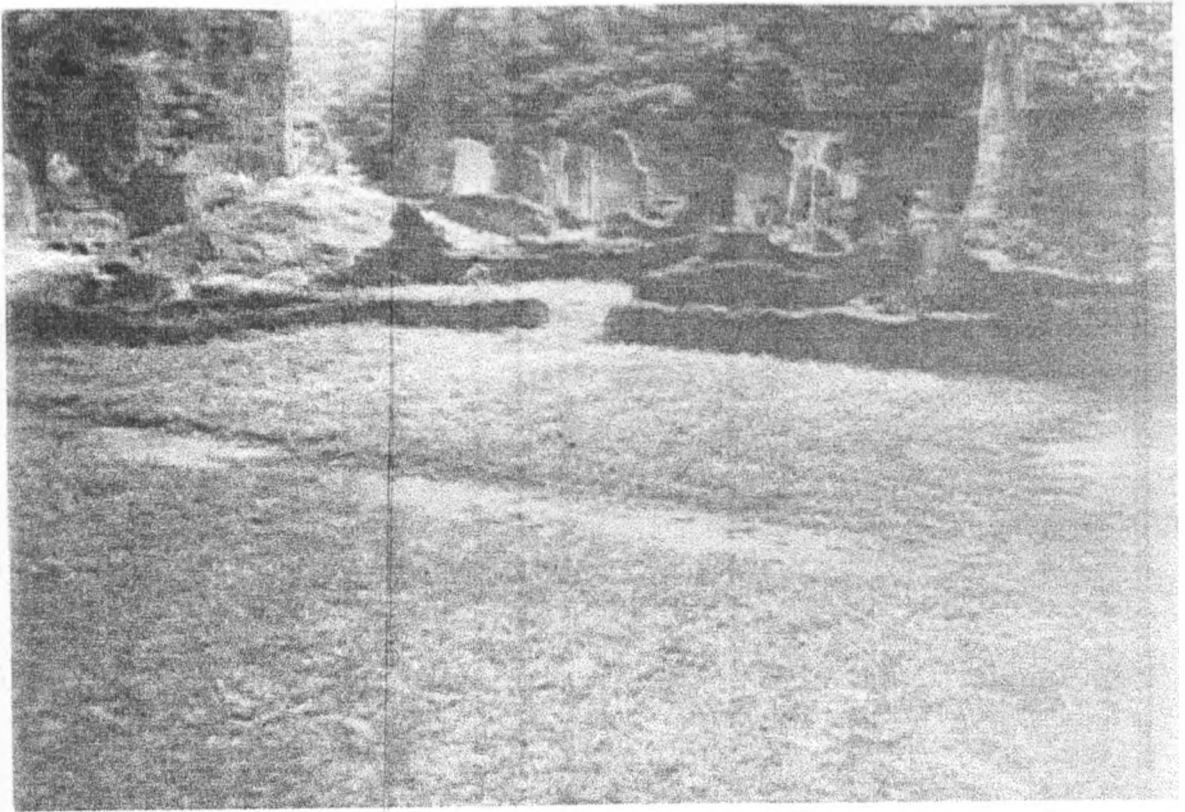
Plate 7. A Path through Jumba La Mtwana

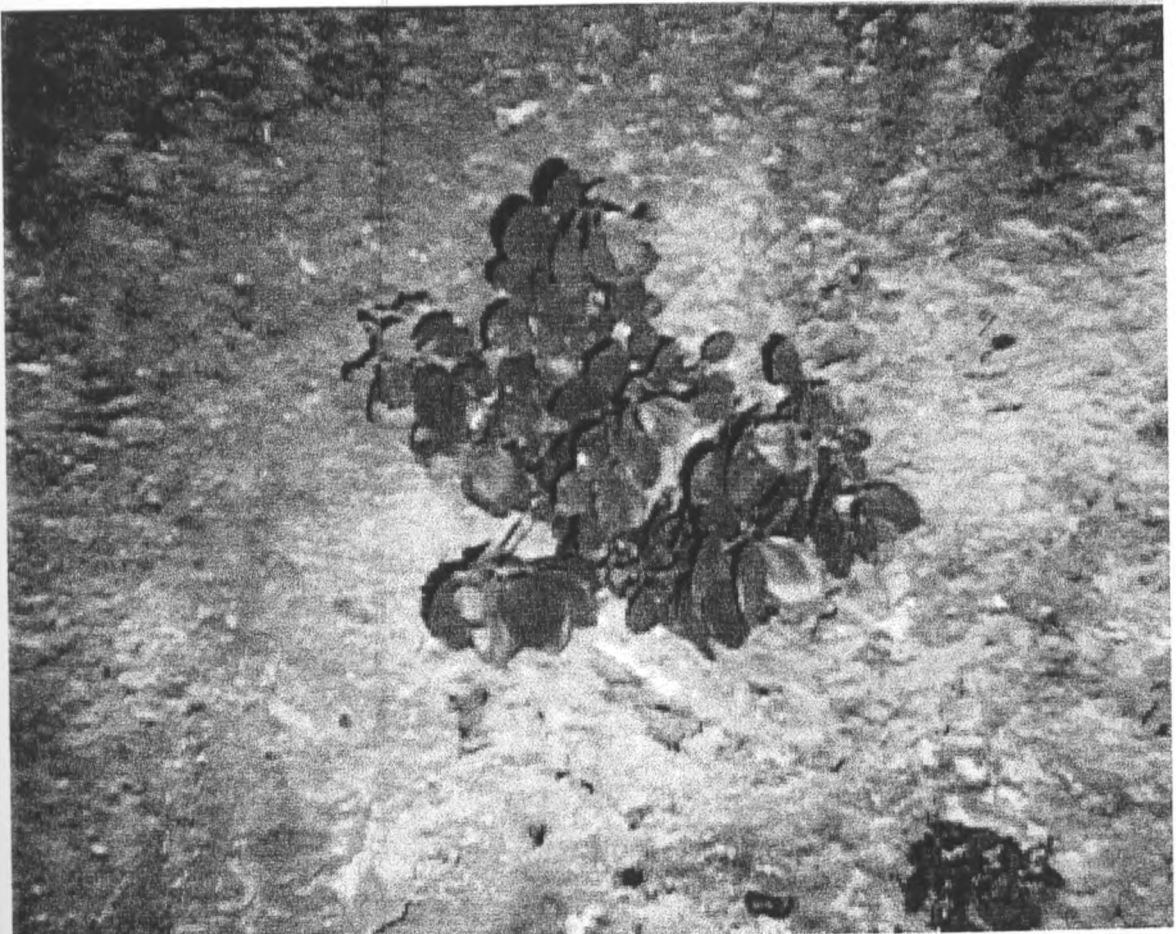
Plate 8: An unidentified plant growing on one of the ruined structures
