MANAGEMENT OF BILATERAL FRACTURE FEMUR WITH IMPLANT FAILURE: A CASE REPORT

J.C. Mwangi, MBChB, MMed(Surg), Lecturer, and A.A. Admani, MBChB, Resident, Department of Orthopaedics, College of Health Sciences, University Of Nairobi, P.O. Box 19676-00202, Nairobi, Kenya

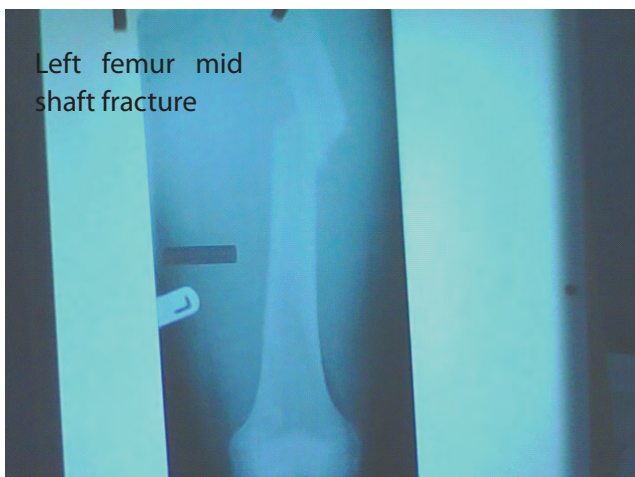
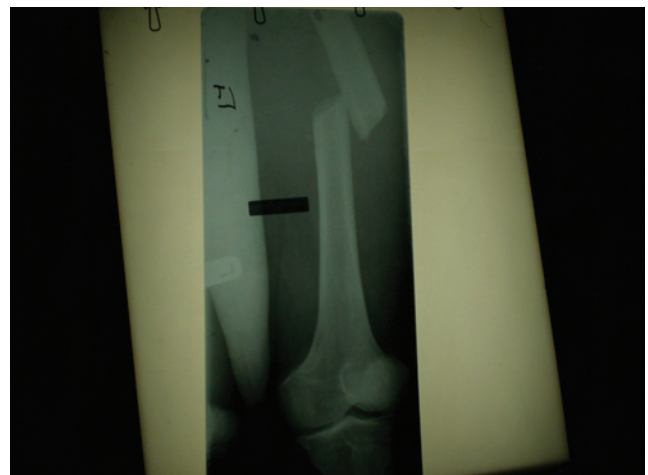
The left femur had a fracture of the mid shaft, as seen above and the right femur had a fracture of the proximal third (initial radiographs not available to us). Other investigations showed a haematocrit of 33.9%.

Traction was applied awaiting ORIF. On 24th July 2009, surgery was done, whereby the right femur was plated. The left midshaft fracture was fixed with a K-nail. IV ceftriaxone, chloramphenicol, and heparin were administered during surgery. The patient was also transfused 4 pints of blood.

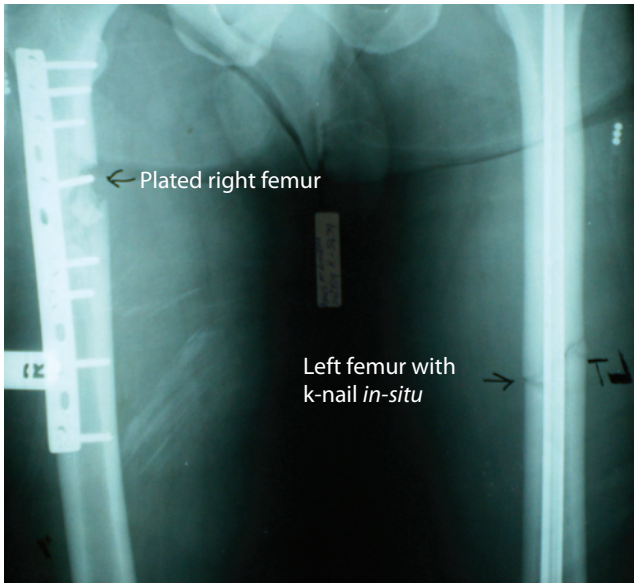
The patient was discharged on 17th July 2009, to mobilise on a wheelchair for 3 months and to be reviewed thereafter. Check radiographs availed to us showed fracture treatment as described:

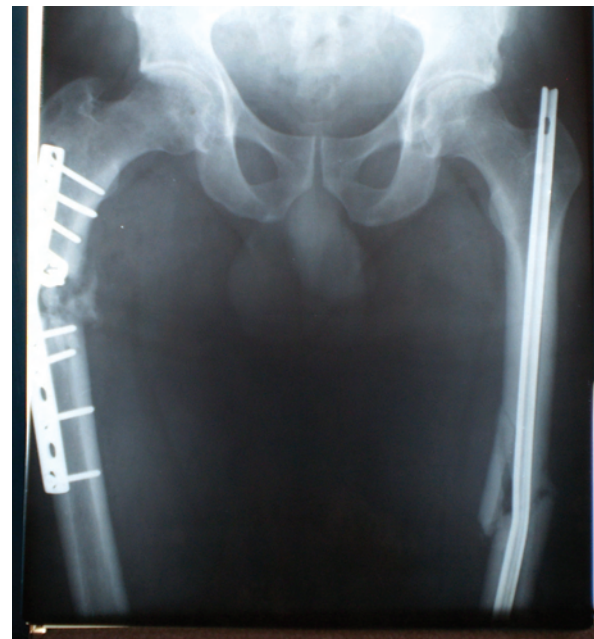
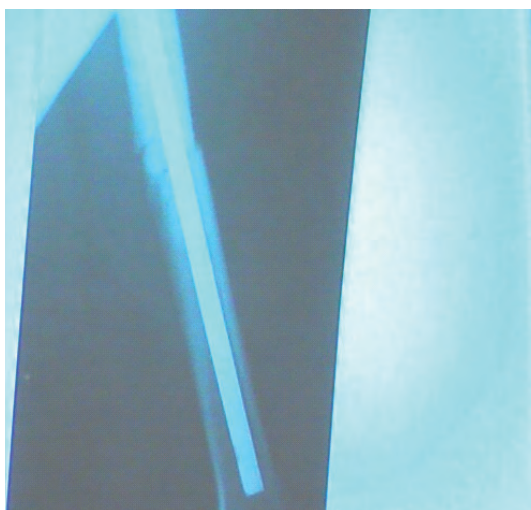
with complains of pain in the mid thigh left side and proximal thigh right side with associated inability to bear weight on the both lower limbs. On examination, we found swelling over right proximal femur- not warm, tender to deep palpation. Hip movement was possible, though limited due to pain. There was some varus deformity over the proximal femur. Knee movement- flexion, extension ranges were satisfactory. Examination on the left side mirrored that on the right except that the point of tenderness was most over the midshaft. Below are the radiographs which show a bent plate on the right side and a bent nail on the left side.

Left femur with bent nail- lateral view shows minimal bending in coronal plane

On the left side a K-nail was used to fix a midshaft fracture of the femur. This would be considered appropriate given the fracture pattern and the site of the fracture. Unfortunately the size of the nail was only 11. This may be considered small given that the patient himself was of a large body stature, and that we were comfortably able to ream upto size 13 when doing the exchange(4).

The patient was of large body structure, and had a fracture on both femurs. He also likely stressed the implants in a way that they were not designed to face, and this would likely have strongly contributed to the failure.

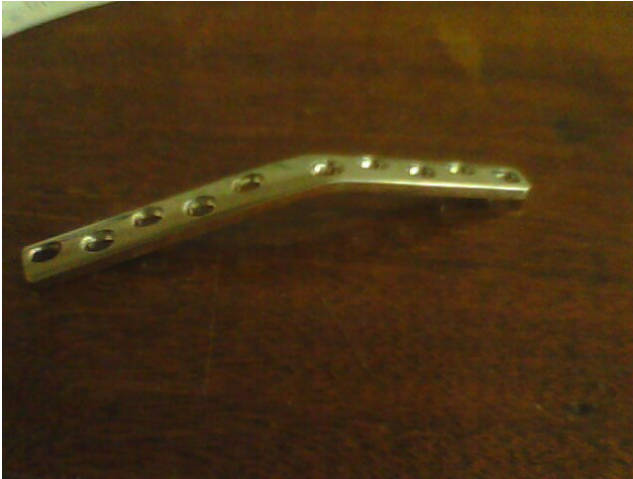
We took the patient to theatre on the 5th March 2010 and removed the plate on the right side. We replaced it with an intramedullary SIGN nail size 11. We used the remainings from the canal as bone graft

Post operative check X-rays are shown

To minimise the phenomenon of stress shielding during revision, we avoided the use of a plate on the right side. Thus we did minimal dissection to open the fracture site, placed an IM nail and used reamings as bone graft on the medial aspect of the femur(5,6).

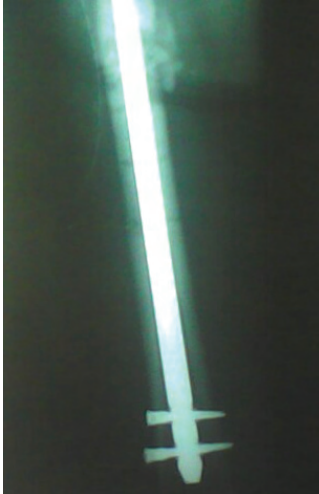
Distal femur showing distal locking

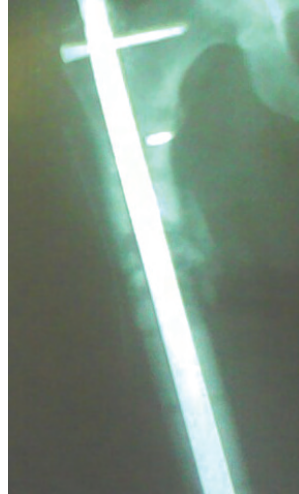
Proximal femur showing locking and fracture reduction

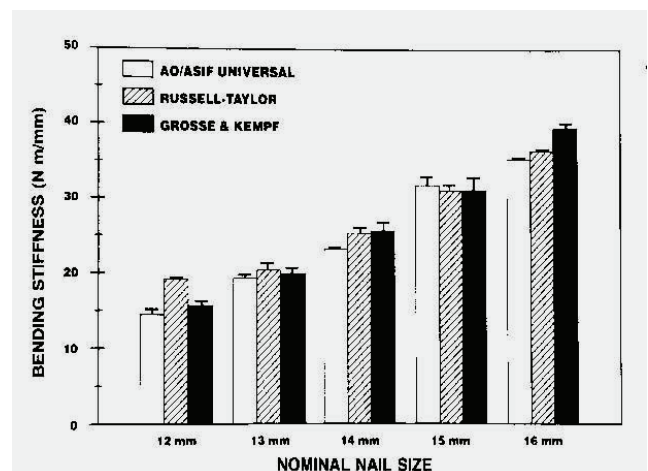
Figure from: Tencer *et al*, Biomechanics in Orthopaedic Trauma, Lippincott, 1994.

By increasing the nail diameter by a factor of 2 we greatly increased the 'strength' of the nail, reducing its chance of failure.
