University of Nairobi

**INVESTIGATION OF WELDING QUALITY IN THE  
KENYAN INFORMAL SECTOR (“JUAKALI-SECTOR”)**

**A thesis submitted in partial fulfillment for the Degree of Masters of  
Science in Nuclear Science of the University of Nairobi.**

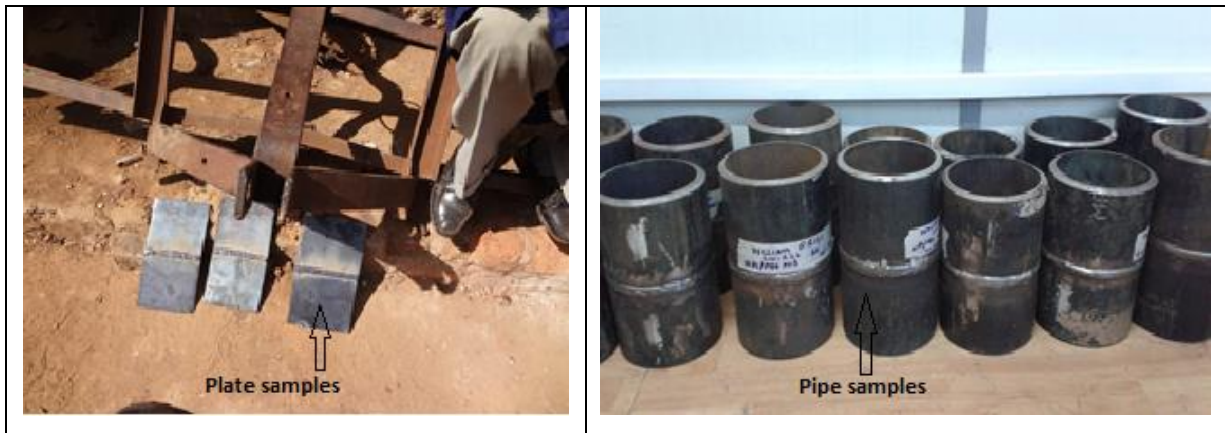
Figure 3.1: Plate and pipe test coupons analyzed

requirements. The test coupons were then taken to the laboratory for evaluation by visual, radiographic and tensile tests. SME test coupons on the other hand were sampled from welders who were applying for new welder certifications or re-certification at KEBS. These samples were prepared and analyzed following ASME IX guidelines. The entire process was similarly witnessed starting from the surface preparations and welding in the field. The SME coupons (92 plates and 18 pipes) were butt welded by the manual shielded-metal-arc-welding method. The samples were then taken to laboratory for visual and radiographic examination. The findings from JKS and SME were then compared. Figure 3.1 shows plate and pipe test coupons analyzed.

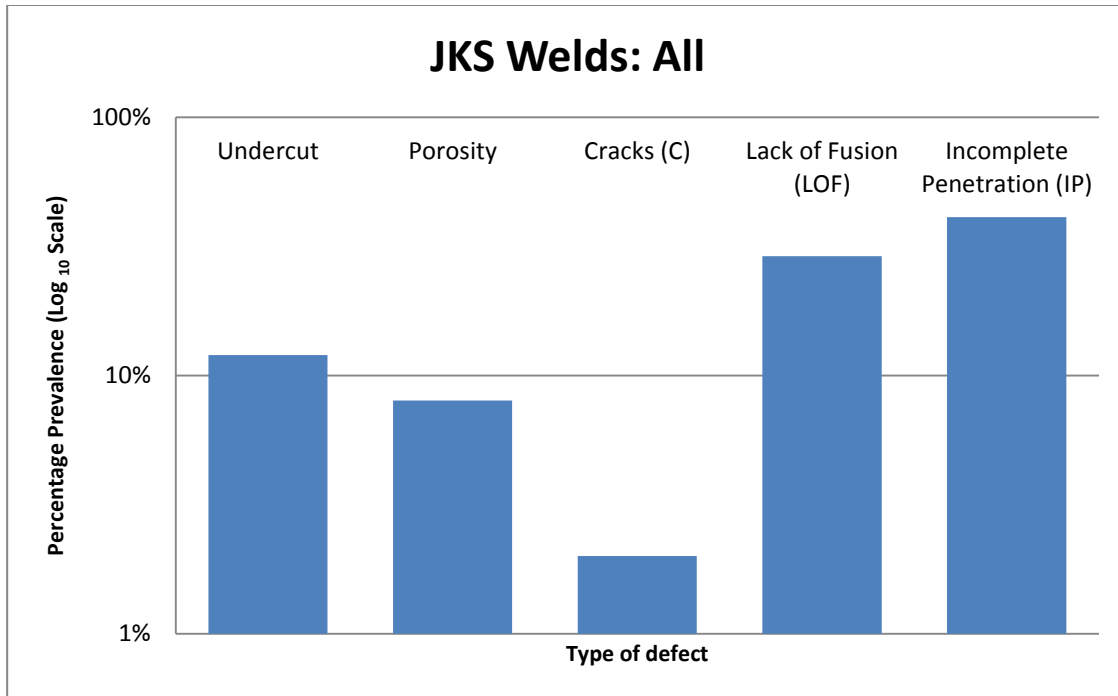
Figure 4.6: Overall defect prevalence in JKS samples

The “Juakali” welds subjected to visual and radiographic inspection were found to have the following dominant discontinuities; incomplete penetration (41 % of the samples), undercuts (12 %), porosity (8 %), lack of fusion (29 %) and cracks (2 %). Figure 4.6 shows graphically the overall defect prevalence in JKS samples.

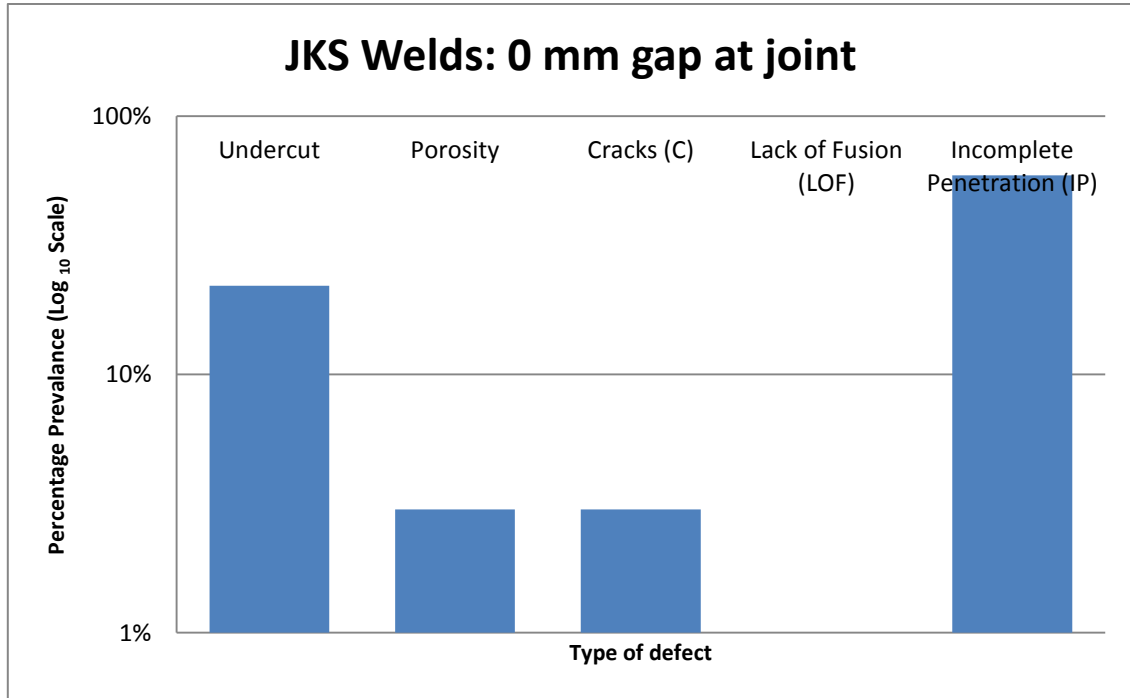
Figure 4.8: Defect prevalence on JKS samples with 0 mm gap at joint

Visual and radiographic inspection of the samples welded with 0 mm gap at joint revealed the presence of the following dominant flaws; incomplete penetration (59 % of the samples), undercuts (22 %), porosity (3 %) and cracks (3 %). Figure 4.8 shows a graphical presentation of defect prevalence on JKS samples with 0 mm gap at joint. When these samples were subjected to tensile tests, 55 % of them failed at the weld joints. Appendix 2 gives the detailed results for each of the samples. The high percentage of samples with

insufficient penetration was due to improper weld joint gap and was a common problem with a majority of “Juakali” welders. Undercuts were due to poor manipulation of the welding electrode. It was observed that most of the welds done in the “Juakali” sector are done with with 0 mm gap at joint and was the main reason for incomplete penetration defects.

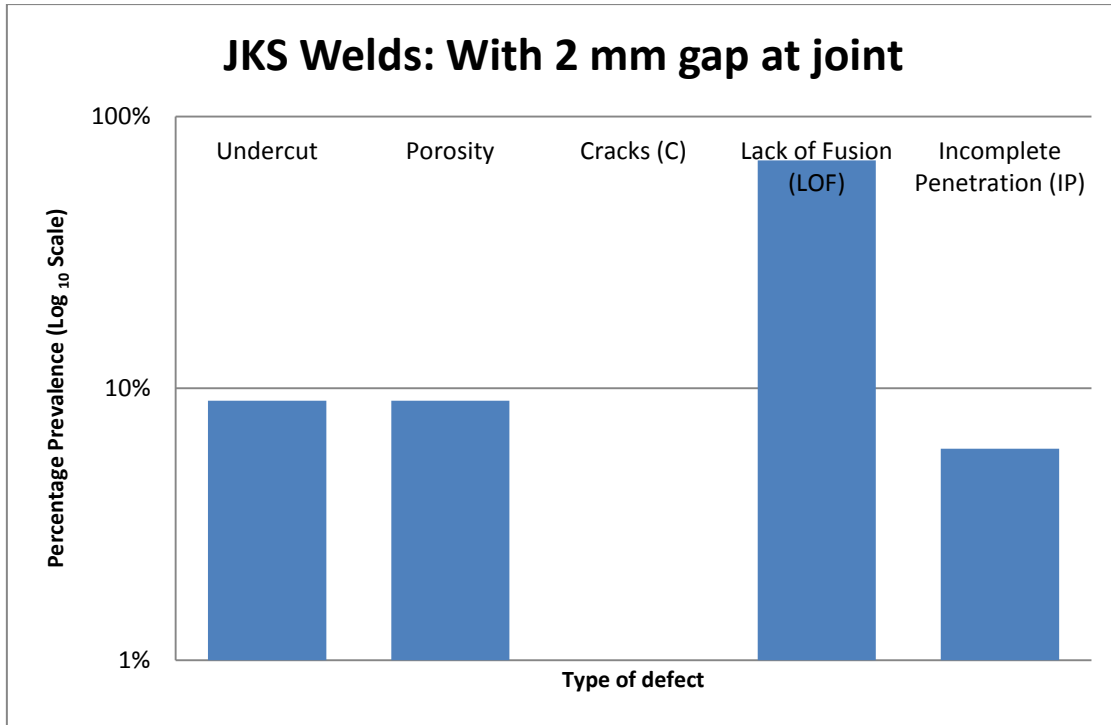
Figure 4.9: Defect prevalence on JKS samples with 2 mm gap at joint

For the samples welded with 2 mm gap at joint, the following flaws were observed upon visual and radiographic inspection; incomplete penetration (6 % of the samples), undercuts (9 %), porosity (9 %) and lack of fusion (69 %). Figure 4.9 graphically show the defect prevalence on JKS samples with 2 mm gap at joint. When subjected to tensile tests, 66 % of these samples failed on the weld joints. Appendix 3 gives the detailed results for each of the samples. The failure in tensile tests was attributed to lack of fusion which rose to 69 % up from 0 %. Lack of adequate skills and workmanship of welders on manipulation of welding electrode was observed when performing these welds on samples with 2 mm gap at joint. The difficulty observed here when welding 2 mm gap joint explains why “Juakali” welders preferred and did most of their welding by having no gap at the joint. The zero gap enabled

them achieve a nice looking weld at the surface but with no penetration through the entire thickness of part. With 2 mm gap at joint on the other hand they were able to achieve full penetration. However the welders lacked proper skills required to make proper weld joint when the gap was introduced hence leading to a lack of complete fusion at the joint.

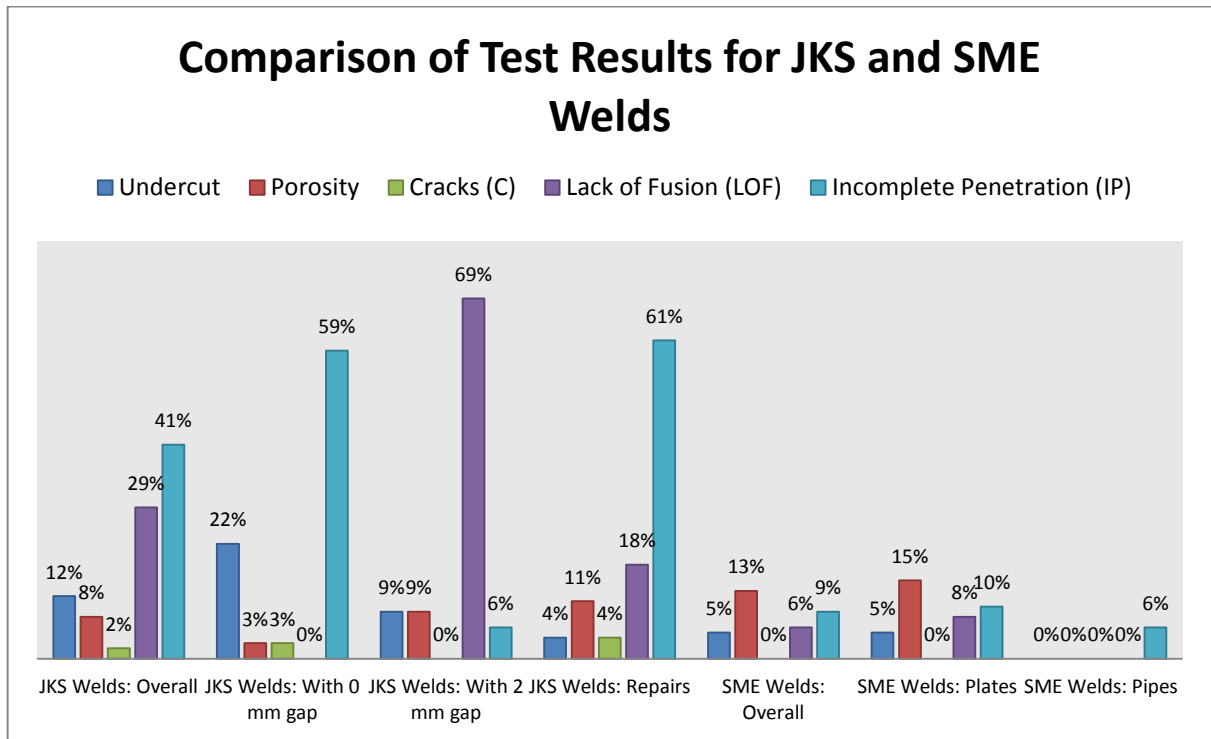
**Figure 4.15: Comparison of Test Results for JKS and SME Welds**
