**AN INVESTIGATION INTO THE IMPACT OF FAILURE IN THE
PLANNING PHASE OF MEGA INFRASTRUCTURE PROJECTS
(CASE STUDY: ROAD SAFETY ON THIKA SUPERHIGHWAY)**

**A Research Project Submitted In Partial Fulfillment of The Requirements for the Award
of the Degree of Master of Arts in Construction Management in the Department of Real
Estate and Construction Management, School of the Built Environment.**

JULY, 2015

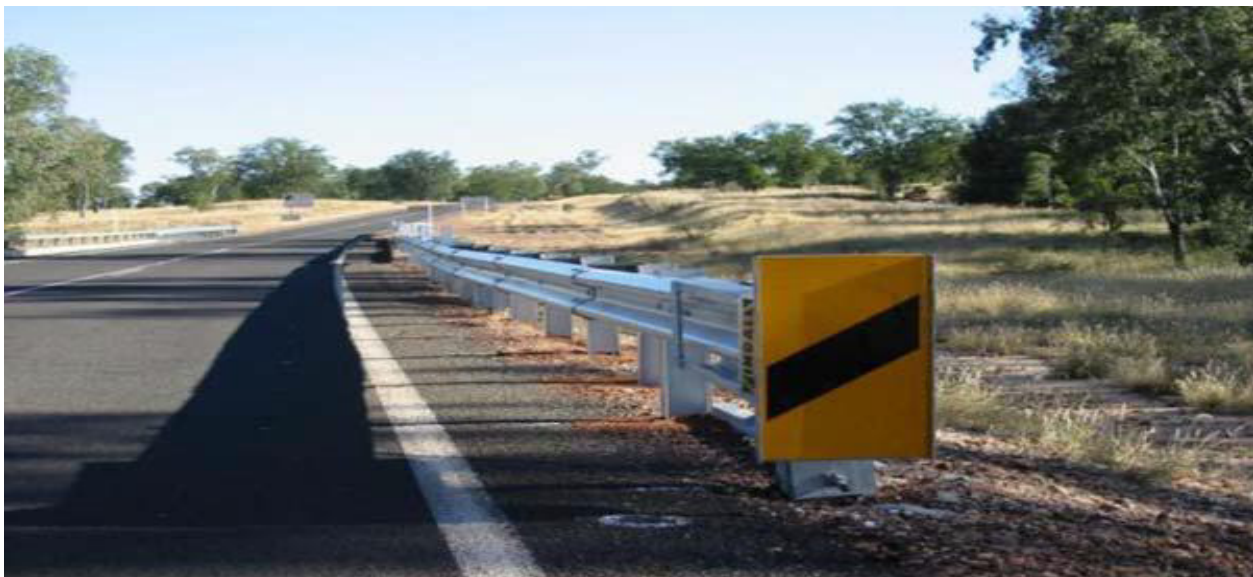
Plate 2.4 Extruder

According to Timcon (2012), the portion of a roadside protection system intended to prevent the barrier from spearing an errant vehicle on impact is called an end treatment. These generally apply to semi-rigid systems. Examples of end treatments are presented below.

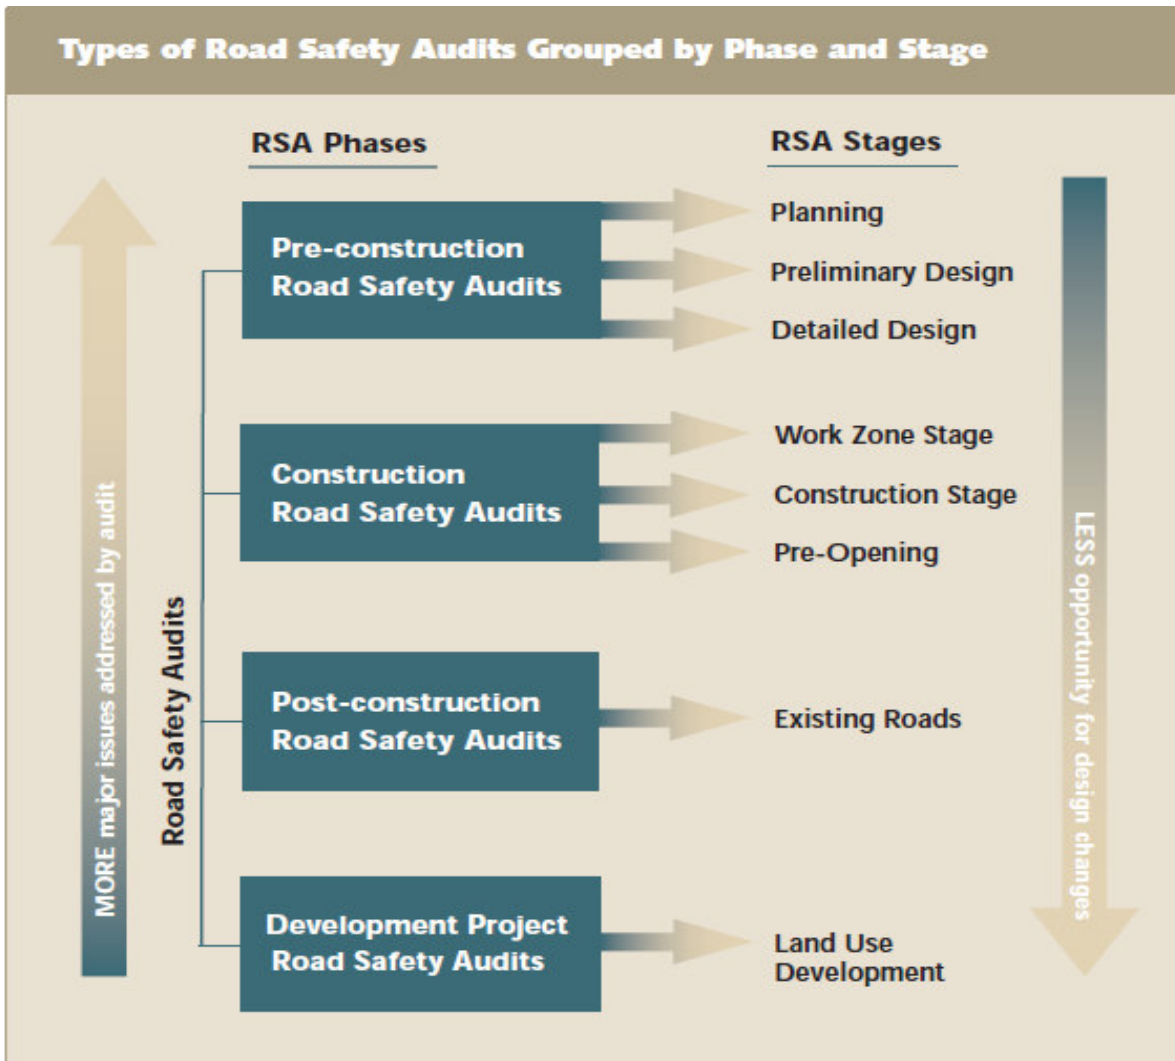
Figure 2.10 Types of Road Safety Audits Grouped by Phase and Stage

Figure 2.10 illustrates a method of grouping RSAs by phase (pre-construction, construction, and post-construction) and by stage (planning, preliminary design, etc.). An overview of each RSA phase and stage follows.

55% and 54% of the respondents from KeNHA and APEC respectively who had indicated that road safety audits had been considered during the planning phase stated that they had been given the highest consideration during the pre-opening phase with the least consideration being at the planning phase. Road safety audits were not considered important during the planning phase due to the perception that this was the preliminary phase of the project with “no major issues” to be tackled. Road safety audits at the pre-opening phase even though given the highest priority during the planning phase present less opportunities for design changes hence compromising the safety of road users. See Figure 2.10 on page 65.

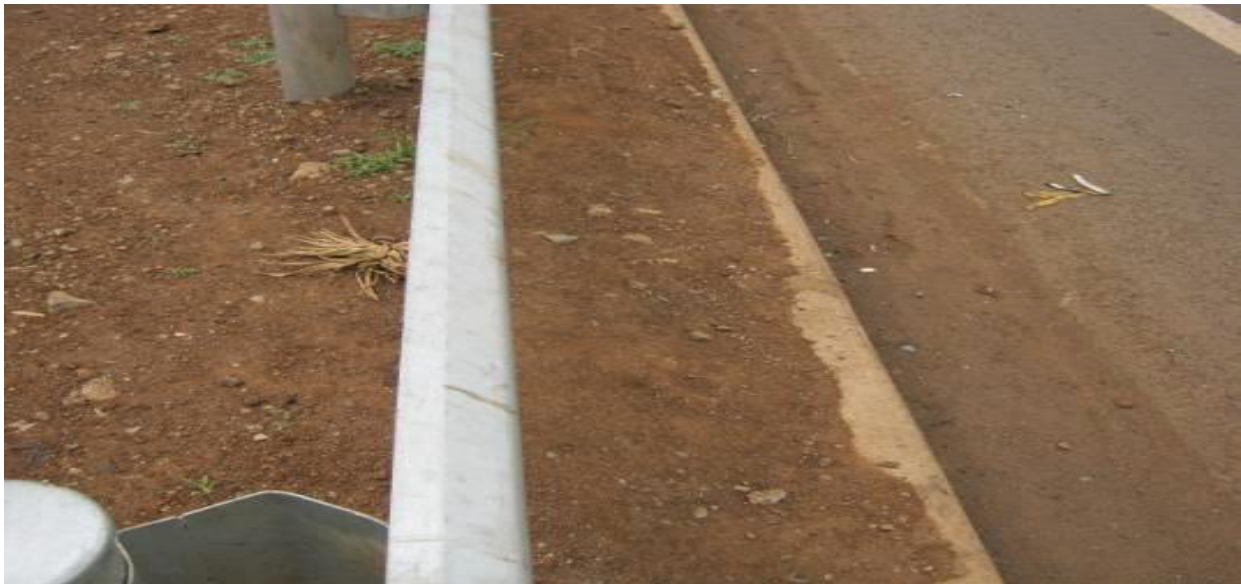
Plate 4.1 Guard rails not installed adequately

Spacing provided between the face of the guard rail and the face of the curb is larger than 0.2m, a vehicle hitting the curb will be projected into the air and will not hit the guard rail at the proper height or angle.

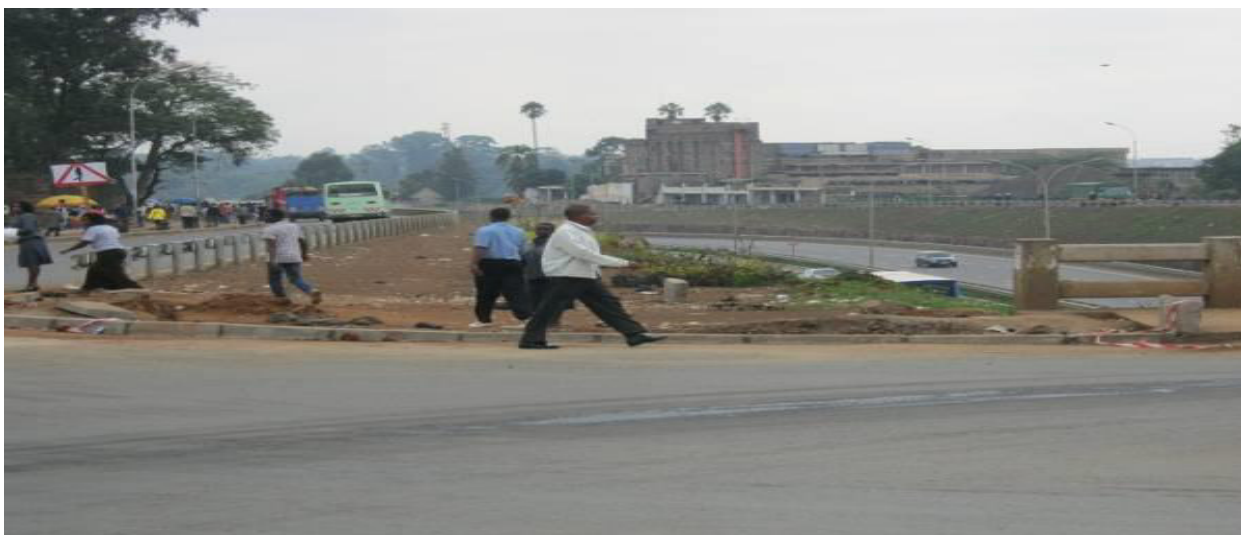
Plate 4.2 No guard rail installed on the overpass bridge approach

No guard rail installed on the overpass bridge approach (bridge on Museum Road ramp) in case of loss of control, the vehicle will end up on the underpass.

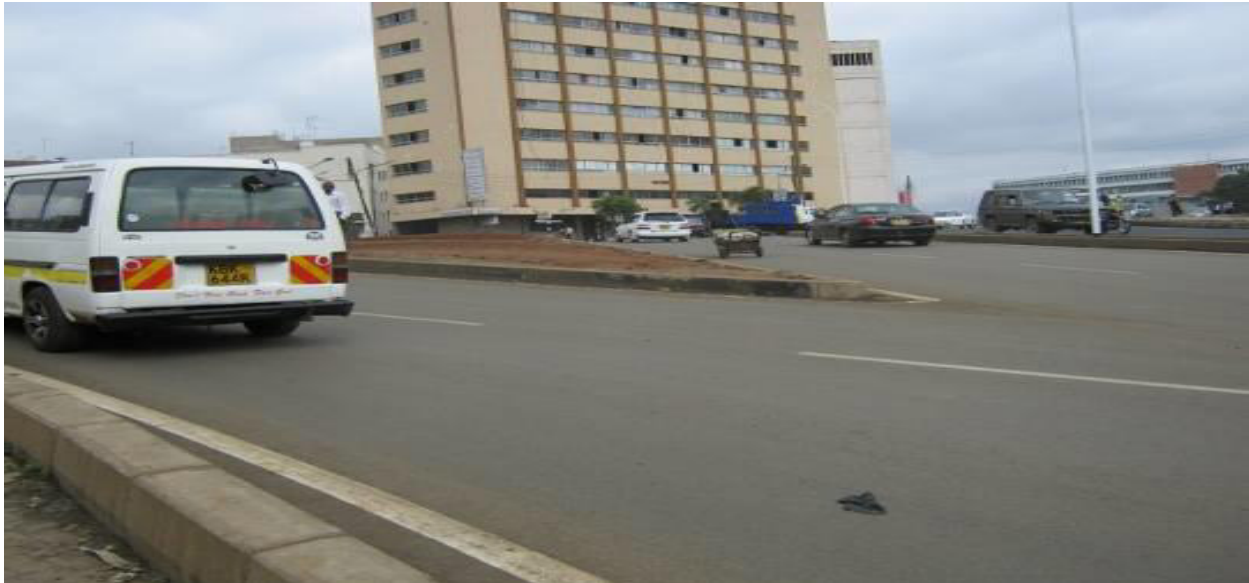
Plate 4.3 No end treatment in gore area

The “gore”, which is the area at the beginning of the divergent island, must be protected as it is an opportunity for a vehicle to hit the curb and overturn on high speed road.

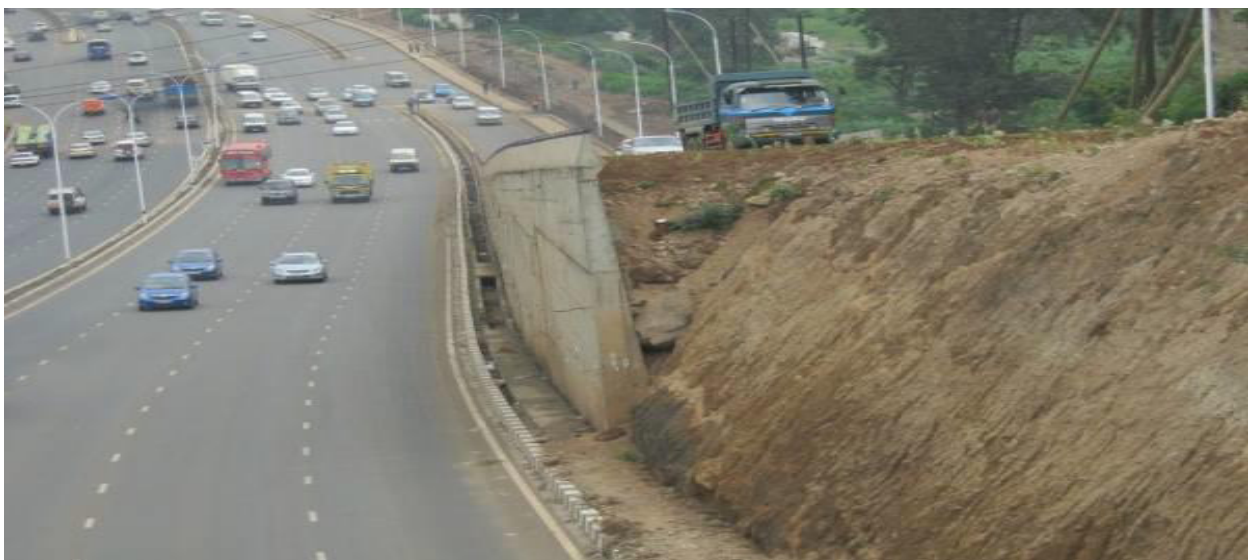
Plate 4.4 Clear zone

Steep slopes not protected by guard rail, vehicles may fall. This situation violates the concept of the “clear zone”. There must be sufficient space beside a road to allow a driver to make an error, run slightly off the road and recover without striking an object or the terrain causing the driver to lose control. This bridge abutment was a serious hazard which was too close to the road. The curbing was not sufficient to deflect an errant vehicle back away from the abutment.

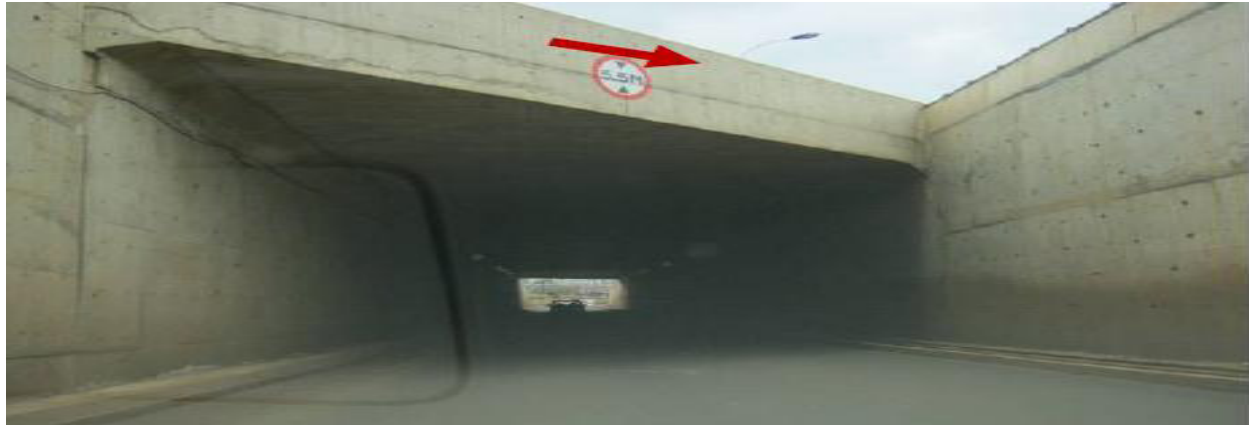
Plate 4.8 Materials used for signs

darkness in tunnels created temporary loss of sight. Situation exacerbated by the fact that few vehicles have head lights functioning during daytime. This meant that there was increased risk of rear-end collisions and/or impacts to the wall.

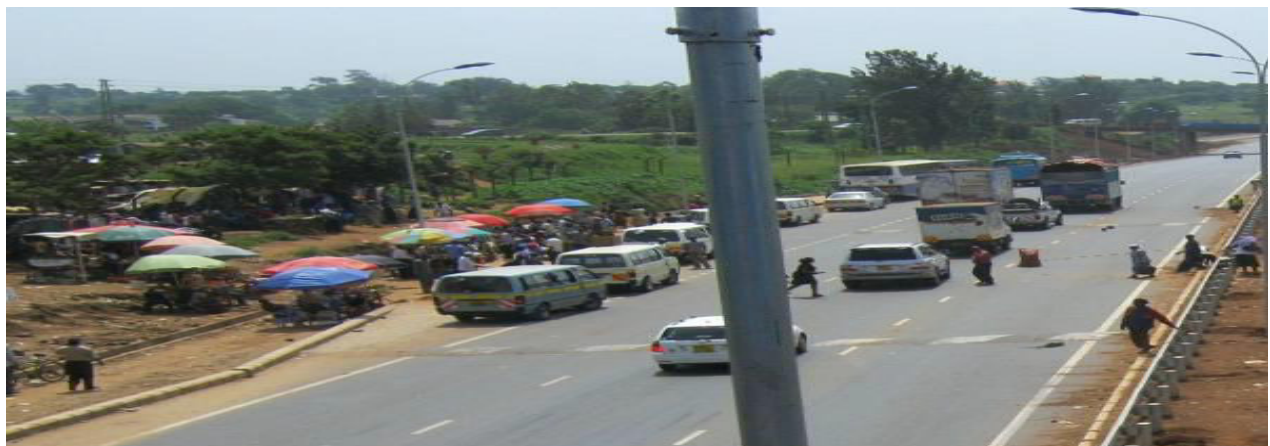
Plate 4.9 Speed humps on carriageway

For road markings and road appurtenances, drivers were not informed in time of the presence of traffic calming measures (no signs). Speed humps are not typically used on higher speed roadways. Understanding that there may be a particular need in some locations chosen, this still means that the speed humps should be signed both at the hump and in advance, as well as be marked with pavement markings. Broken line pavement markings painted on carriageway indicate that passing was permitted in high speed locations and where sight distance was limited.

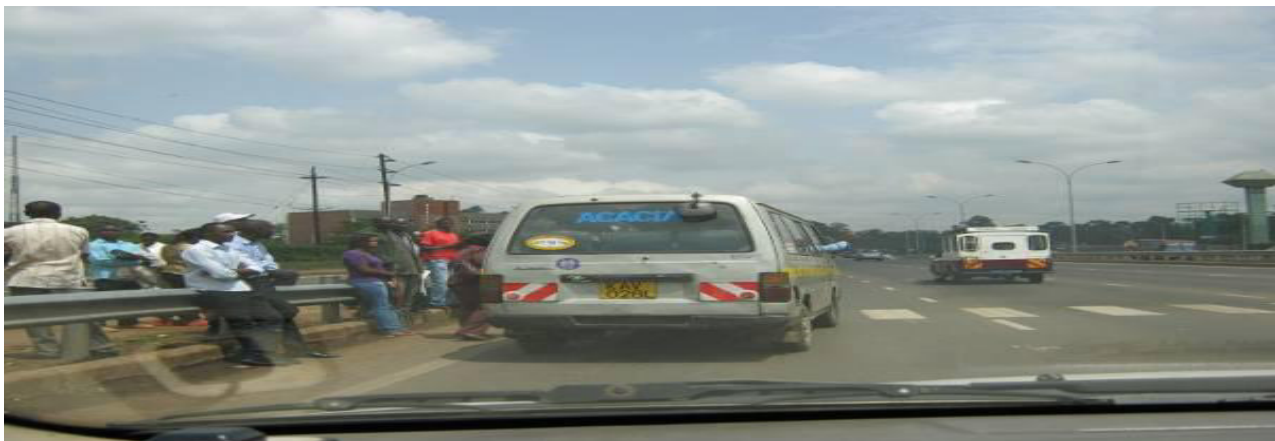
Plate 4.10 Buses stopping on the main carriageway

Public transport users had not been provided with bus stops or the bus stops were located far from where pedestrians were coming from hence transit users stood a few hundreds of metres from the bus stops. The bus stops had also not been provided with adequate space hence forcing buses and matatus to stop on the carriage way when passengers were boarding and alighting from them. There were also not enough wayside amenities along the highway like petrol stations and repair centres and also there were no provisions for cars that broke down or ran out of fuel. This posed safety hazard where the car that had broken down could easily be run over by a vehicle travelling at high speed. Construction of sidewalks and pedestrian elevated structures such as cycle lanes and footbridges was delayed until the opening of the carriageway and interchanges affecting pedestrian safety.

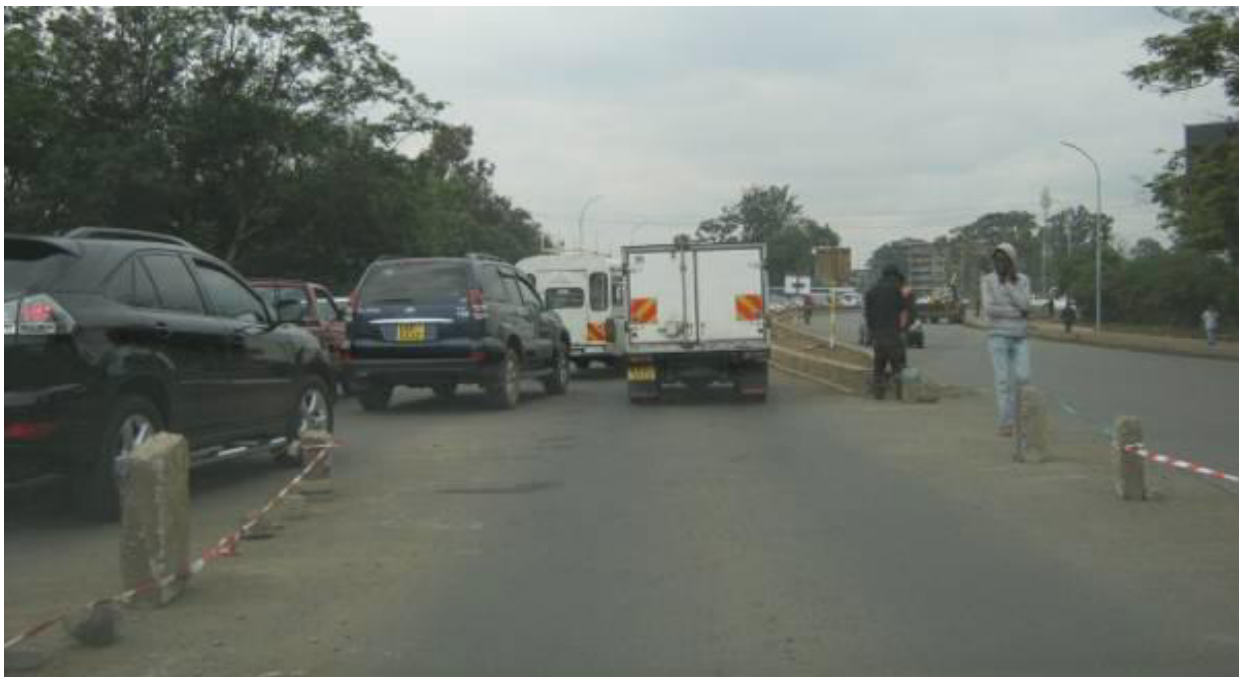
Plate 4.11 Closure and guiding of vehicles

Bricks and stones used to guide drivers (exit of flyover towards Kariakor Road)

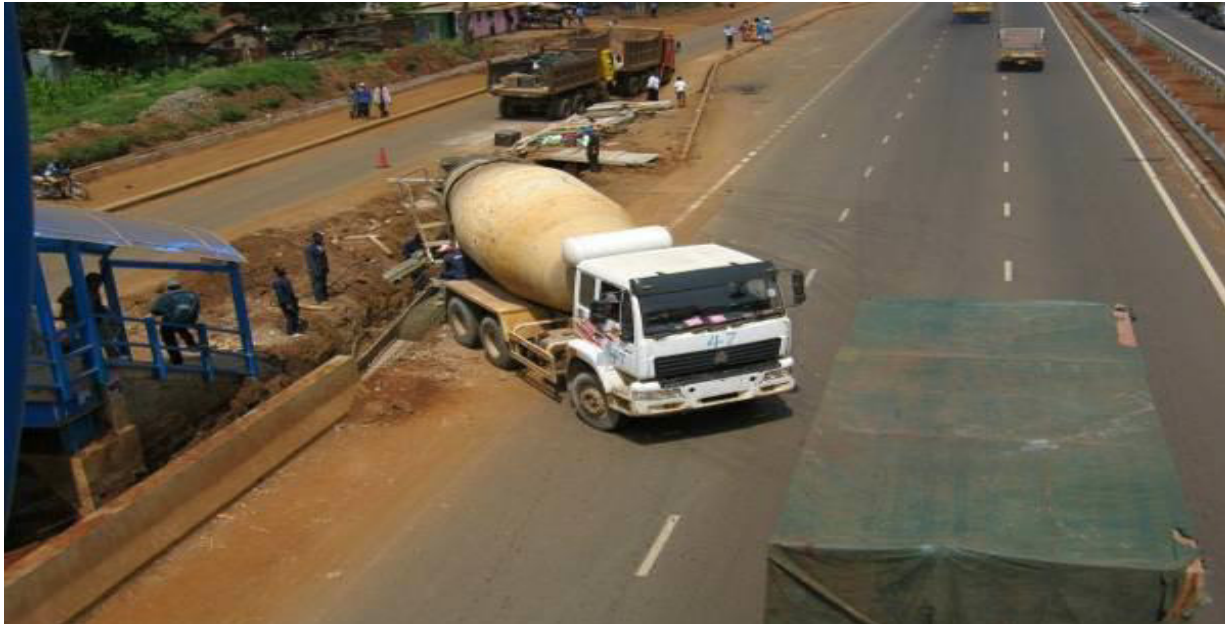
Plate 4.12 Signage in work zone

No signage in work zone to increase conspicuity of work zone. Work zones were not signed sufficiently in advance to allow drivers to adjust their speed and change lane in the presence of obstructed lanes and workers on the roadway.

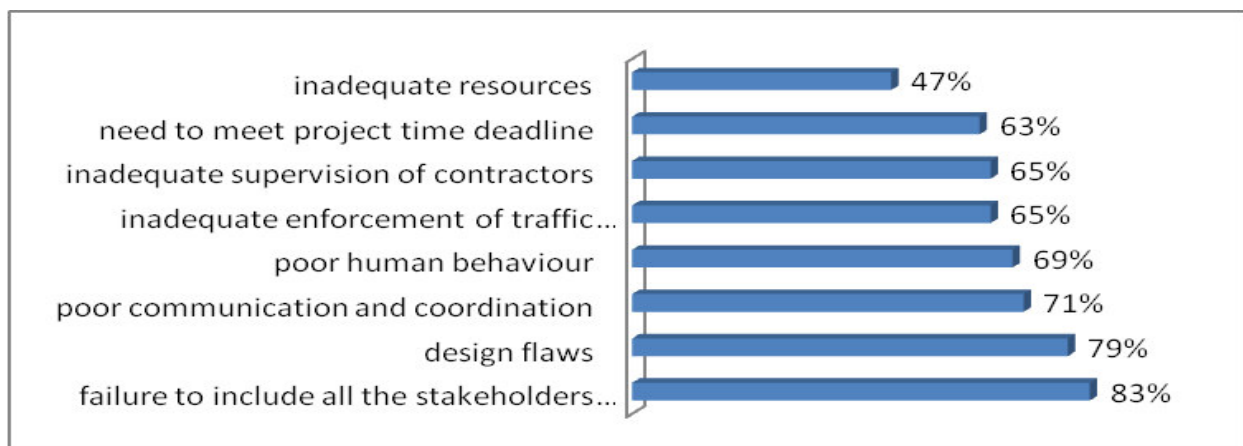
Figure 4.32 Reasons for lack of safety

The failure to include all the stakeholders during the planning phase of the project was cited as the main reason for lack of safety at 83%. The different stakeholders for example the residents did not get the opportunity to give their views and opinions about their safety and this contributed to the design not incorporating their safety requirements also where safety measures were implemented they did not match the road users' safety requirements. For example, bus stops were located far from where people were coming from hence forcing passengers to board and alight at non designated areas hence exposing them to accidents. Some footbridges were constructed in areas where there was low human traffic for example next to Mang'u high school while at Juja pedestrians and vehicles had to share the same overpass while crossing from one side of the road to the other. The involvement of all the stakeholders could have ensured that the road users' requirements were taken into consideration and incorporated into the design of the project and also road users could have adopted the right attitude towards the project in as far as their safety was concerned.

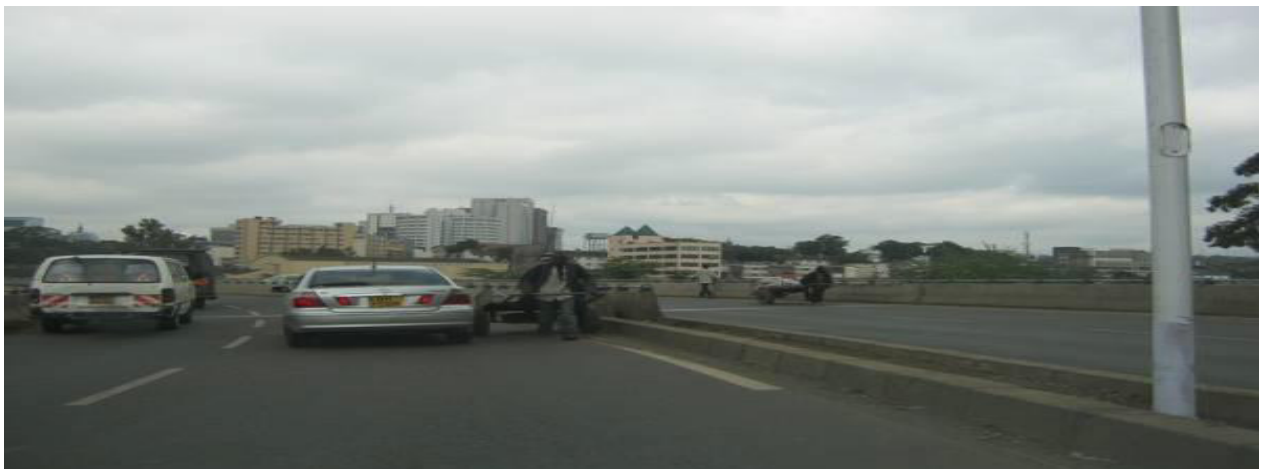
Plate 4.17 Carts present on carriageway

No sidewalk provided for pedestrians along the service road forcing the pedestrians to use the service road. Carts present on the carriageway since no path has been provided for them.

The various challenges faced by the project implementers are an indication of failure by the planners to consider road safety during the planning phase of the project. Poor human behavior for example could have been avoided by carrying out public participation and stakeholders engagement right at the planning phase of the project. This could have ensured the road users especially the local residents ‘owned’ the project thereby reducing incidences of vandalism of
