**REMOTE SENSING AND GIS USAGE IN
MAPPING VULNERABLE LANDSLIDE AREAS
IN MURANG'A COUNTY, KENYA**

A PROJECT REPORT

Submitted to the Department of Geology and the School of Physical Sciences in
partial fulfilment for the award of the Postgraduate Diploma in Natural and
Environmental Disaster Management

UNIVERSITY OF NAIROBI

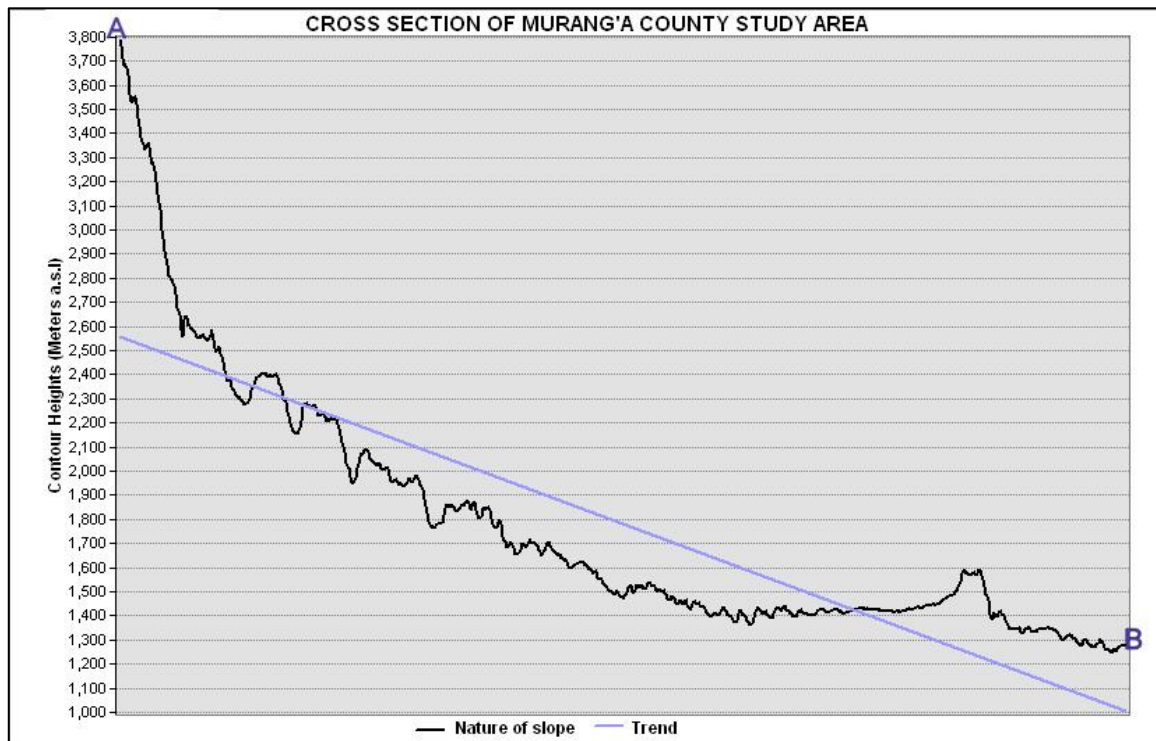
Figure 4.4b: Results of cross section done over Murang'a County

From the cross section above, we can observe that the terrain where the trend line cuts i.e. section identified by slope contours ranging from 1400m to 2400m, is highly rugged especially to the western side to which the land rises. This is also the section where all the landslides recorded and mapped above have been experienced.

From these observations it is evident that slope failure likelihood is very high at this region which when combined with other instability factors such as heavy rainfall and little steep slope disturbance either by ground tremors or human activities such as farming and constructions, will highly increase the propensity of landslide occurrences.

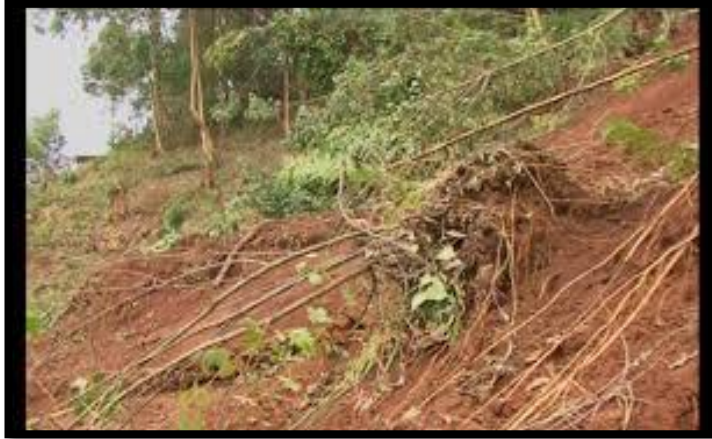
Image 1: landslide which swept away a house in Kahuro village in Murang'a district. The mudslide is said to have occurred after nightlong rains.

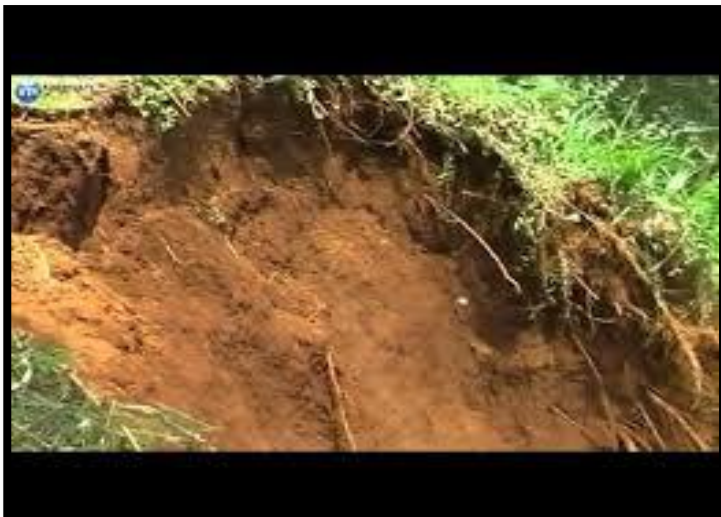
Image 2: The havoc El Nino rain caused in Murang'a with heavy rains and landslides; A 13 year-old girl died in the mud as a landslide hit her home in the area, destroying her home on 03/11/2009. Source; <http://www.demotix.com/news/el-nino-rain-cause-havoc-kenya#media-172030>

losing their coherence. This then results to occurrences of slides which can take different forms e.g. mudflow, debris flows and slump-earthflows (Appendix 7.2; image 2, 4 and 5).

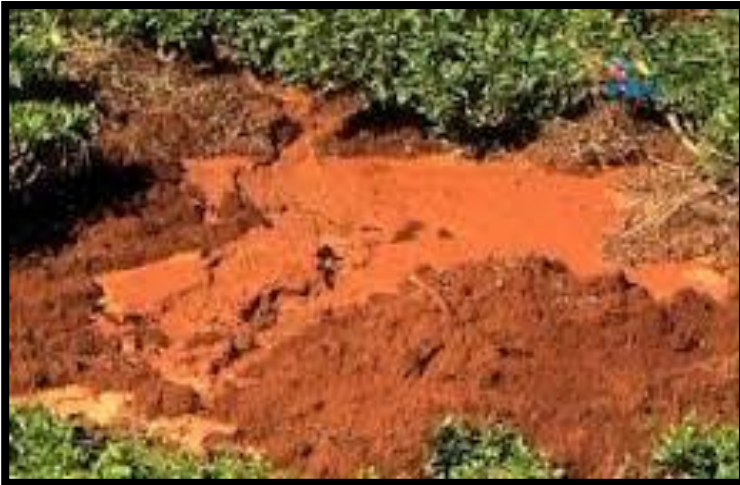
Image 4: a landslide which has swept away a tea farm in Gathaiti location of Murang'a District, barely a month after a woman perished in a similar incident. Posted on Fri, 25 Dec 2009 03:34:47 -0800 by NTV Kenya <http://www.ntv.co.ke> Source; <http://article.wn.com/view/2011/08/01/>

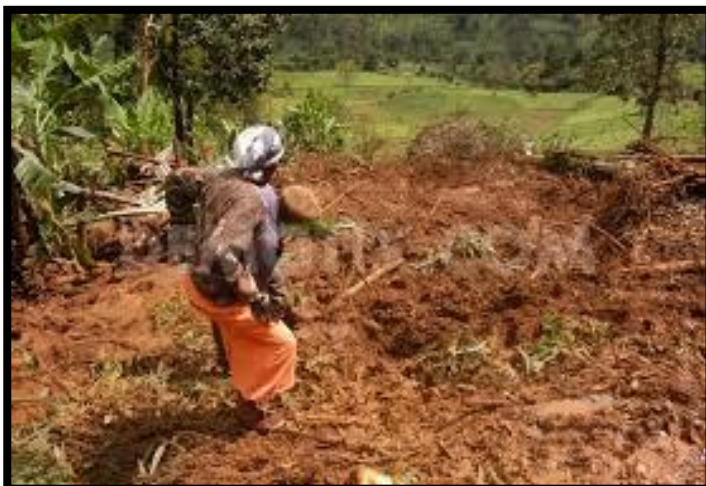
Image 5: The havoc El Nino rain caused in Murang'a with heavy rains and landslides 03/11/2009. Source; <http://www.demotix.com/news/el-nino-rain-cause-havoc-kenya#media-172030>
