**WORKMANSHIP IN CONSTRUCTION OF SMALL AND MEDIUM
HOSPITALITY ENTERPRISES IN NAIROBI CENTRAL BUSINESS
DISTRICT**

**A RESEARCH PROJECT SUBMITTED IN PARTIAL FULFILLMENT OF
THE REQUIREMENTS FOR THE AWARD OF MASTER OF
ARCHITECTURE, SCHOOL OF THE BUILT ENVIRONMENT,
UNIVERSITY OF NAIROBI**

2016

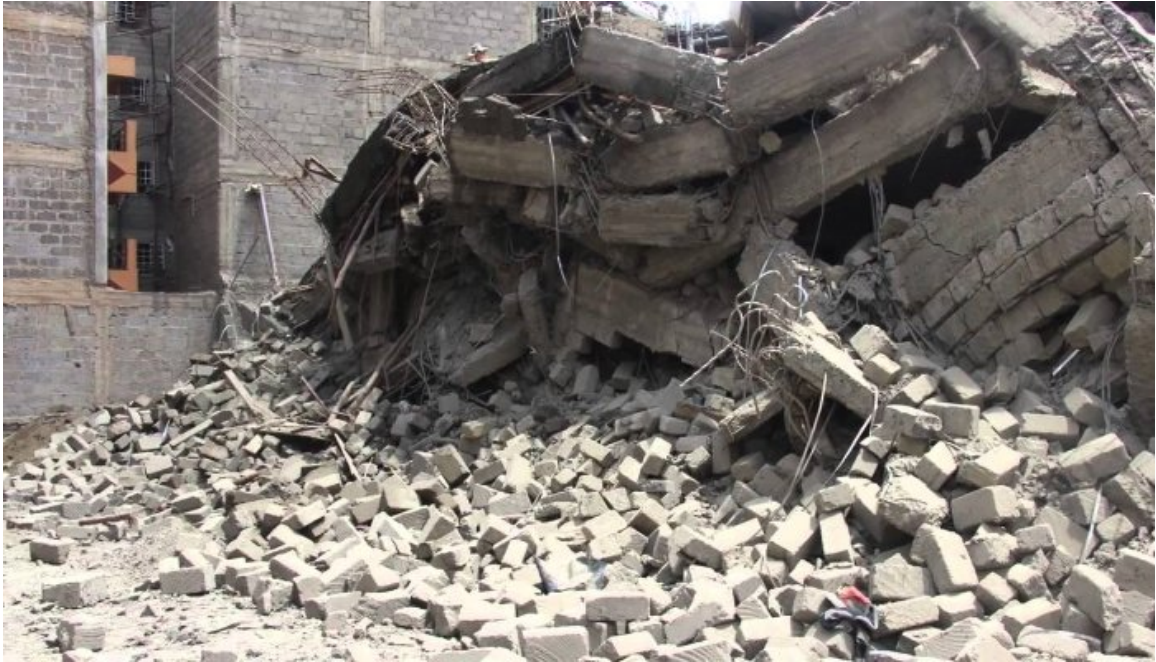
Figure 1.1 Collapsed Building in Nairobi

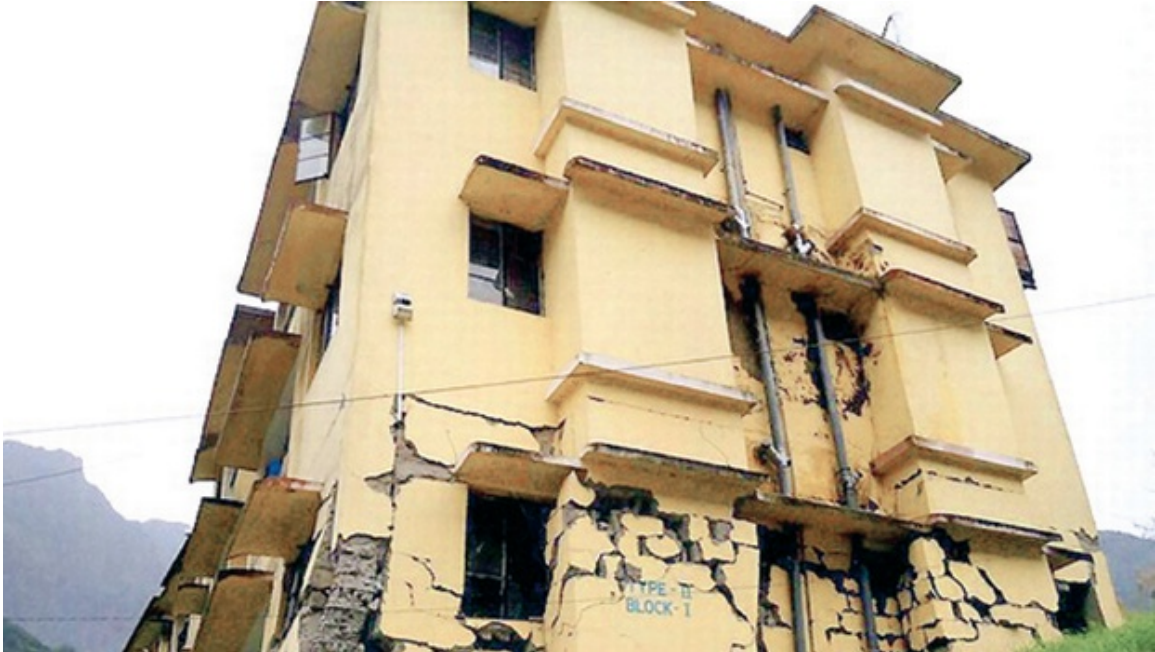
Figure 2.1: Cracks caused by faulty foundation

Settlement in a structure refers to the distortion or disruption of parts of a building due to either unequal compression of its foundation, shrinkage such as that which occurs in timber framed buildings as the frame adjusts its moisture content, or by undue loads being applied to the building after its initial construction. The other defect is deterioration of roofing systems. The roofing system in a building contains many components, such as framing, plywood decking, felt underlayment, sheet metal flashing, tiles and other exterior roofing materials. Construction defects in roofing systems can cause damage to personal property in a home or building, and also to the interior framing members, ceilings, drywalls, and paint by allowing water into the building. Common roofing system construction defects are broken roof tiles, damaged framing, exposed or damaged felt, improper flashing, and loose tiles. A

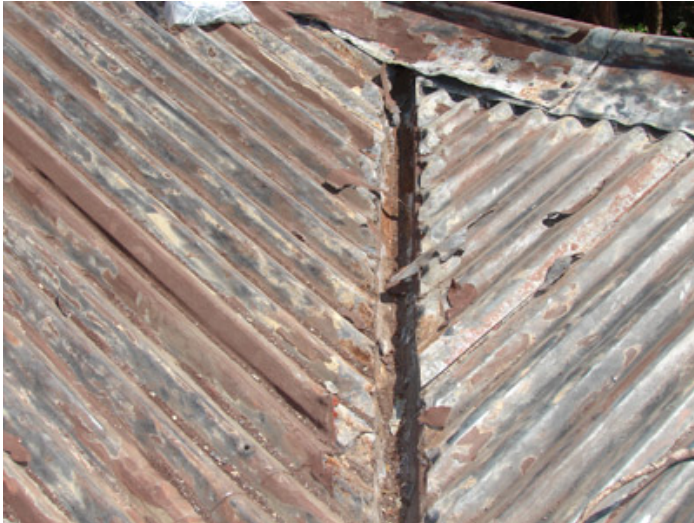
Figure 2.2: Corrosion of roofing iron sheets causing leaks

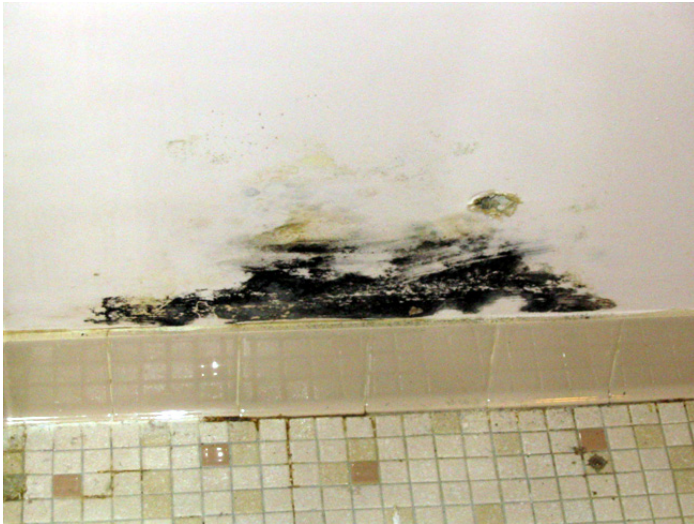
Internal staining, mold growth and fungal on external wall defects occur if there is a water intrusion. The presence of mold on a wall of a building can affect occupants' health. Once discovered, mold infestation should be remedied immediately in an effort made to minimize the possibility of health issues. Dampness can also occur. Damp is defined as unwanted water or moisture and its existence in buildings is one of the most damaging failures that can occur. It can cause damage in brickwork or masonry by saturating it, decay and break-up of mortar joints, rotting of timber structures, corrosion of iron and steel and damage to building equipment (Betts, 1999).

Figure 2.3: Black mold in wall

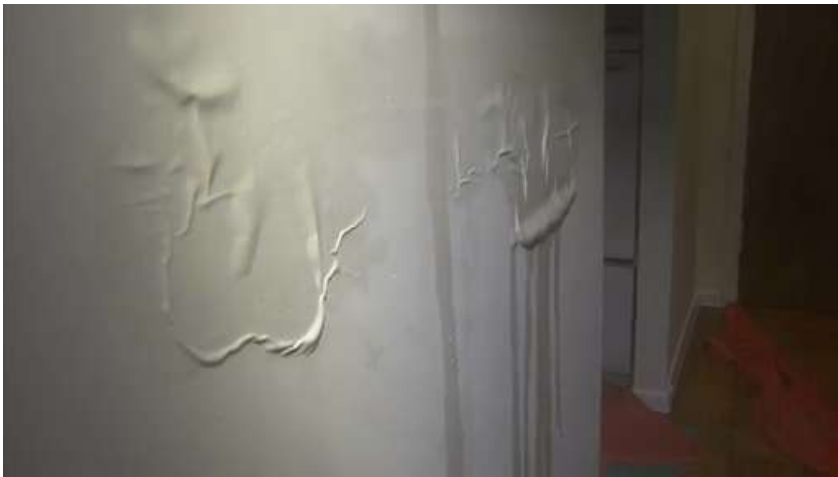
Peeling paint usually occurs on building facades, mainly on plastered walls, columns and other areas that are exposed to excessive rain and dampness. The amount of constant wind, rain and sun received can easily turn the surfaces of the paint to become chalky and wrinkled or blistered. This problem can become worse if the paint used during construction is of low quality and mixed with excessive amount of water. Leaking is another defect. Leaking is water that seeps out from behind walls, under concrete slabs and asphalts, basements, landscaping, water intrusion in roofs, irrigation systems, and radiant heat system. Leaking mostly happens due to improper installation of piping systems that can cause dampness and mold growth (Zunguzane et al., 2012).

Figure 2.4: Peeling paint due to water leakage

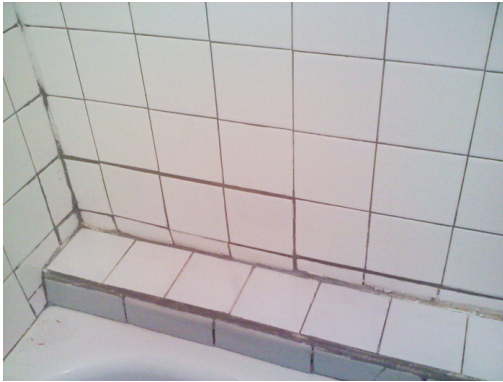
Figure 4.1: Uneven spacing between tiles

The tiles are not in line and have unequal spacing between them. In some cases, the tiles were fixed with wrong adhesives resulting in falling of wall tiles or loosening of floor tiles. In many of the areas studied, the tiles were hollow underneath indicating that not enough adhesive was used.

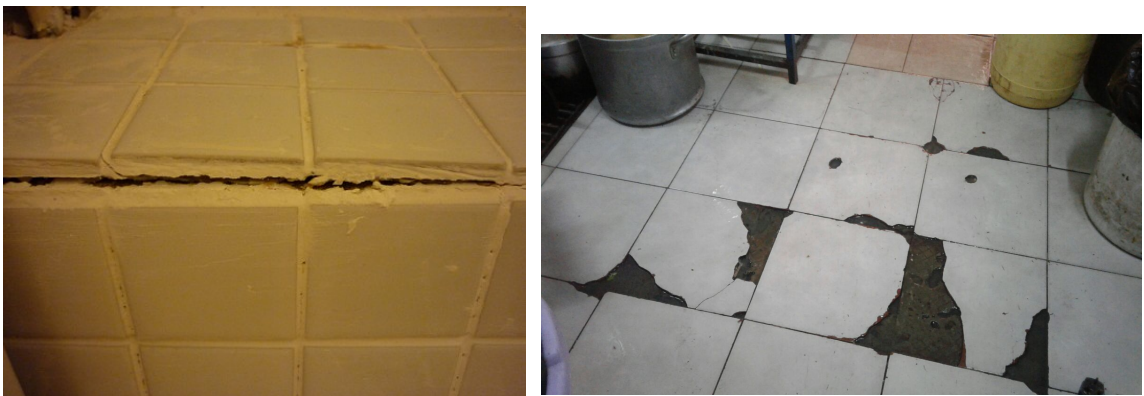
Figure 4.2: Loose Tiles

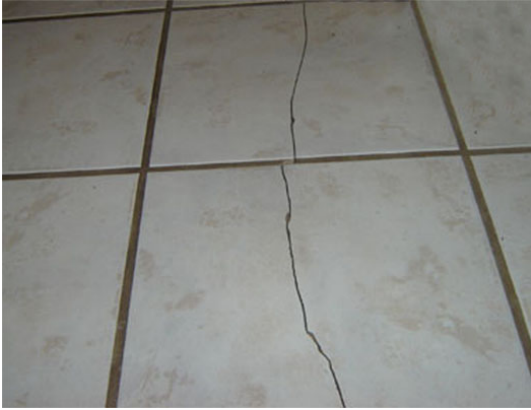
Figure 4.3: Cracks on tiles

Cracked tiles on both floors and walls indicated structural defects that may have resulted due to settlement of the buildings or poor concrete or mortar mixes.

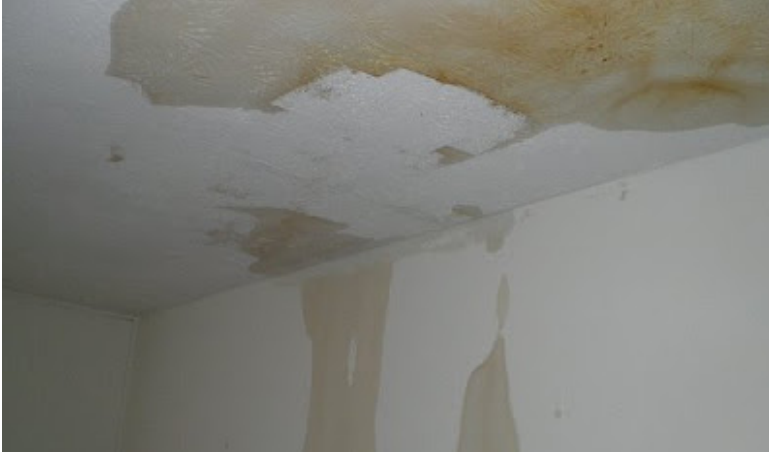
Figure 4.4: Leaks on ceilings and walls

Leaks from poor plumbing works or rainwater stain many interiors. In many cases the sources of the leaks were not easily traceable and the stains would take very long before they were repaired.

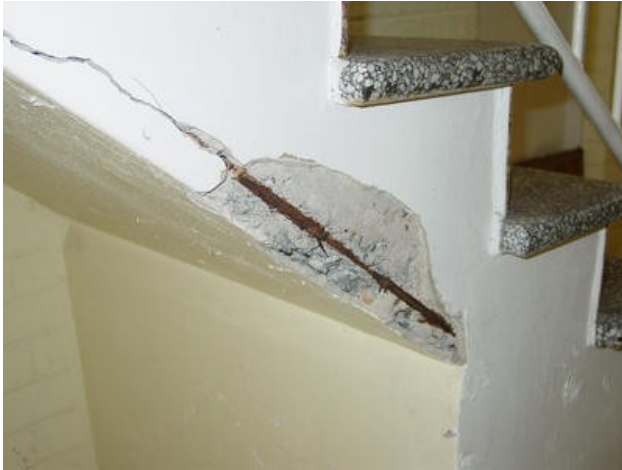
Figure 4.5: Exposed reinforcement bars

Exposed reinforcement bars on staircases and other structural members in buildings.

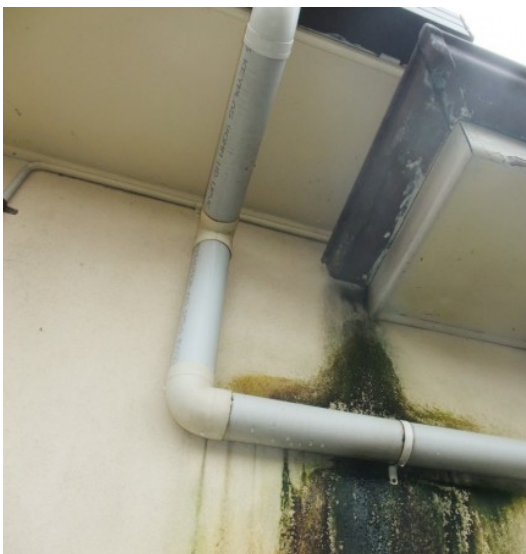
Figure 4.6: Leaking gutters & downpipes

Poorly built and constructed gutters and downpipes cause leaks and molding in many restaurants and hotels.

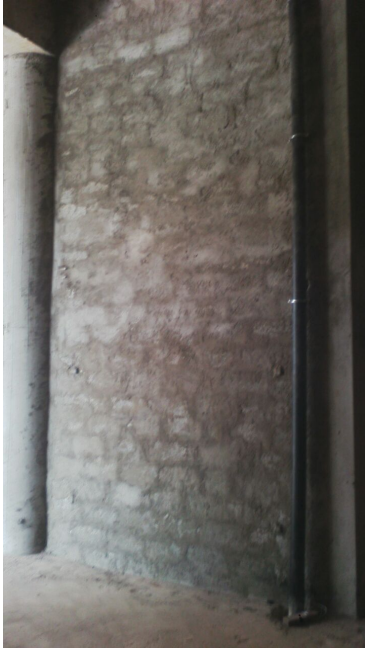
Figure 4.7: Gutters placed within shop space

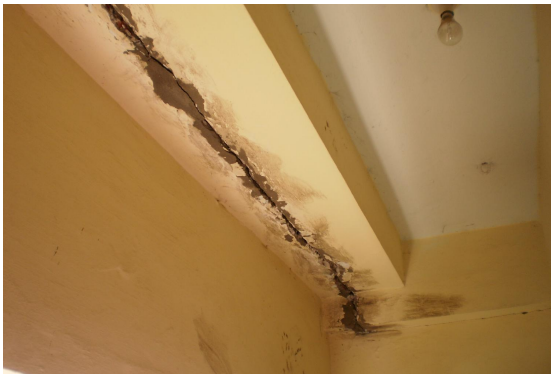
Figure 4.8: Wall Cracks

Cracks in some parts of the buildings looked dangerous. In some cases, unsuccessful repairs were attempted.

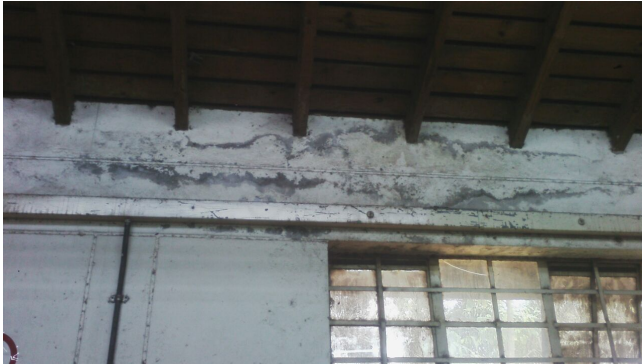
Figure 4.9: Leaking through walls

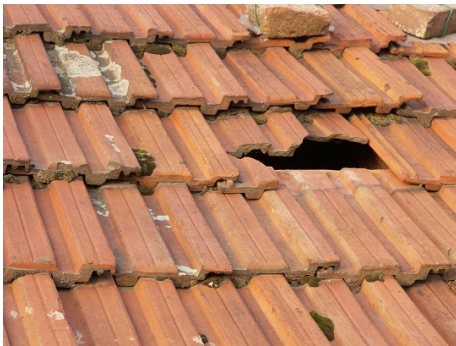
Figure 4.10: Poorly constructed and maintained roofs

Poorly maintained roofs were common. These led to leaks within the buildings.

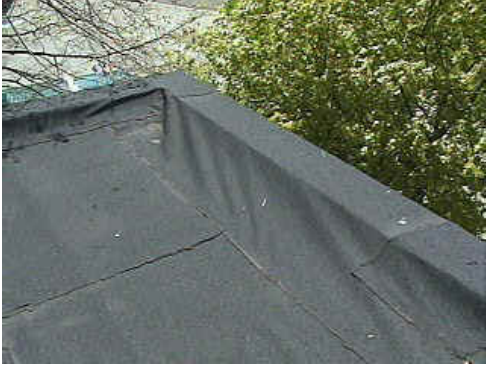
Figure 4.11: Poorly constructed roofs

Waterproofing membrane fitted too tightly tears easily, causing leaks from rain water.

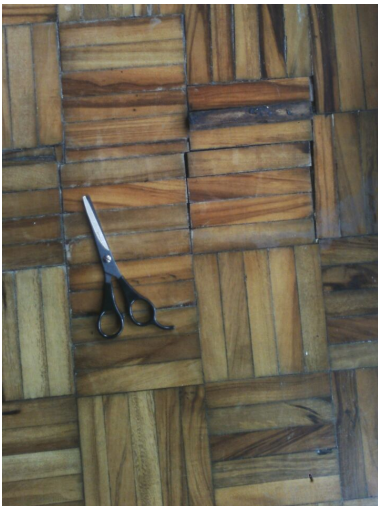
Figure 4.12: Parquet flooring damaged by leaks.

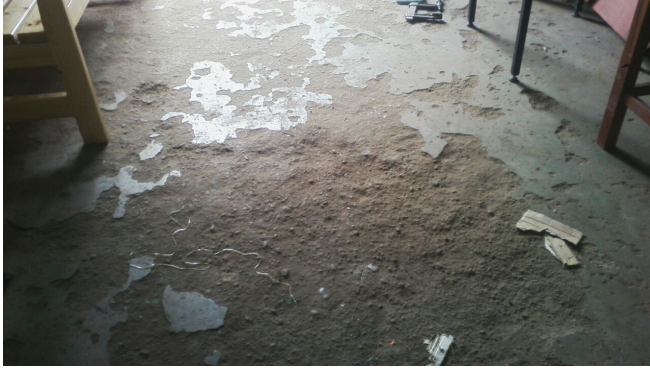
Figure 4.13: Loose floor screed and finish.
