UNIVERSITY OF NAIROBI

**EVALUATION OF EFFECTIVENESS OF NON DESTRUCTIVE TESTING
TECHNIQUES FOR INSPECTION OF CRITICAL AIRCRAFT COMPONENTS:
A CASE OF THE KENYAN AVIATION INDUSTRY**

A thesis submitted to the Graduate School in partial fulfillment of the requirements for the award
of Master of Science degree in Nuclear Science of the University of Nairobi

January 2020

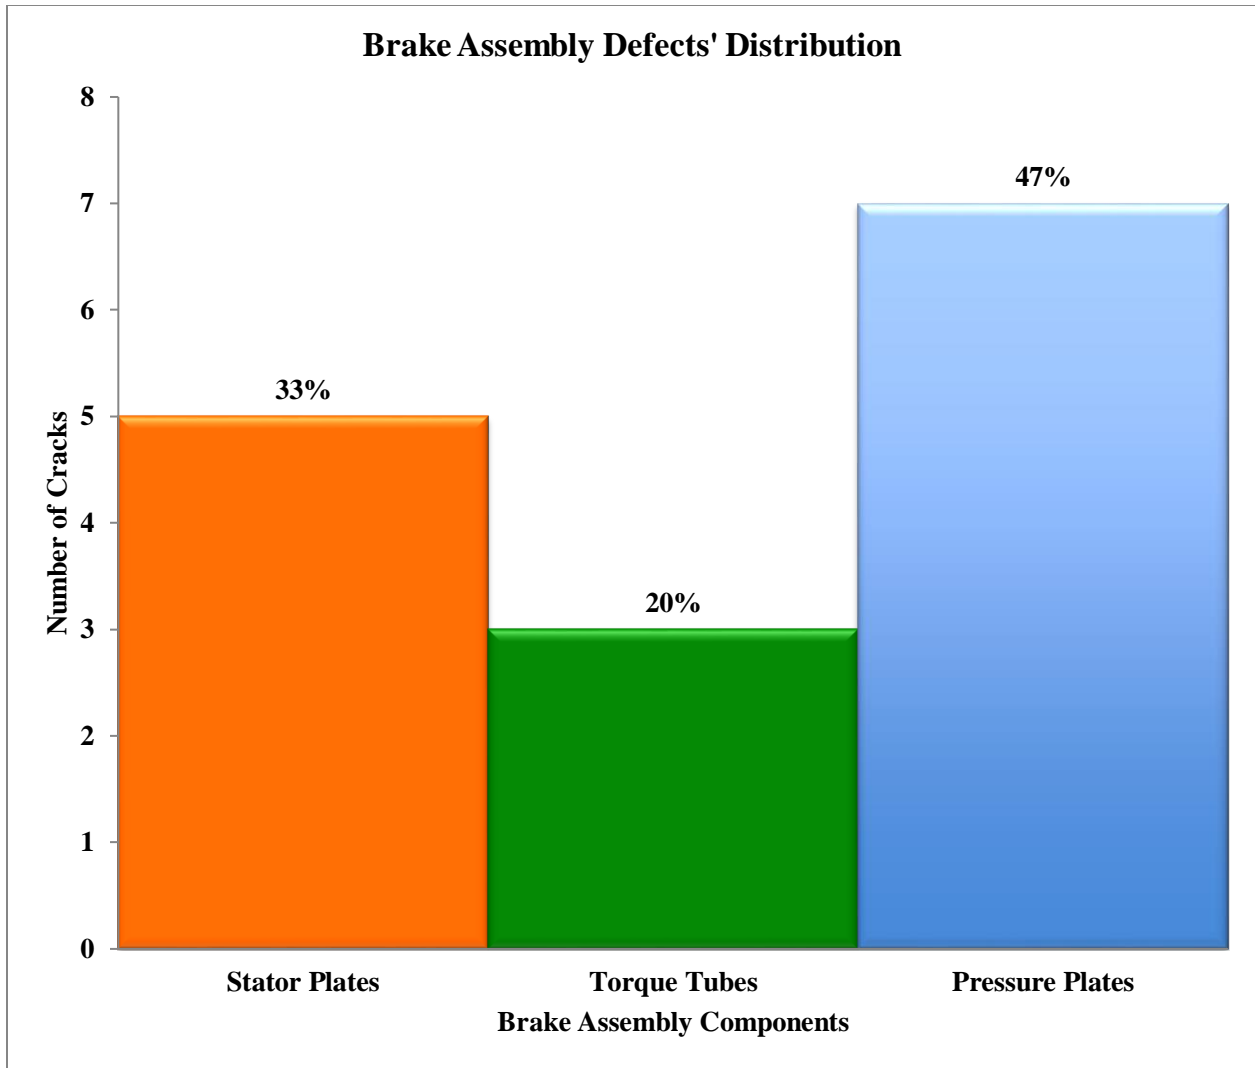
Figure 4.1: Distribution of Cracks in Brake Assembly Components.

The aircraft components were inspected using MPI method in accordance with aircraft technical manuals. Overall, the brake assembly components inspected, had fifteen (15) crack defects varying between 1.9 mm - 14.8 mm, of which, the Stator Plates had 33%, Torque Tube 20% while Pressure Plates had 47% of brake assembly defects. The high occurrence of cracks in the pressure plates is attributed to the nature of operation of the aircraft braking system during landing phase.

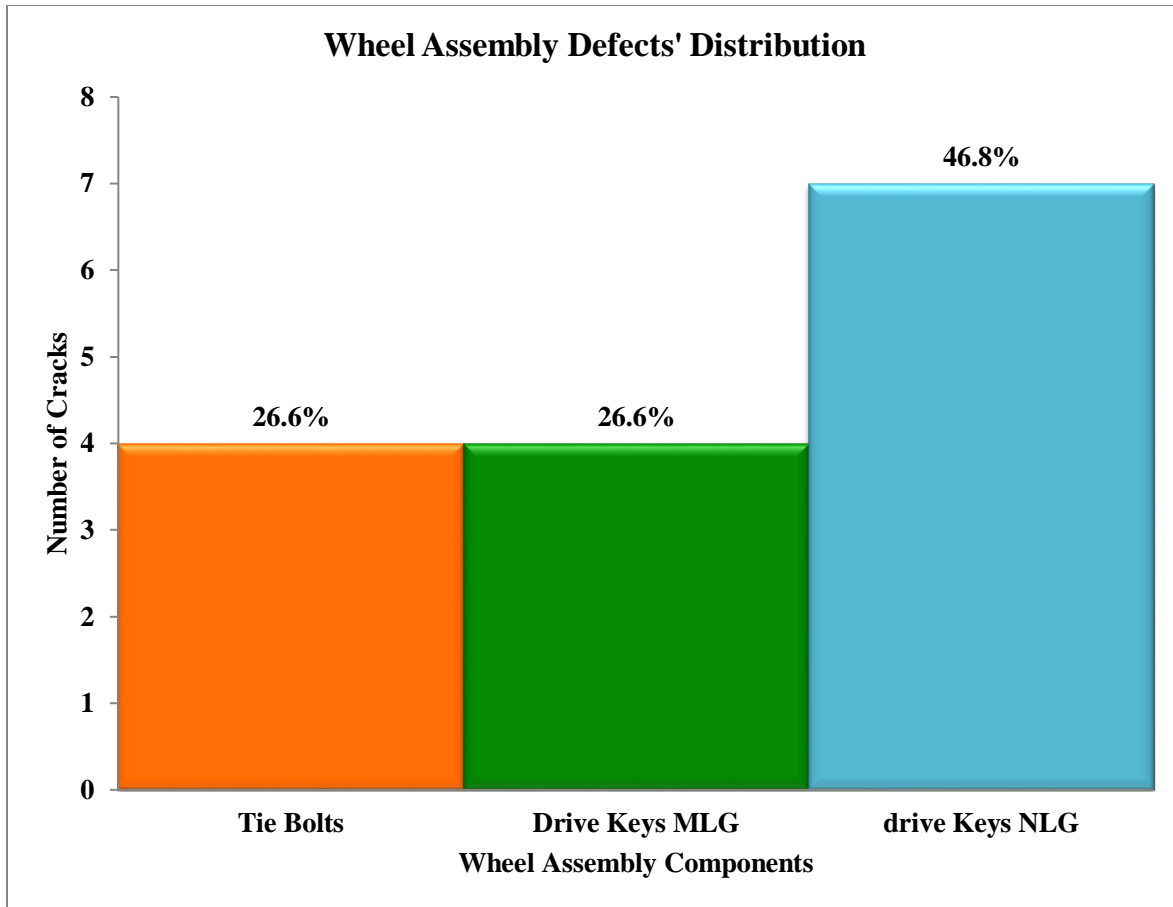
Figure 4.2: Distribution of Cracks in Wheel Assembly Components.

The aircraft components were inspected using MPI, UT and RT methods in accordance with aircraft technical manuals. Overall, there were fifteen crack defects, 2.5 mm - 10 mm (55.6%) of the wheel assembly components, most of which were concentrated in the Nose Landing Gear drive keys, approximately 47%. The high occurrence of cracks in the drive keys in the wheel assembly components were attributed to the proximity of these parts to the aircraft braking system.

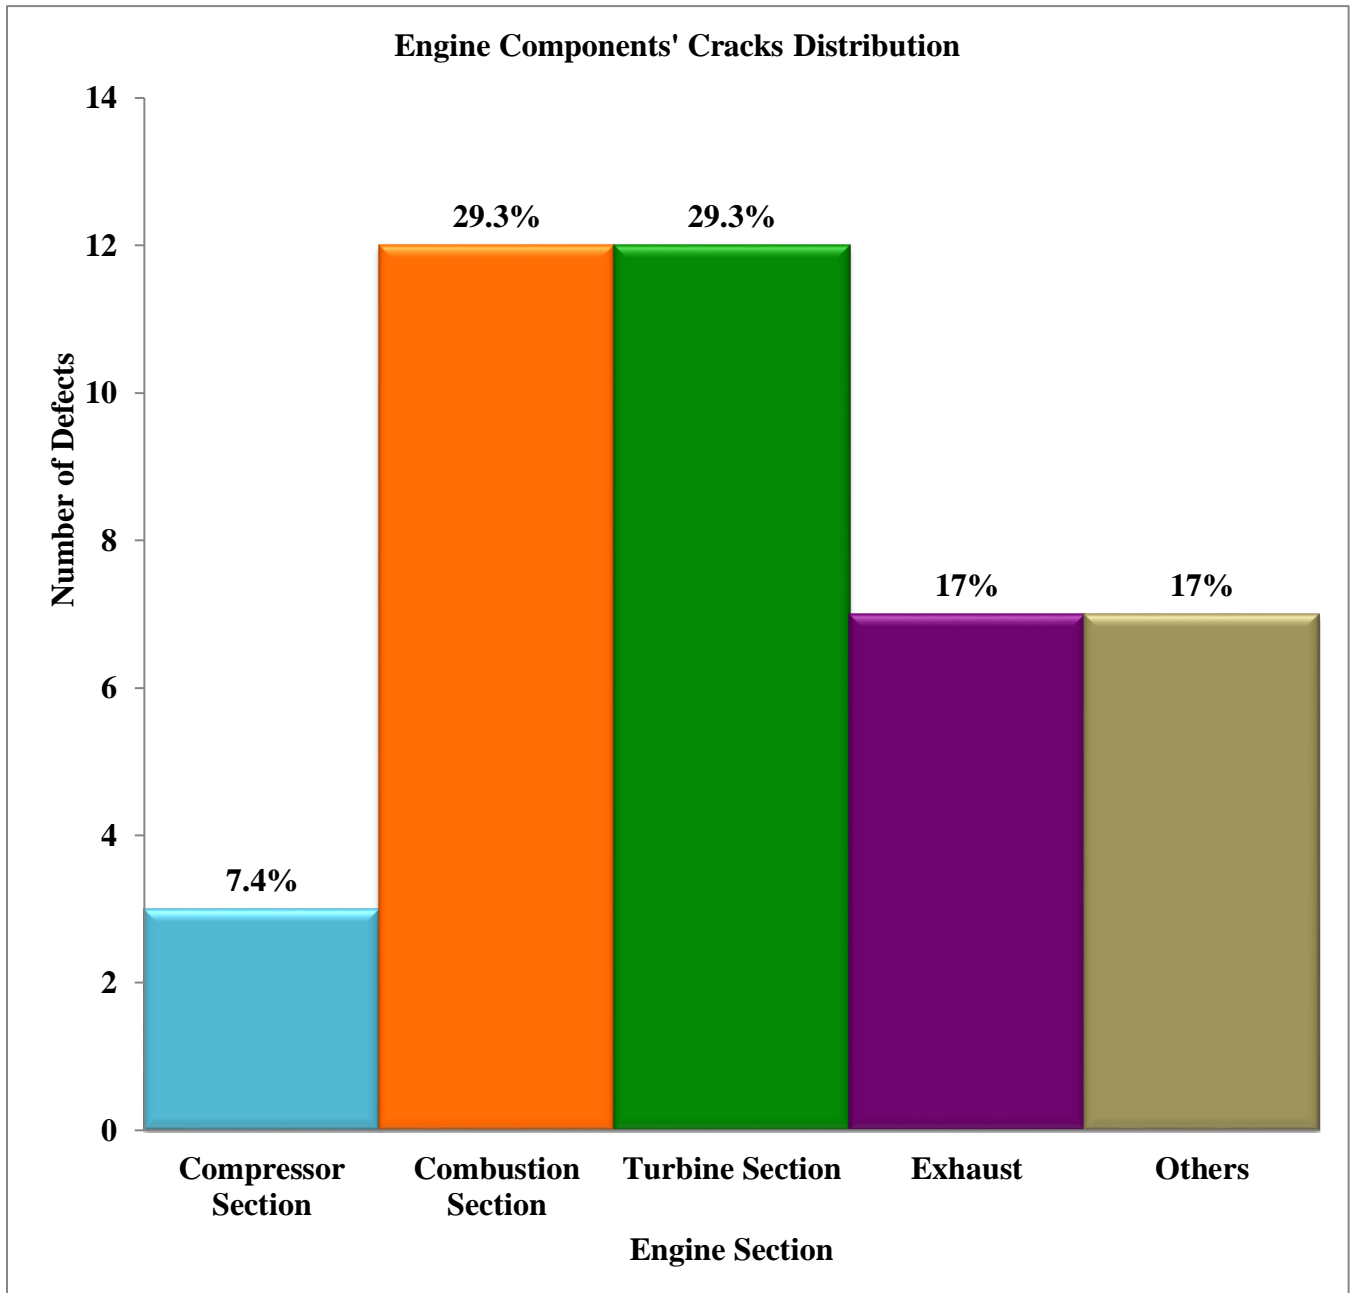
Figure 4.3: Distribution of Cracks in Engine Assembly Components.

Crack defects were found in all the engine components; highest, in combustion chamber at 24.4%, turbine section at 24.4%, followed by the exhaust section at 14.6%. Other engines components had less than 10% of other defects; corrosion, disbond and delamination. In general, the cracks defects varied between 1.00 mm - 220 mm, for corrosion between 5 mm - 40 mm, disbond between 1.8 mm - 3.00 mm and delamination between 0.5 mm - 1.00 mm. However, there were no defects found in the helicopter landing gear (Appendix 17).

The results of the forty three (43) engine components that were inspected, in this study; indicate that, forty one engine components (95.4 %) had defects in varying proportions; compressor section (7.4% - Fig. 4.3) and vary from 8 mm – 40 mm (Appendices 18, 19, 20, 21, 22, 23 and 24). The specification limits requires no defect whatsoever. The combustion section had 29.3% defects, ranging from 1.8 mm – 10mm in the inner and outer shell and the louvers but the

The exhaust and other engine components had 17% each of defects range from 3.0 mm - 220.0 mm (Fig. 4.3), (Appendices 37, 38, 39, 40, 41, 42, 43, 44, 45 and 46). For the exhaust section, the allowable limits are from 12.7 mm to 25.4 mm, whilst, no crack is allowed in the oil sump according to the maintenance manual requirements, and in case of any leakage, the sump flanges seals should be replaced. The highest crack defect size of upto 220 mm was detected in the aircraft after burner assembly in exhaust section and the component was immediately repaired using TIG welding (Appendix 42).

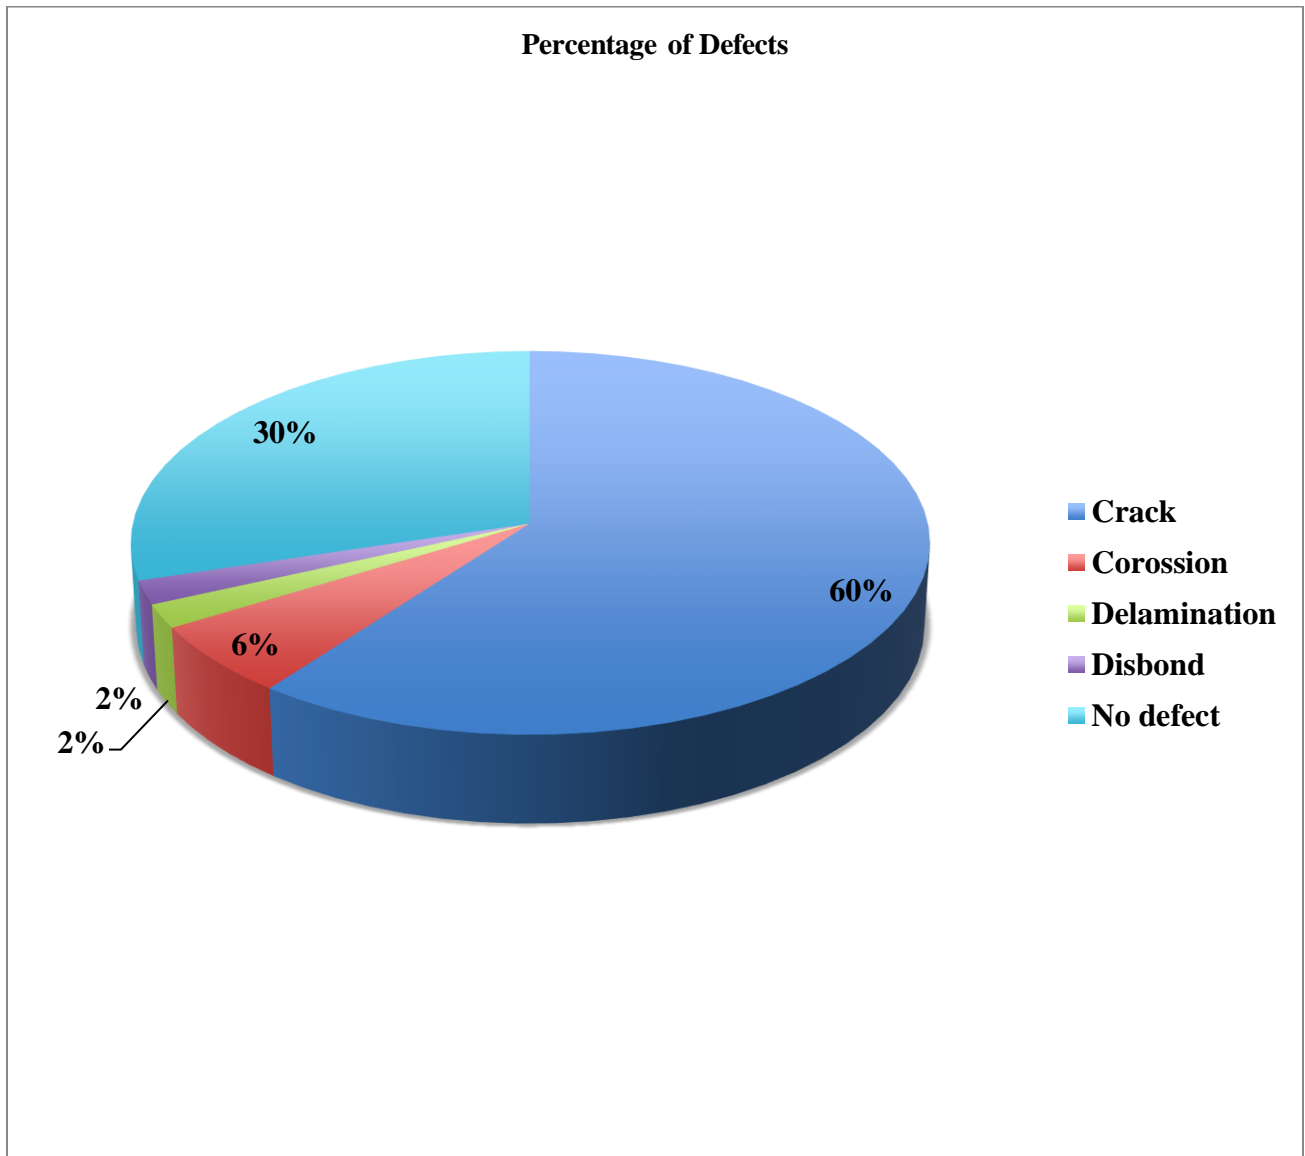
Figure 4.11: Prevalence of Defects in aircraft samples.

Of the one hundred and one (101) aircraft parts examined in this study, the following defects; cracks (60%), corrosion (6%), delamination (2%), disbond defects (2%) were found. Twenty nine samples (30%) had no defects.

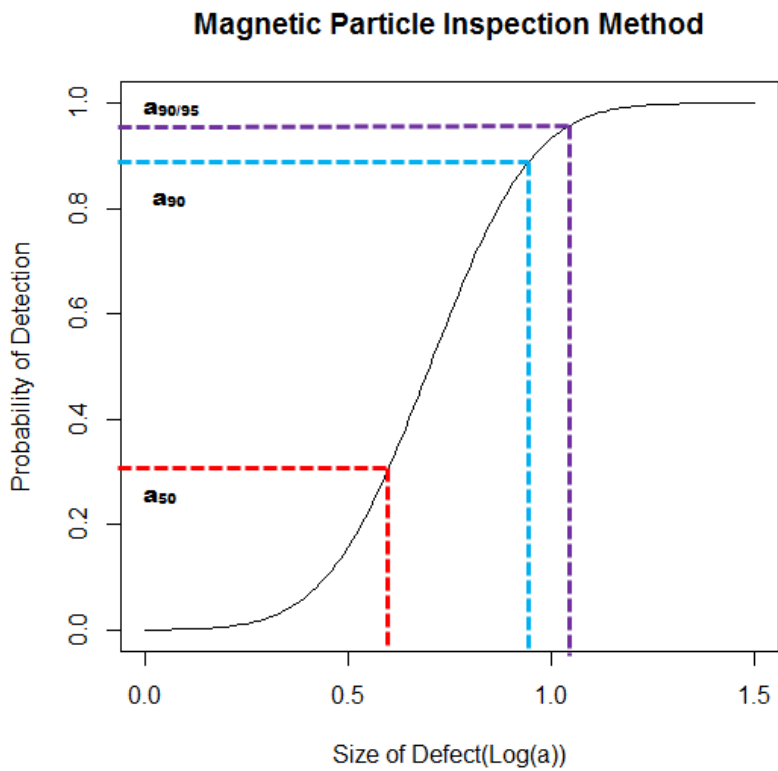
Figure 4.15: POD Curve for Magnetic Particle Inspection Method.

MPI method is appropriate in defect detection of both surface and subsurface defects of the aircraft landing gear and engine parts of ferrous materials, $a_{90/95} = 12.6$ mm (Fig. 4.15). However, demagnetization of inspected parts is required after the inspection. The method requires average skill to do the inspection and offers immediate results.

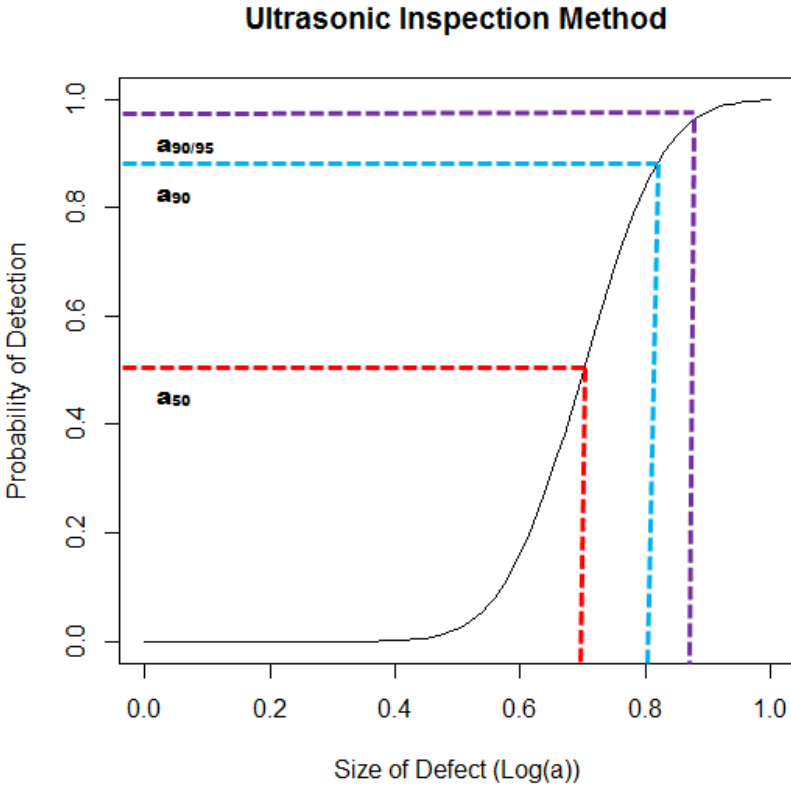
Figure 4.16: POD Curve for Ultrasonic Inspection Method.

The application of UT method was appropriate for use to detect size defects ($a_{90/95} = 7.1$ mm) (Figure 4.16). The UT Machine is portable and has the capability to detect surface and subsurface defects. The results are obtained immediately, however little part preparation is necessary prior to measurements. A wide range of aircraft wheel hub drive keys were inspected using UT and 63.6% were found defective with cracks indications. The limitation with this method was that, the sample surface had to be accessible to the probe, and is sensitive to interference from the rough surfaces and prone to sound beam-defect orientation. It also required high degree of skill to set up.

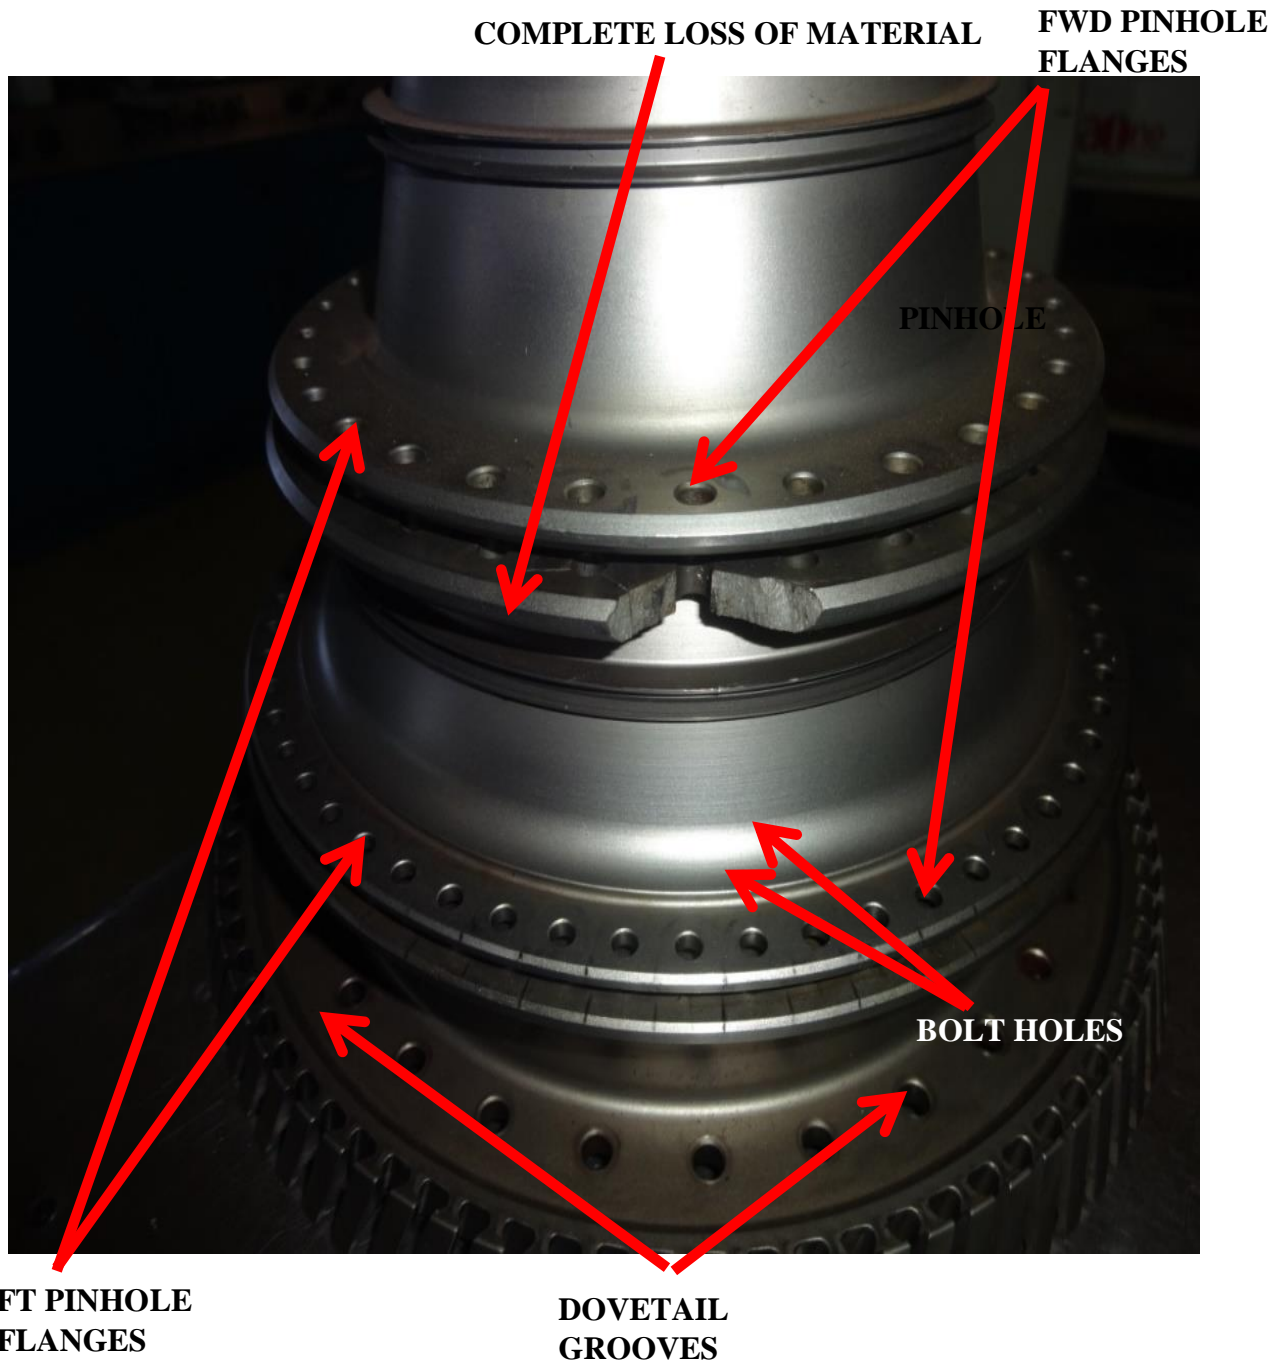
Appendix 19: Photo of Compressor Spool

25. POST INSPECTION PROCEDURES. - Compressor rotor to be replaced with a new serviceable rotor.

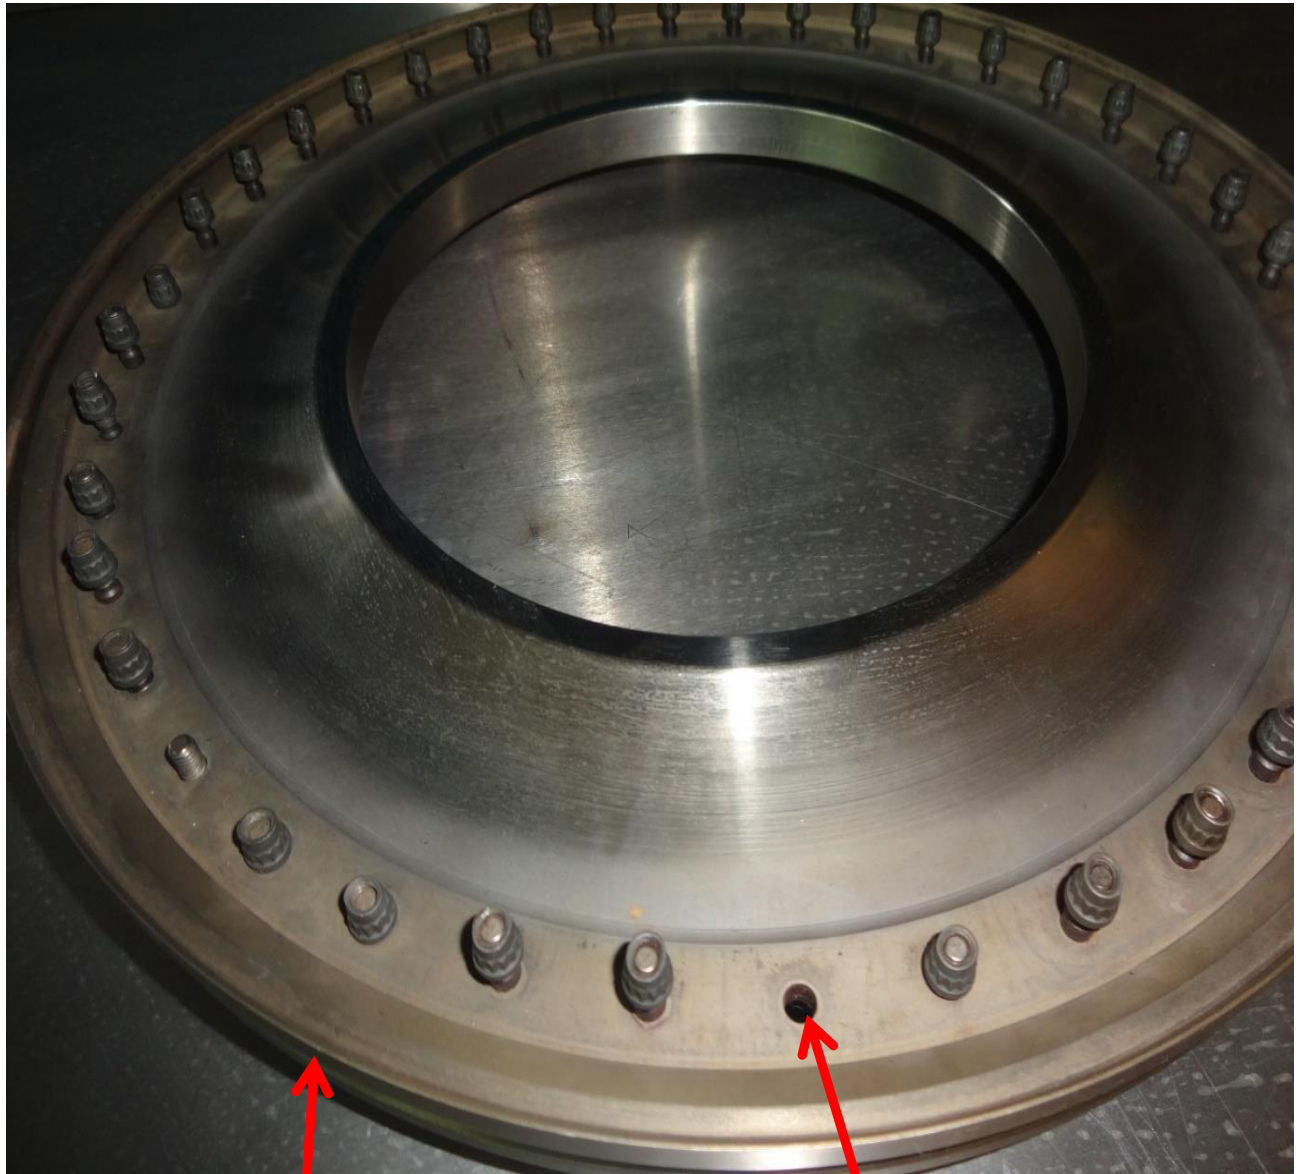
Appendix 24: Photos of Engine Compressor Section

25. EVALUATION - crack of 8.0mm on longitudinal magnetization. - No cracks from belt holes.						
26. POST INSPECTION PROCEDURE (DEMAGNETIZATION, POST CLEAN) - Demagnetize the part to magnetism less than 2 gauss.

COMPRESSOR DISK EDGE

BOLT HOLES

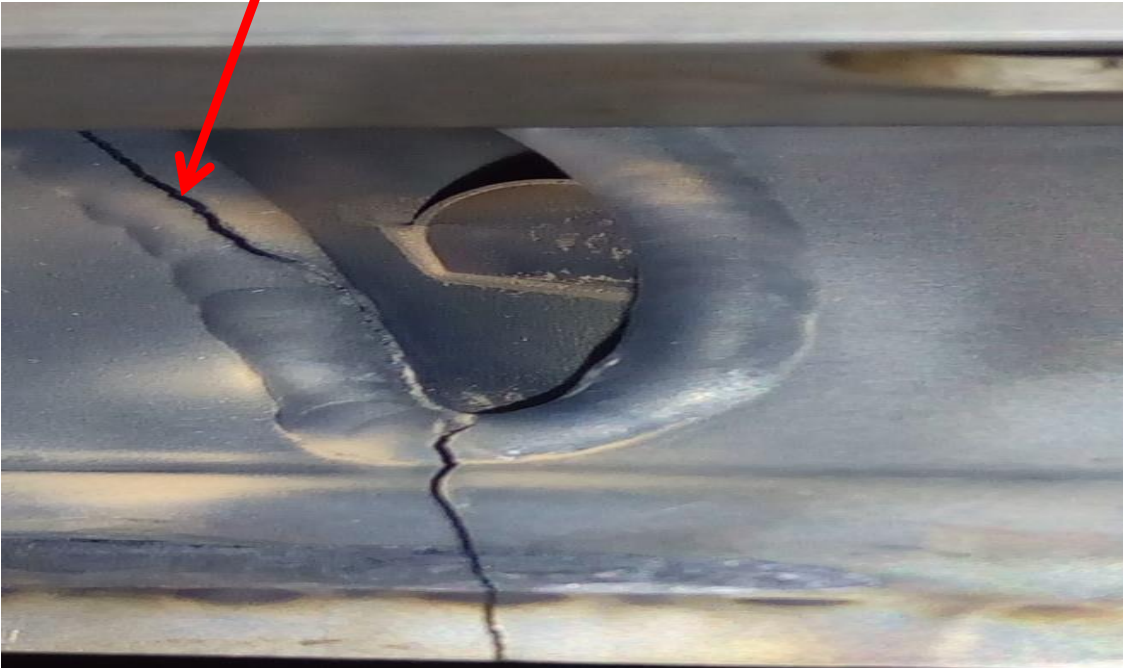
CRACKS AND BURNOUT VIEWED FROM FRONT AND SIDE

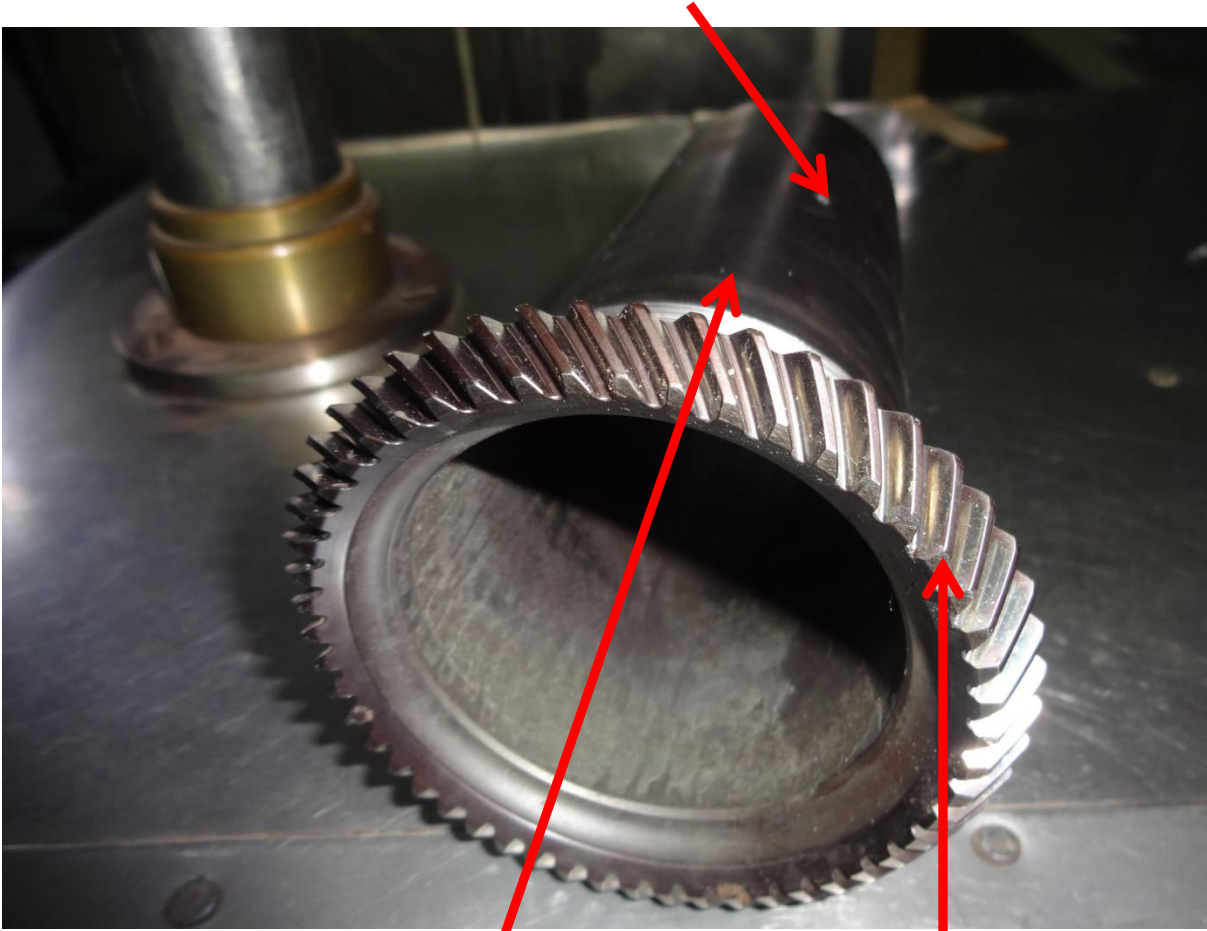
Appendix 36: Photos of PTO Driver Shaft Gear

HOLES ON THE SHAFT

THE SHAFT

BEVEL DRIVER GEARS

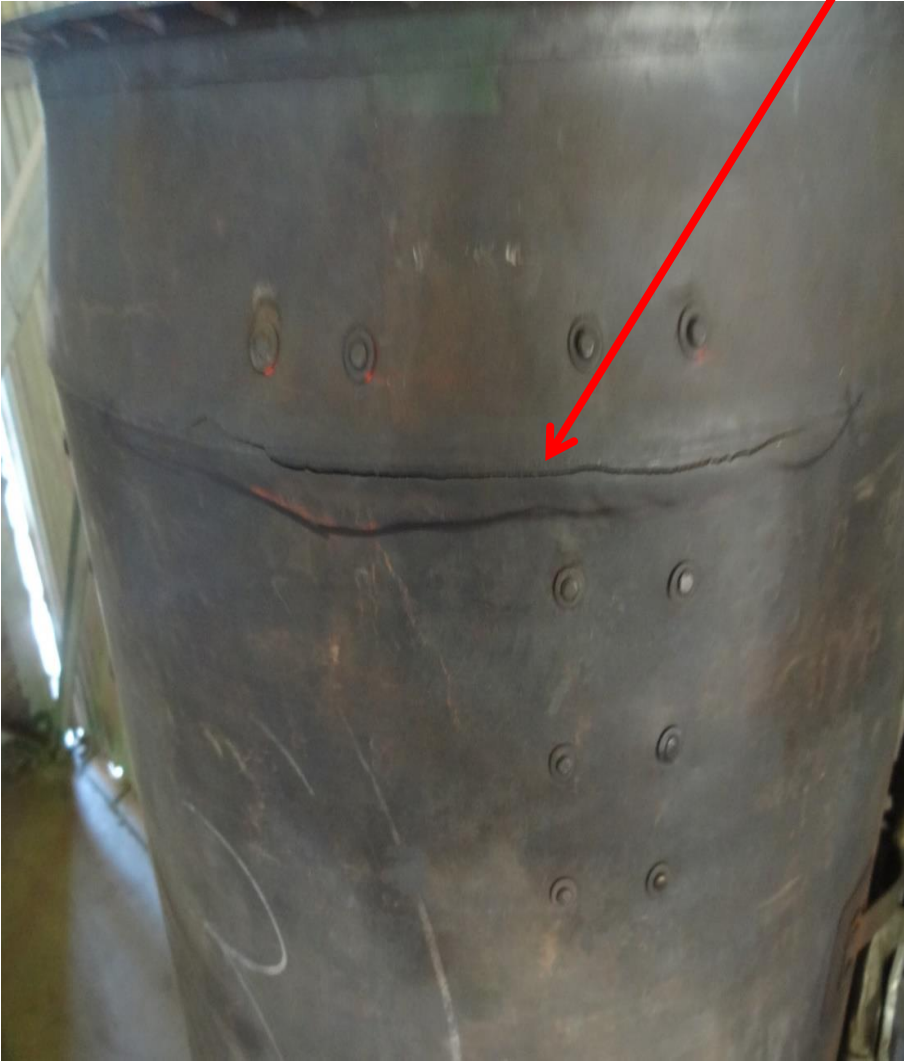
Appendix 42: Photos of Cracked Afterburner Assembly

Crack along the weld
