**TITLE: EVALUATION OF THE PERFORMANCE AND
SUITABILITY FOR USE OF VARIOUS FLOORING MATERIALS
IN STUDENTS' HOSTELS;**

**CASE STUDY OF THE HOSTELS IN THE UNIVERSITY OF
NAIROBI (MAIN CAMPUS) AND KENYATTA UNIVERSITY.**

**A PROJECT PAPER SUBMITTED IN PART FULFILMENT OF
THE**

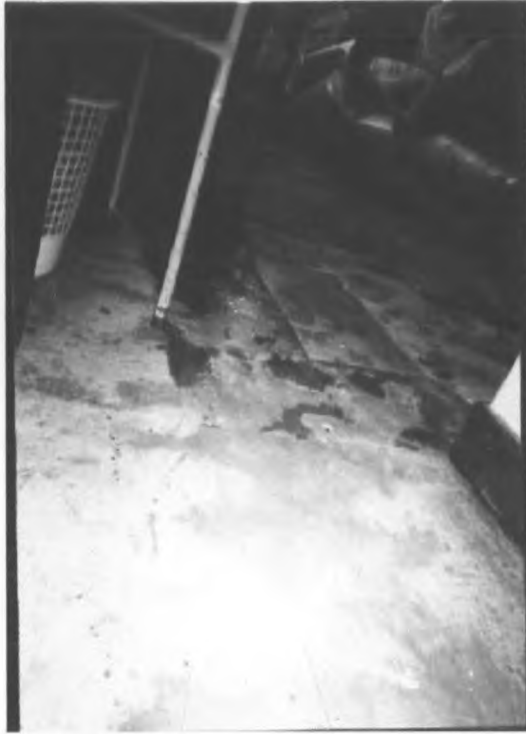
Plate 3

have virtually no single PVC on them. This explains some of the answers got from these halls saying, they have 'no finishes' on their floors. Refer to plate 3.

Refer to plate 3. The students here use double-Decker beds thus exerting too much pressure on the tiles, which the tiles cannot bear.

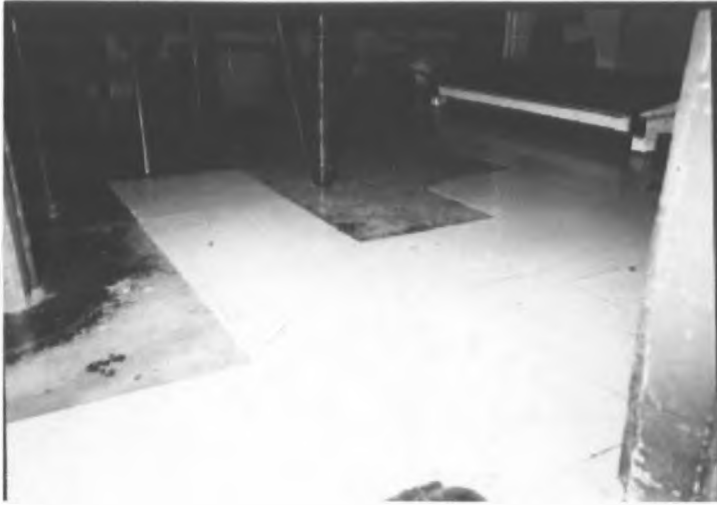
Plate 5

Both of these halls were built in 1972 and were finished in PVC tiles as they are today. The general conditions of the finishes can be described as ranging between fair to poor. The condition rating being 4.45, meaning the finishes can achieve only approximately 40% performance standards. See plate 5.

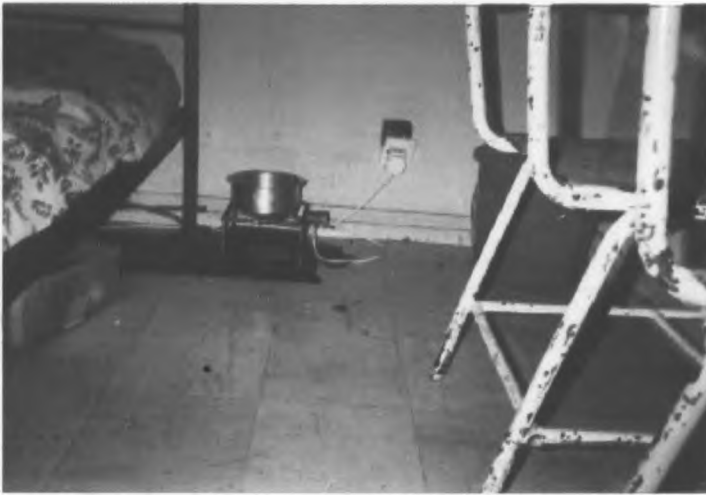
Plate 6

Both the halls studied are finished in PVC tiles 150x150x2mm thick and are suffering from various defects namely; lifting/arching, and peeling off the bed, and staining of the tiles. The double-Decker beds used in these hostels are found to cause the tile breakages under the legs of beds. See plate 6. Such a happening is not observed in Nairobi university, given use of double Decker is only limited to prefabs with screed finishes.

The tiles are also seen to have deteriorated at faster rates in situations where the occupants do cook directly on these finishes. This was also observed in some halls with the affected tiles burning up or peeling off the bed altogether. Refer to plate 6. This was also confirmed by the halls officers' response to the question on the same where they all indicated that they have noticed tiles peeling off the beds due to cooking by the students. This subjects the tiles to higher intensities of temperatures, which then weaken, and consequently destroys the bonds of the adhesives.

Approximately 87.61% of the students cook in their rooms with some putting the heater directly onto the floors. This has the severe effect on the adhesives used in bonding the tiles to the beds. This explains why some of the PVC tiles in such rooms are burnt or peeled off the beds. Refer to plate 6. This raises the temperature of these floors thus resulting into weakening of the bonds and consequently their failure.

(D) The use of double-decker beds on the floors finished in PVC should be avoided at all costs. They, the double-decker beds, were established to cause accelerated rate of floor finishes deterioration; mass peeling in PVC and pitting in screed, with worse effect on the pvc tiles. There is also need for use of leg spreader caps to help spread the concentrated loading from these structures, though the effect would be minimal.

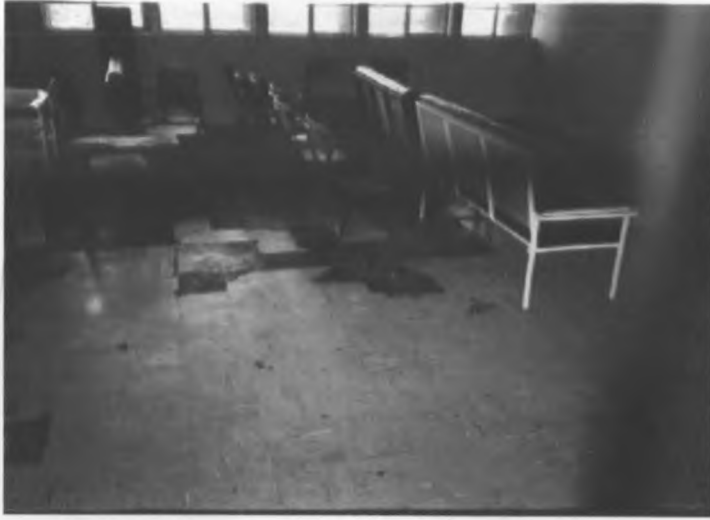
Plate7

These halls have two types of common spaces namely the TV rooms and Reading rooms both of which are finished in PVC tiles showing defects as Mass peeling off the bed, with a respective condition rating of 70% and 75% deterioration. See plate7.

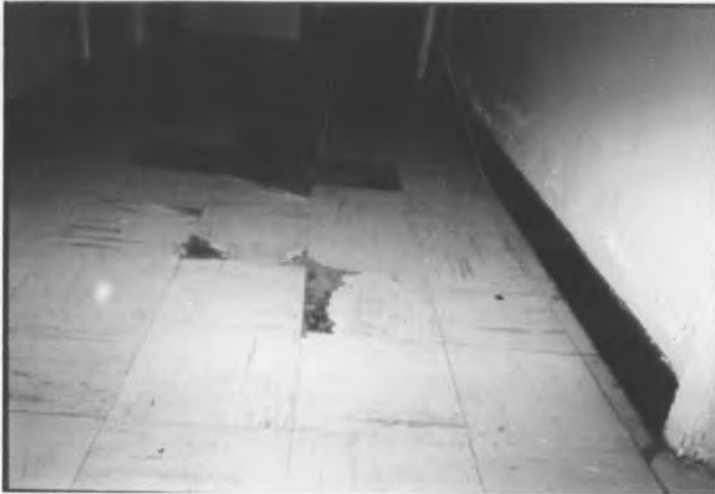
Plate 8

PLATE 8. Mass peeling off bed of PVC, particularly landing, Kilimambogo.

Corridors have materials as above, though the defects here are mass lifting and peeling of the tiles particularly those at the landings of staircase, See plate 8. The rating is 65% deterioration.

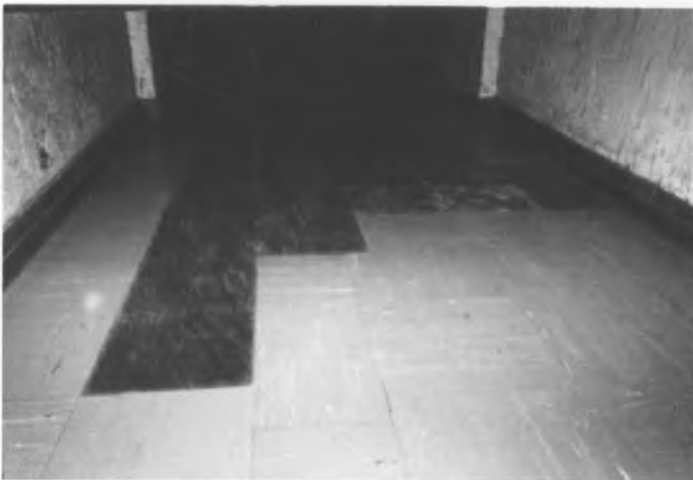
plate 9

PLATE 9. Mass peeling off bed of PVC in corridors, Ngong hills hostel.

Are also finished in PVC tiles with deterioration percentage of 70, suffering from lifting and peeling of the tiles off their beds. See plate 9.
