**UNIVERSITY OF NAIROBI**  
**FACULTY OF ENGINEERING**  
**DEPARTMENT OF CIVIL & CONSTRUCTION ENGINEERING**

**PAVEMENT EVALUATION OF KAMPI YA MOTO -  
ELDAMA RAVINE - KAMWOSOR B77 ROAD**

**MSC THESIS**

**NOVEMBER 2023**

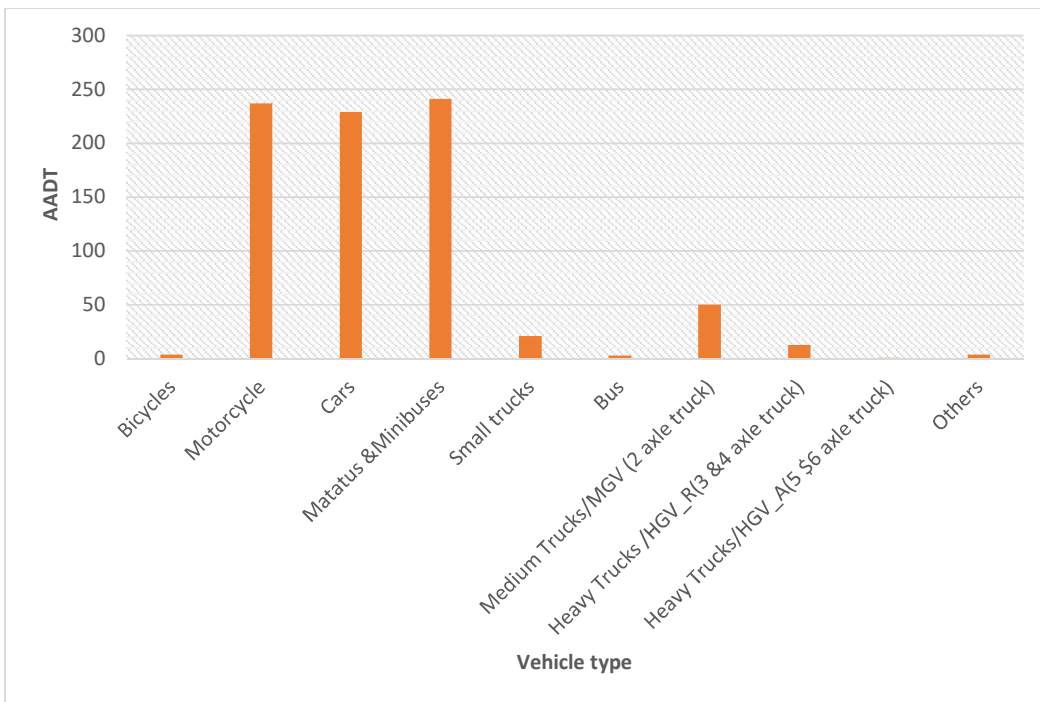
Figure 4-5: AADT of various vehicles along the project road

From Figure 4-5, the highest AADT was the matatus, followed by the motorcycles and cars, with 241,237 and 229, respectively. The high number of Matatus and minibuses in this section was due to the trend of public drivers offering public transport services to people living within the project road. The lowest were bicycles, buses and heavy trucks/HGV\_A, with 4, 3 and 1, respectively.

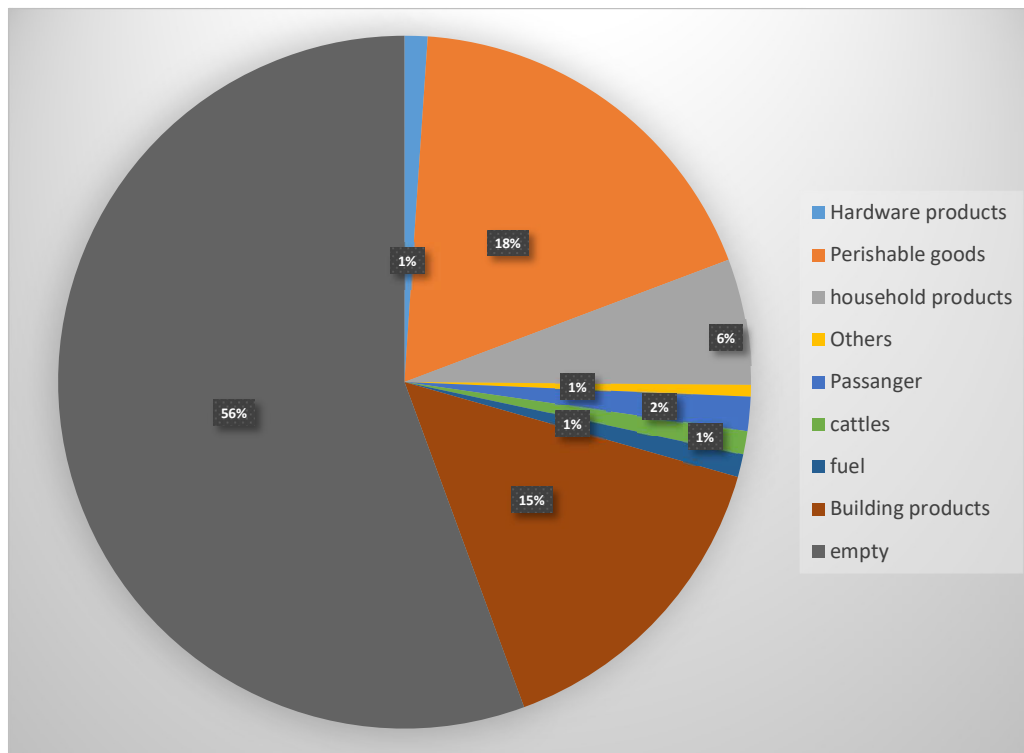
Figure 4-6: Types of Goods/Products Transported/Identified for each sampled vehicle at long the project road.

The pie chart recorded that the empty trucks surveyed were the highest at 56%, followed by the trucks carrying perishables goods at 18%, and finally, the building products such as Stones,

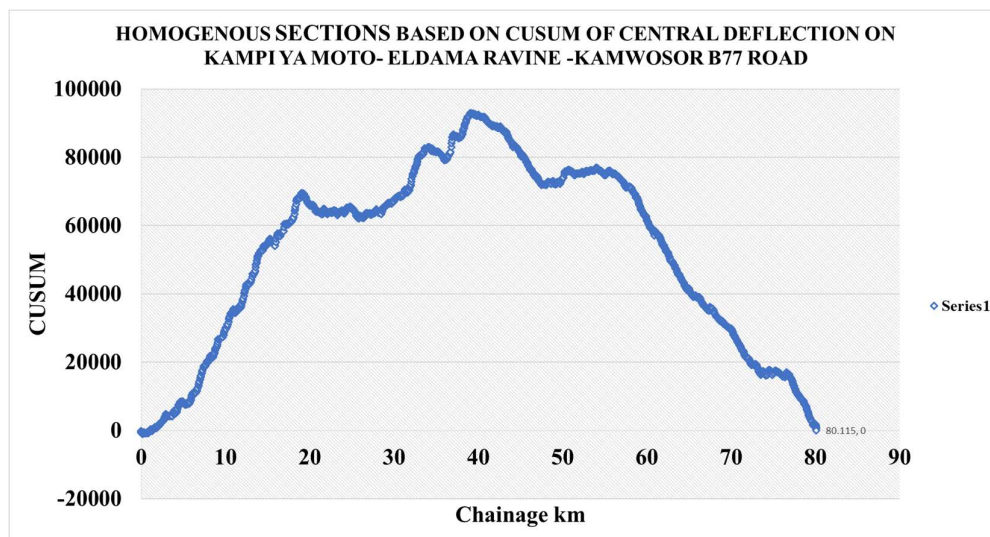
Figure 4-7: Cumulative Mean Difference from Mean (CUSUM) Values of Deflections on Bitumen Pavement of the Kampi ya mot- Eldama Ravine- Kamwosor (B77) Section

The computed CUSUM value is graphically presented in Figure 4-7, indicates that the existing bitumen pavements on the project road have the following homogeneous sections: -
